Restoration of the feudal castle of Ventimiglia family in Castelbuono (Pa)

Federica SCIBILIA,¹ Marcello LA GUARDIA²

⁽¹⁾ Dipartimento di Architettura, Università degli Studi di Palermo, Palermo, Italia

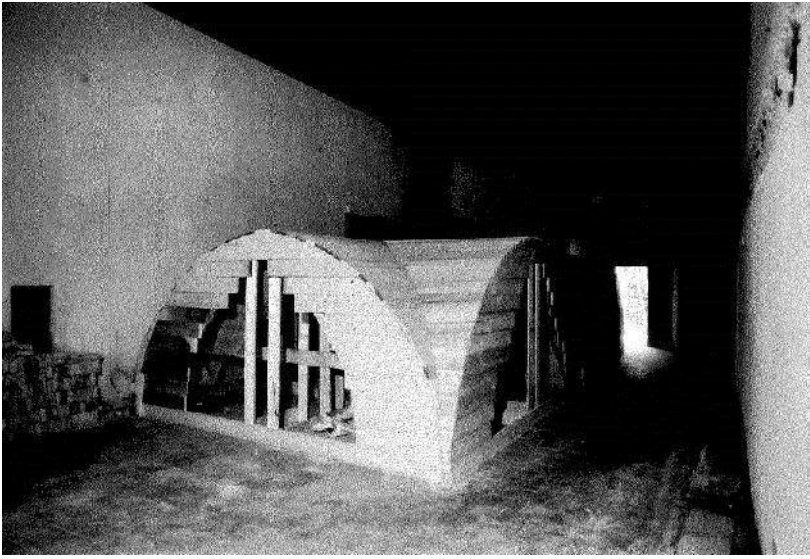
Fig. 7: Preparation of the cross vault ribs.

In two specific cases, the advanced state of instability of the vaults involved the disposal and subsequent reassembly:

- the cross vault that covered the vestry, for which it was decided, by mounting a special bending wood, the disassembly of the upper part, the numbering of all segments shaped, and the subsequent replacement;
- the cross brick vaults, that covered the landing of the middle floor, for which was carried out the reconstruction.
