Forensic Analysis of Fire in a Substation of a Commercial Center

G. Ala, *Senior Member, IEEE*, S. Favuzza, *Senior Member, IEEE*, M. Mitolo, *Fellow, IEEE*
R. Musca, G. Zizzo, *Senior Member, IEEE*

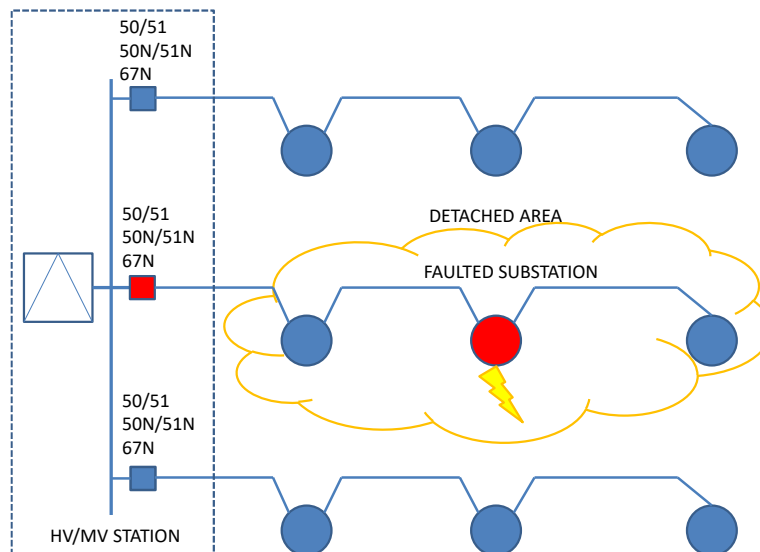
in Italy. The fire destroyed the MV switchgear and cables and the LV switchboards inside the substation and caused the tripping of the protective device of the electrical utility located at the upstream High Voltage-Medium Voltage (HV-MV) station. The operation of this protective device caused a black-out in the area where the shopping center was located (Figure 1). The loss of revenue, and the consequently hazardous conditions, prompted the electrical utility to take legal action against the owners of the shopping center, which were sued for damages.

Fig. 1. Black-out caused by the fire in the faulted substation.

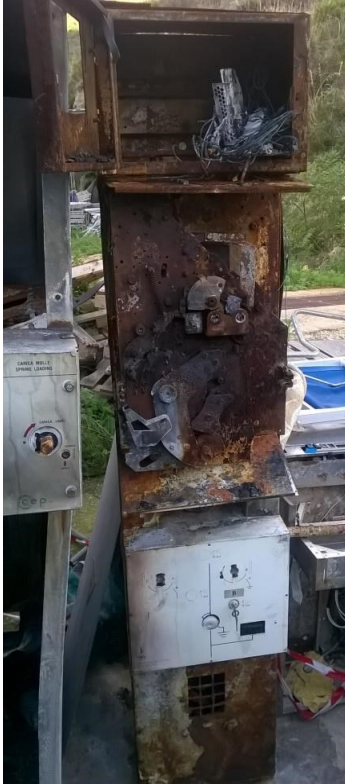
Particular 1. 1st Switchgear

parts or a documented chain of custody. The physical evidence was stored in an outdoor area, exposed to weather, which compromised its integrity. The artifacts remained in the outdoor area for months before their inspection was scheduled. During the multi-party examination, large metal areas of the switchgears were covered in rust (Fig. 3) and several electrical components were missing.

Fig. 3. Pictures of a fire-damaged MV switchgear.

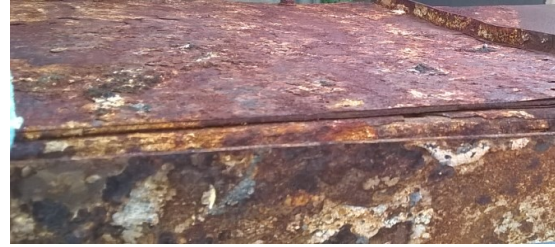
Particular 2. Presence of rust

The artifacts were neither marked for proper identification at the accident site, nor properly stored in the storage area. Thus, during the inspection was not possible to find evidence to determine possible ignition points within the artifacts, where the fire may have started.
