Effects of corrosion on a steel bowstring bridge in marine environment: a case-study of assessment and retrofit

Michele Fabio Granata^{1*}

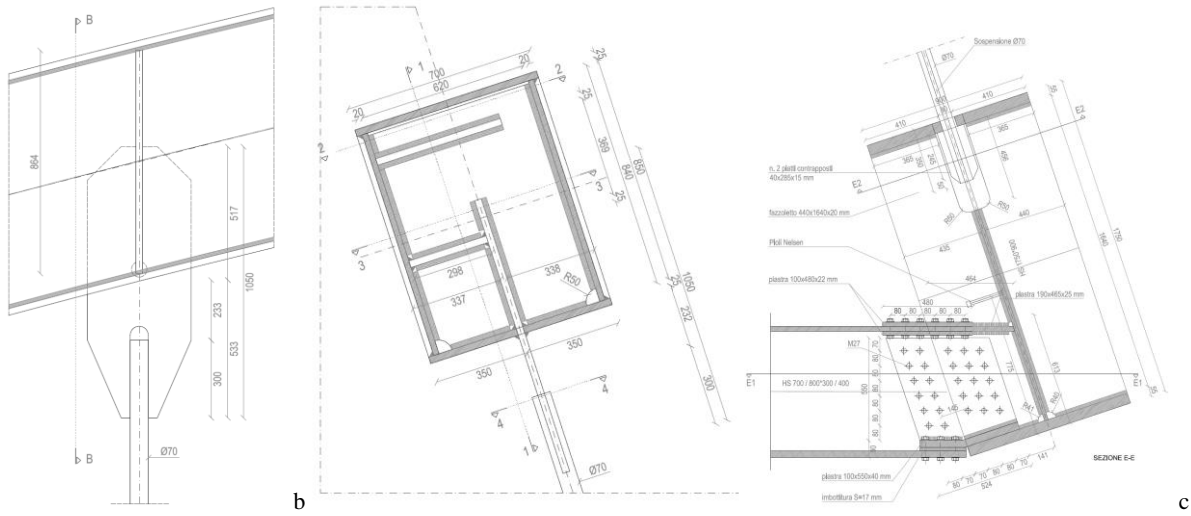
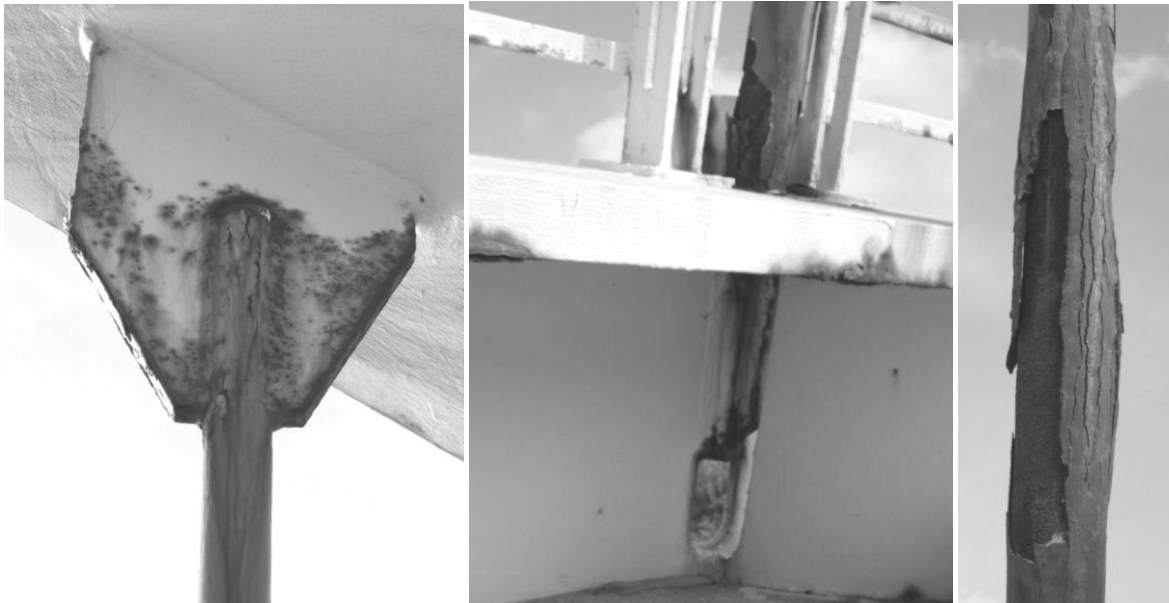
Figure 3. Hanger attachment joints (welded connections) to the arch (a,b) and to the main beam (c). Views of corroded hangers and attachment joints (d)

245 a) the lower junction of the hanger welded to the web of the main beam (fig. 3c);

246 b) the upper joint of the hanger welded to the connection plate to the arch box (fig 3a,b);

248 In the lower junction of the type (a) there were many surface defects due to the high degree of corrosion with some
249 cracks, mostly superficial. No deep cracks emerged that seem to compromise the tightness of the joint.

250 For the upper joint of type (b) there were surface defects and advanced corrosion in some upper plates, especially
251 in the lower area of the connection (lower point of attachment between the hanger bar and the connection plate)
252 with exfoliation and deep incision of the weld due to oxidation. The tightness of some connections is therefore to
253 be considered compromised.

260 From the analyses it can be concluded that while the joints of the hanger with the deck beam, although corroded,
261 are not of particular concern, the situation of the joints at the top of the hanger with the arch and the coupler joints
262 are to be considered damaged by corrosion with some elements that cause particular concern for the joint strength.

263 In addition, at the base of the hanger high corrosion damage is located when the hanger passes through the hole in
264 the beam upper flange.

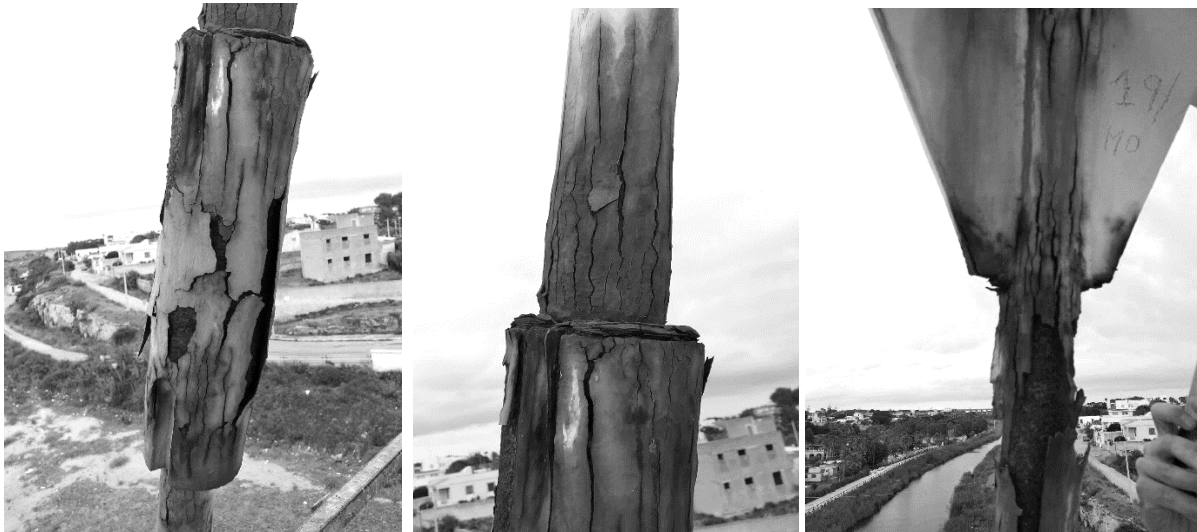
Figure 4. Pictures of hanger corrosion: bar coupler and upper joint welded to the arch

247 c) the coupler joint with welds between the coupler and the bar of the hanger (fig. 4).

254 For the joint of type (c) between the hanger and the coupler, very significant defects were found due to the
255 extremely high state of corrosion, especially in the upper attachment areas of the coupler, with exfoliation of the
256 coupler body, fractures on the welds and reduction of the cross-section at the attachment of the hanger bar. This
257 situation made it impossible to carry out an internal investigation of the welds, since cleaning with sandblasting
258 would be necessary before reaching the still effective area. As a result, many coupler joints are limited in
259 functionality and unreliable.

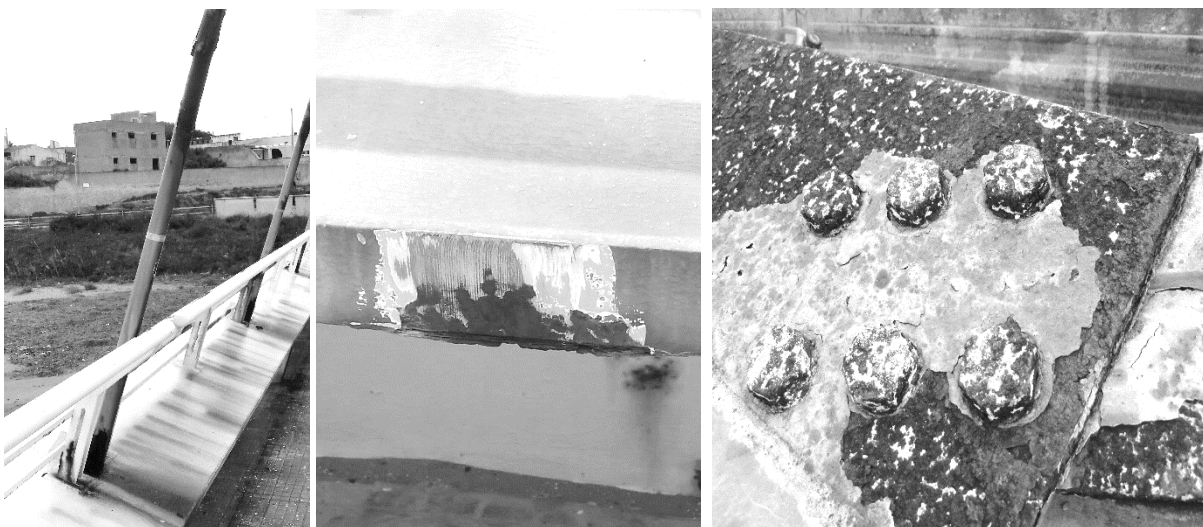
Figure 5. Pictures of member corrosion: joint of hangers to the principal beam, pitting in the principal beam, transverse beam bolt connection

114 Corrosion is also localized in some areas of the beam (inner edge of the upper flange, attachment
115 areas of the hangers, lower transverse beams and bolted connections, etc.) and of the arch (connections
116 with the transverse beams, drains on the inner area and outside of the web). In some points, pitting
117 phenomena were detected, i.e. very localized corrosion that goes deep inside the steel section, compared
118 to the surrounding areas [8].

119 The deterioration of structural elements is mainly caused by corrosion in the marine environment. In
120 this specific case, the high rate of corrosion is the essential element to be faced in the assessment because
121 after fifteen years of life the bridge shows signs of serious damage, especially for the hangers, despite
122 the fact that maintenance has already been carried out. Corrosion proceeds in these elements very
123 quickly, even under the skin, that is, under the detached coating, with inhomogeneity on the surface, and
124 concentration of deep corrosion in some points up to pitting phenomena (fig. 5), exfoliation and fractures
125 with reductions of steel cross section.

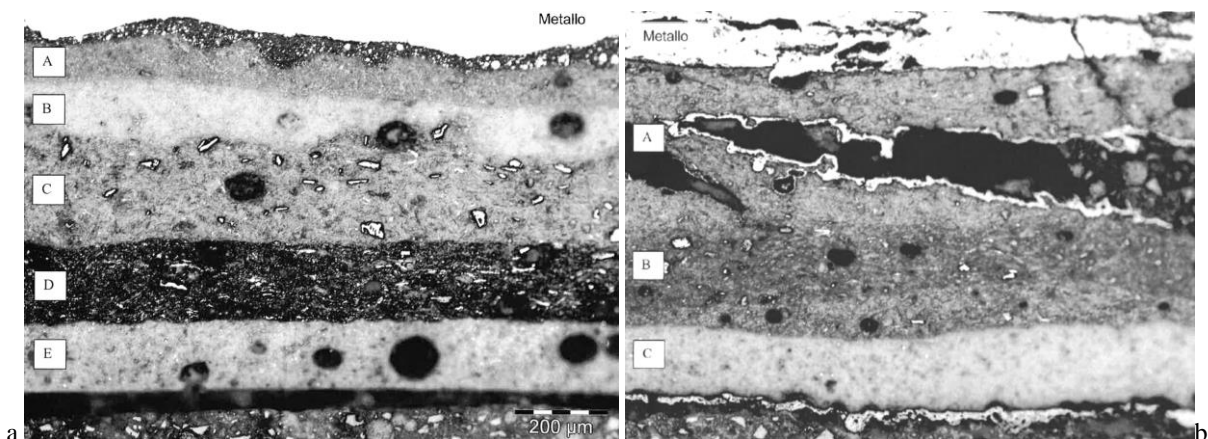
Figure 6. Microscope sections (100X) of two samples: a) deck beam; b) hanger

The results of the samples always show five different coating layers indicated with the letters A to E starting from the steel towards the outside (fig. 6a). Layer A is always an attack; in general it appears that the first three layers A, B, C refer to the period of construction, and the layers D and E to a later period, referable to the maintenance intervention carried out in 2010. The thickness of layers A and B is always around 100 μm , layer C doubles to about 200 μm , and layers D and E are instead about 140 μm thick each. The overall thickness of the coating package is approximately 700 μm , compatible with the average of the coating thicknesses detected by the in-situ tests. Evidently in these cases, the 2010 intervention only cleaned the surfaces of the previous coating and the epoxy-based Surface Tolerant paints overlapped those already present; here when layers are well bounded, the steel is well protected from corrosion. No traces of previous galvanizing layers were detected.

The result of the hanger samples instead shows 3 layers (fig. 6b):

- the inner layer is indicated by A and it is very thick (about 350 μm) with showy inclusions of oxides, hence it refers to the three original layers detected in the other samples covered in turn by the post-construction intervention. Here the painting was carried out on an already oxidized surface, in the absence

183 of a thorough cleaning of the steel support, or without sandblasting.

184 - The outer layers B and C are therefore attributable to the maintenance intervention carried out in 2010.
185 Unfortunately, the investigation on the hanger shows that the cleaning was not thoroughly carried out; hence the
186 application of the paints included the oxidized layer and the progression of corrosion continued in time. This may
187 explain the advanced state of corrosion suffered by the hangers compared to other elements.

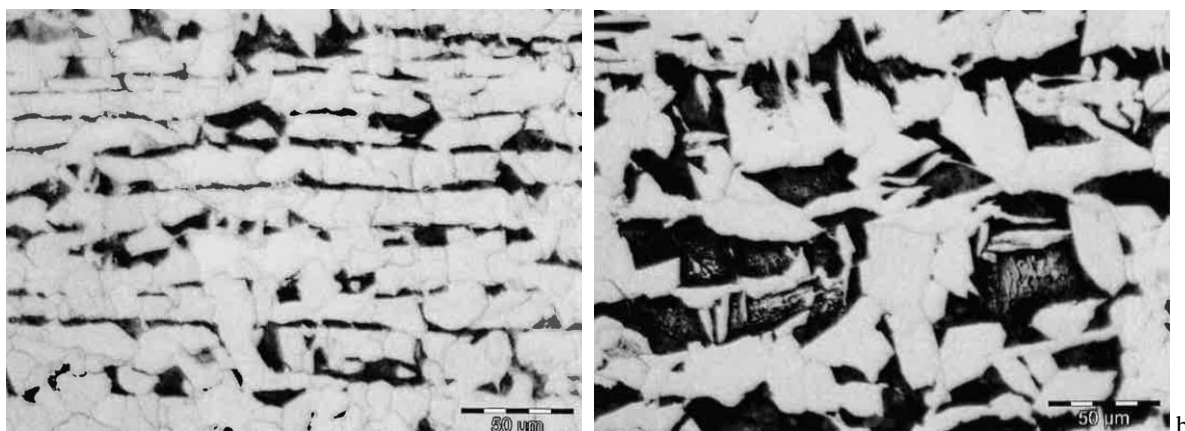
277 Metallographic analyses were carried out under the microscope on the four in-situ samples. Samples W1, W2 and
278 W3 appear with ordered structure without defects and with medium-sized grains. Samples W2 and W3 show a
279 band structure typical of structural elements with hot laminated steel, with longitudinal arrangement of the pearlite.
280 From the metallographic point of view, the samples have comparable characteristics in the distribution of pearlite
281 within the ferritic matrix. Sample W4 (taken from the deck steel beam) has a larger size and quantity of pearlite
282 grains than the other samples. The strength and hardness of this steel were higher than the others, as was the
283 percentage of carbon. From the comparison it can be said that the steel used for the main beam is different from
284 that used for the other elements. The best results provided by the mechanical tests on sample W4 (deck beam)

285 seem to be confirmed by the metallographic analyses (fig. 7); comparison of the metallographic analyses, strength,
286 hardness and chemical compositions seems to assign a reduced mechanical performance to the other elements, in
287 line with the onsite investigations.

289 a
290 *Figure 7. Metallographic views under the microscope (500X). a) steel with minor size of pearlite grains; b) steel*
291 *with major grains and best strength properties*
292
