# **Some experiences about the retrofitting of tower masonry structures**

L. Cavaleri & G. Zingone

*Dipartimento di Ingegneria Strutturale e Geotecnica,  
Università di Palermo, Italy.*

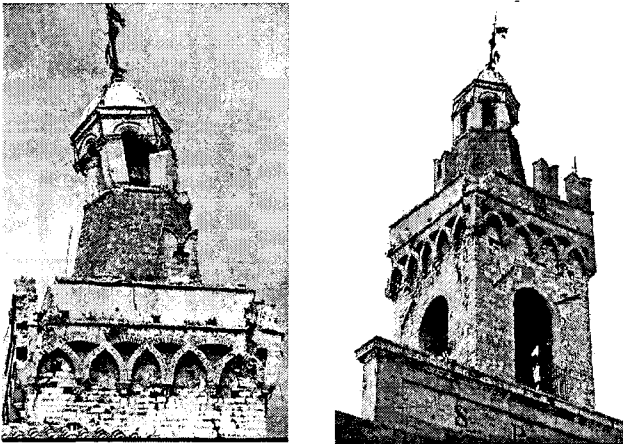
The high vulnerability of the ancient masonry tower structures with respect to the normal loads suddenly suggests the low capacity that these kind of structures may have with respect to the seismic loads. Certainly the brittle behaviour of the masonry associated to the generally little dimensions of the base, where the stresses are bigger, doesn't help to remove this statement. As an example in Fig.1 the collapse of the bell tower of the Foligno town hall during one of the Umbria-Marche earthquakes on September-October 1997 is depicted.

Figure 1: Two views of the bell tower of the town hall at Foligno, collapsing during the Umbria-Marche earthquake in the 1997

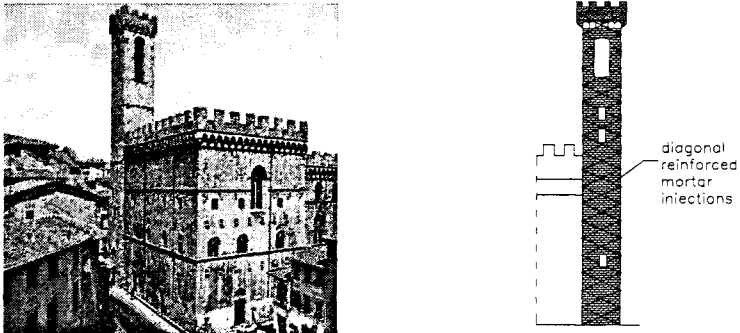
Figure 2: Rehabilitation of the Bargello tower at Florence

In some cases reinforced injections are used in order to enhance the capacity of the masonry with respect of tensile strength. For example the Bargello tower in Florence was improved by means of diagonal reinforced injections displaced along the height of the tower (see Fig.2).

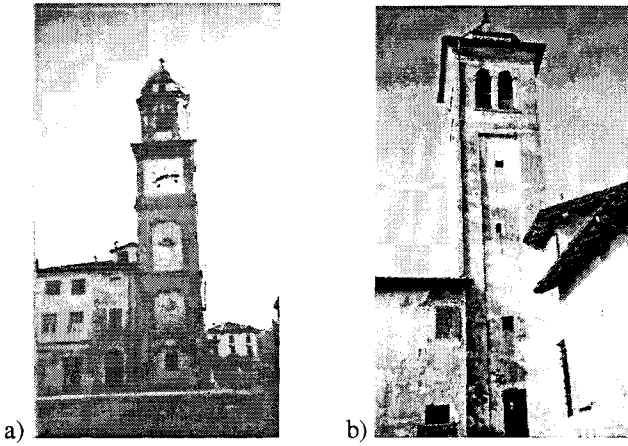
In other cases the mortar injections are coupled to other kind of improvement devices. For example the S. Martino in Rio Civic Bell tower (Fig.3-a), damaged during the earthquake of October 15<sup>th</sup> 1996 that interested the area around Modena and Reggio Emilia, was retrofitted by means of special mortar injections, aimed at re-establishing the continuity of the cracked masonry; then the insertion of 16 post-stressed steel bars into the walls (connecting the bell cell to the foundations) was taken in place in order to increase the bending resistance [3].

Also the bell tower of San Giorgio church at Trignano (Fig.3-b), damaged during the above mentioned earthquake, was repaired by using steel vertical post-stressed bars, but in this case the bars were placed in series with Shape Memory Alloys (SMA) devices (Fig. 4), which are able to recover totally the

Figure 3: a) Civic bell tower at S Martino in Rio; b) Bell tower of S. Giorgio church at Trignano

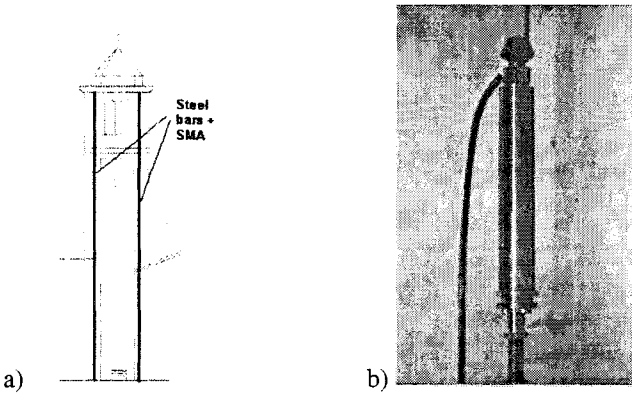
Figure 4: a) Layout of improvement devices in S Giorgio church; b) SMA device

deformation and dissipate energy at the same time. In this case the dissipation features of the structure were highly improved.

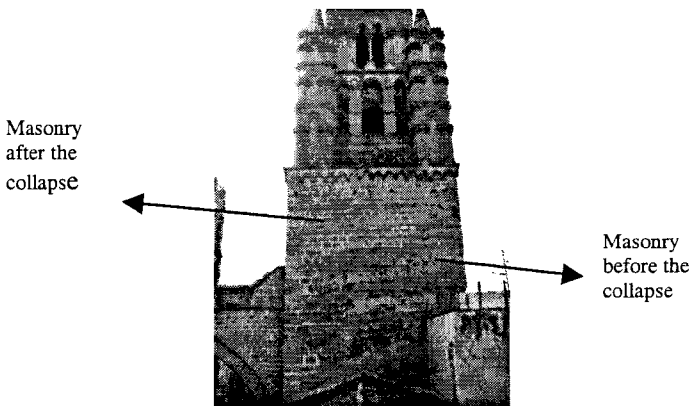
In the XIV century the Cathedral and the tower were reformed for the desire of having a symbol more and more great. The most important reform was the raising of the bell tower that produced in 1350 the partial collapse of it and the arches. Subsequently the tower was restored thanks to the intervention of the Pope in Rome. The signs of the collapse are still in evidence, as a matter of fact, on the North-East side, a line inclined toward the Cathedral divides the masonry realised before the collapse and after the collapse (Fig.6).

Figure 6: The North-East side of the bell tower of Palermo cathedral constituted by two different kind of masonry, before and after the collapse of 1350

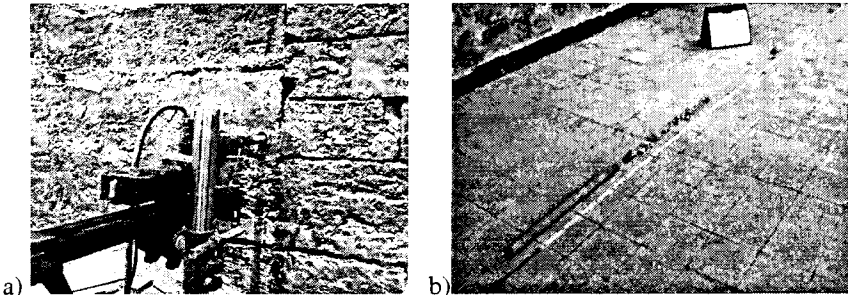
On the walls of the tower 22 horizontal and 13 vertical perforations were done by means of an hole drilling machine (Fig.7-a) for the extraction of cylindrical samples of the masonry, further 3 manual surveys were executed. Several samples of mortar were chosen among the extracted material after the perforations for the chemical analysis. Then stone specimens were obtained from the extracted materials for their mechanical characterisation. The internal structure of the walls was observed through the holes and the rate of empty spaces, the type of resistant materials with respect to the external ones and the conditions of the internal joining mortar were defined. A sample of an extracted cylinder is shown in Fig.7-b where a difference between the features of the internal and external masonry can be seen: the first is constituted by high strength calcarenite stones of great dimensions while the second by an aggregate impossible to extract in the cylinder form for its little strength. The same fact was observed for every perforation.

Figure 7: a) Hole drilling machine; b) extracted cylinder

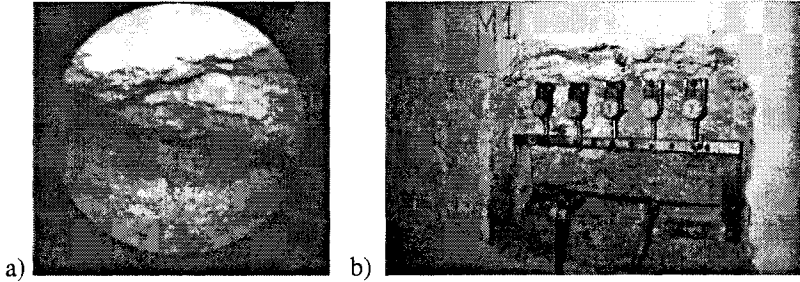
The state of the internal masonry was further observed by endoscopic camera. In Fig.8-a the absence of joining mortar between two ashlars causing a not correct transferring of the stresses noted by endoscopic camera is showed.

The mechanical features of the calcarenite stones were evaluated referring to cylindrical and cubic specimens. Moreover the tensile strength was evaluated by means of the indirect tensile test (Brazilian test). The mortar was chemically analysed and compared with similar composition mortars with known mechanical features. The level of the acting stresses in the masonry was evaluated in situ by means of the flat jack test (Fig.8-b).

Figure 8: a) Endoscopic camera view; b) Flat jack test

Values of the stresses compatible with the materials used were obtained.

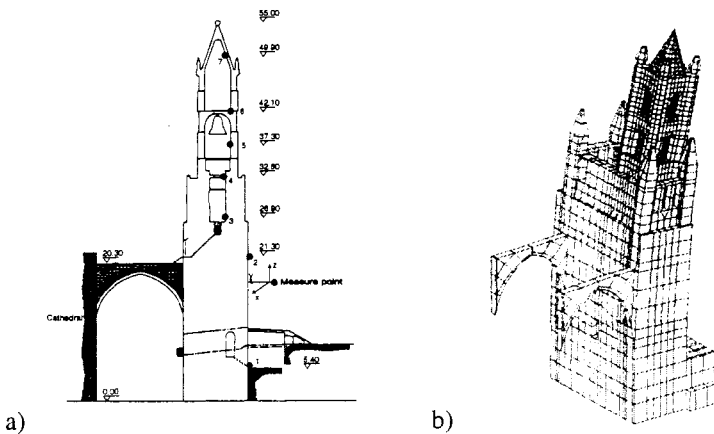
The dynamic response of the structure to the environmental noise (urban traffic, wind, etc.) and other usual excitations (for instance the bell moving) was recorded. Seismometers located in different points of the tower were used to this goal (Fig.9-a). The simple observation of the response gave the first information about the stiffness of structure and the constrain degree of the tower with the arches that connect it to the Cathedral. Then the response was analysed by means of proper identification algorithms and the analytical model of the tower was obtained (Fig. 9-b)[6,7,8]. The seismic analysis was performed and the weakest zones of tower were localised [9].

Figure 9: a) section of the tower with measure points; b) model of the tower - first modal shape (1.70 hz)
