The stabilisation of a slope-viaduct system without closing traffic

C. Valore^{*1} and M. Ziccarelli¹

¹ *DICAM - Dept. of Civil, Environmental, Aerospace, Materials Engineering - Università di Palermo, Italy*
^{*} *Corresponding Author*

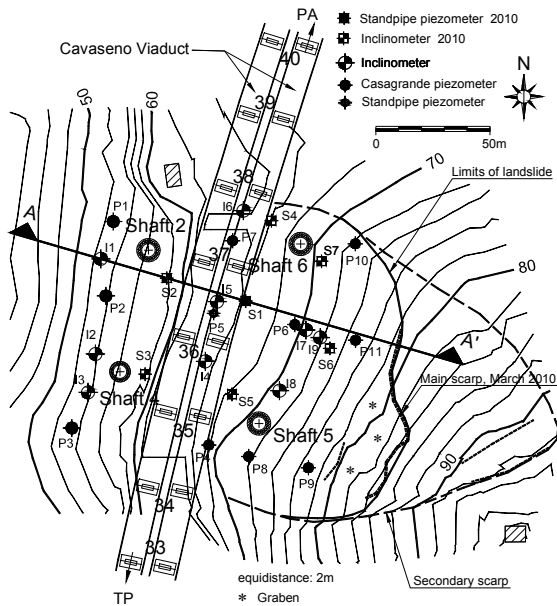
Figure 1. Schematic plan with location of viaduct, boreholes drilled soon after the occurrence of the landslide (S1-S7), other piezometers and inclinometers installed subsequently, and drainage shafts. Elevation: m above mean sea level.

The area of the slide and the plinths were surveyed a few days after the occurrence of the landslide. As a result, a contour map with the limits and the head-scarp of the slide were drawn, Figure 1.

The headscarp was clearly marked on the left side (as viewed from the crown) by a steep 1-1.5m high scarp; on the right side the scarp was 0.10-0.20m high (Figure 1). Near the main scarp the rows of vines were distorted indicating that the displacements of the slid mass had a prevailing downhill component towards the West and a much smaller transversal component towards the North. Only a small extent of the slide limits on both flanks was evident on the upper reach of the slide. The length and the width of the slide are 100m and 135m respectively. The slip surface was clearly pointed out by inclinometers S2 and S4 (cfr. Figure 1) at a depth of 12m and 18m respectively; the horizontal downhill displacements of the ground surface were 38 mm and 24mm 8 months after the installation of the inclinometers. The other inclinometers did not evidence any shear strain localisation. Based on these limited data the slip surface shown in Figure 3 was inferred for section A-A'; it passes through the fine grained soils of T1 unit and always overlies the top of T3 substratum. The slide involves a substantial part of the soil volume relevant to the piers' foundations. The estimated volume of the slide is $215 \times 10^3 \text{ m}^3$. The maximum recorded velocity of the sliding mass did not exceed 5 mm/month; it became almost negligible six months after the onset of movement.

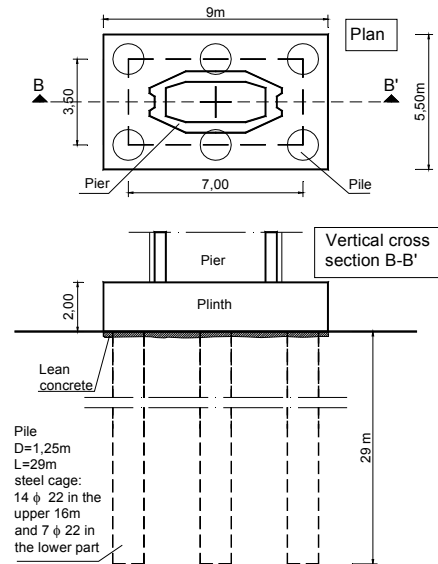
Figure 2. Schematic plan and vertical cross section B-B' of the existing foundations of piers.

Two piles of the piers 36 and 37 have been cored up to depths of 7.70m and 6.50m respectively. In 2010 the pile-plinth connection of the above piers was uncovered on the downhill side. It was found that a layer of lean concrete, about 0.2m thick was interposed between the plinth and the pile head, see Figure 2, and that the piles were fissured just near the head; fissures extended all over the cross section of the pile; there the pile steel bars were partially corroded.

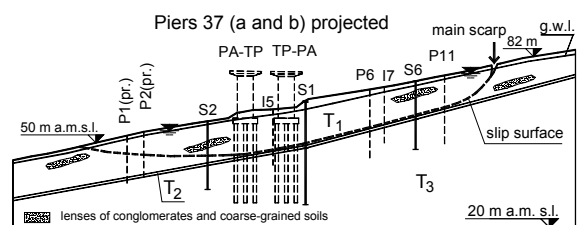
A schematic section of the slope is reported in Figure 3 from which the relationships between the soils and the foundations of the piers are apparent.

Figure 3. Schematic cross section A-A'. T₁: brown clayey sandy silt; T₂: water bearing layer made of sand and gravel mixed with cobbles; T₃: stiff grey clay, grey marls, and very dense sandy clayey silts. Top soil not shown.

estimated piezometric surface shown in Figure 3. 2D and drained conditions were considered. For $c'_m=0$ and a safety factor $FS=1$, a value of the mobilised angle of shear strength $\phi'_m = 24.7^\circ$ was backcalculated by the Morgenstern & Price method. The influence of the foundations of piers was disregarded in the analyses. This value of ϕ'_m is close to the residual ($\phi'_r=19^\circ-22^\circ$) as well as to the peak strength ($\phi'_p = 26^\circ-27^\circ$) of the fine-grained soils of the T1 unit; it is therefore almost undecidable if the slide is first-time or reactivated, since documented evidence of past failures is lacking. In any case, the main triggering factor appears to be the increase of the pore water pressure induced by prolonged and exceptionally intense rainfall during the six months preceding the slide. In fact, the cumulated rainfall from September 2009 to March 2010 reached the record value of 997.2 mm, which exceeded by 63% the average rainfall and by 153% the minimum rainfall in the previous decade. It is worth mentioning that this record cumulative rainfall was approached only two times during the period 1921-2010, namely in 1951-52 (805mm) and in 2004-2005 (884.8mm) when the slope might have been on the verge of failure.

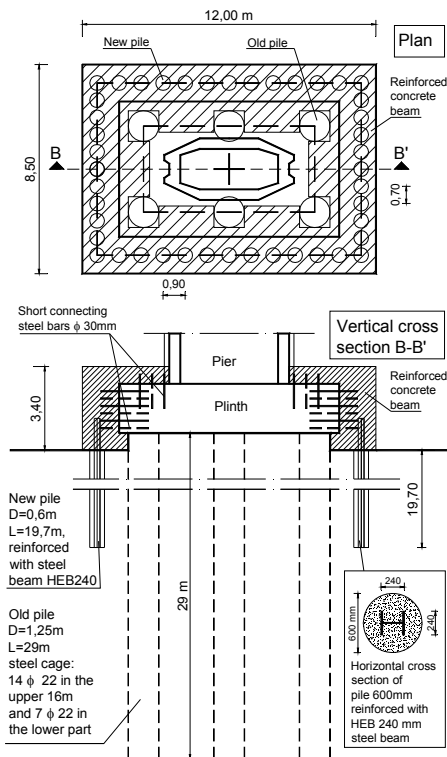
Figure 4. Measures for strengthening the existing foundations of the piers. Schematic plan and vertical cross section B-B'.

The above analysis pointed out that the slope-viaduct system needed interventions aiming at stabilising the slope, strengthening the piers' foundations and improving the bearings of the deck. It was soon evident that slope stabilising interventions only were not sufficient to return the viaduct to safe conditions as the existing piles were clearly unable to withstand vertical and horizontal actions. It was also clear that the slope stabilising works could not be carried out if the foundations and the superstructure were not strengthened beforehand. Moreover the owner asked to find a solution that did not require the closure of the motorway to traffic. The selected solution comprises the following phases. 1) The improvement of the bearings of the decks; 2) The strengthening of the foundations of the piers by encircling them by means of a "curtain" of concrete piles (reinforced by HEB240 steel beams) capped by a "ring" beam connected, in turn, to the existing plinth. The installation of the steel beams and the pouring of the concrete ought to

The strengthening works of the foundations of piers 35 (a and b), 36 (a and b), 37 (a and b), 38 (a and b) were carried out in 2012-2013. During the construction of the ϕ 600mm piles around the existing foundations the pulvinos experienced cumulative horizontal displacements lower than 2 cm except on one occasion when the pouring of concrete for two piles was delayed some hours; as a consequence the lateral movement of the pulvino of the involved pier increased rapidly by about 1 cm with a corresponding tilt of about 1/1200; however the rate of increase slowed down as soon as the concrete was poured. The construction of the subhorizontal tubular drains started in September 2013 and was completed in June 2014. The effectiveness of the stabilising measures can be assessed on the base of both the decrease of pore water pressure, Δu_w , and the movements of the slope and of the viaduct. As yet horizontal displacements and settlements of the viaduct are negligible. Δu_w on or near the slip surface up to now ranges from 30 kPa to 101 kPa with a mean value of 59.5 kPa; typical trends of Δu_w vs time are shown in Figure 7. The decrease of pore water pressure brought about an increase of the safety factor by 28%. The flow rate

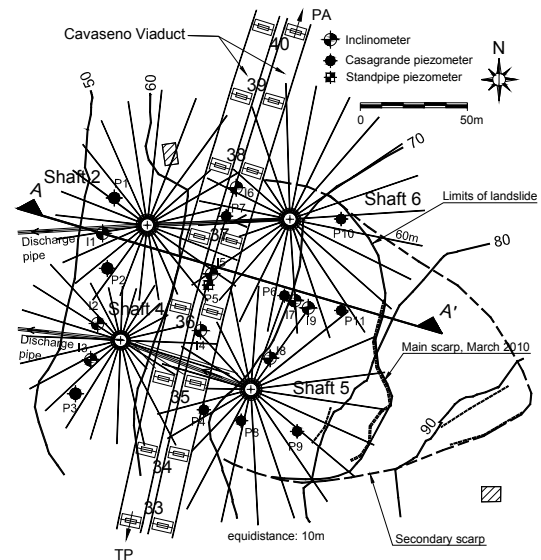
Figure 5. Layout of drainage shafts, radial subhorizontal drains, conduits connecting the shafts, and gravity discharge pipes.

take place immediately after drilling each pile; 3) The slope stabilisation by subhorizontal tubular drains installed radially from drainage shafts (Hutchinson, 1977). The latter were excavated after the realisation of a “curtain” of almost contiguous reinforced concrete piles, diam. ϕ 1.00 m. The installation of the reinforcing steel cage and the pouring of the concrete took place just after the completion of the perforation of each pile. The piles were capped by a rigid annular beam before the start of the excavation of the shaft. The interventions are schematically shown in figures 4-6.

of individual tubular drains was extremely variable and was higher when the drain passed through coarse materials. The maximum flow rate from the drainage system amounted to 105 litres per minute and was recorded in July 2014; it came prevalingly from drains installed in the North-East side of drainage shaft P2. At the end of September 2014 the flow rate almost halved.

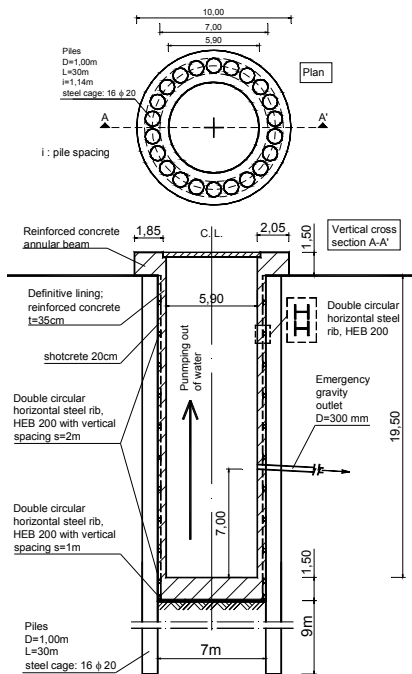
Figure 6. Schematic plan and vertical cross section A-A' of drainage shafts.
