# Joint Investigation with Ground Penetrating Radar and Infrared Thermography as a Diagnostic Support for the Restoration of Two Wall Mosaics in the Church of St. Mary of the Admiral in Palermo, Italy

**Abstract:** The church of S. Mary of the Admiral in Palermo, known as “La Martorana” and very famous for its Byzantine mosaics, has been a World Heritage site since 2015. The mosaic system of the church includes several groups of figures and scenes from the life of the Virgin Mary. From the western part of the ancient church only two mosaics survive, detached from their original position, and are now located in two internal chapels. On the occasion of several restoration works, these two mosaic panels were investigated with non-invasive techniques, in order to provide diagnostic support to the restoration and consolidation interventions. The investigations were aimed at detecting any air pockets that could cause the detachment of the tesserae or of possible differences between cement mortars under the tesserae. For this purpose, the integrated use of two non-invasive techniques namely infrared thermography (IRT) and ground penetrating radar (GPR) was considered. The joint analysis

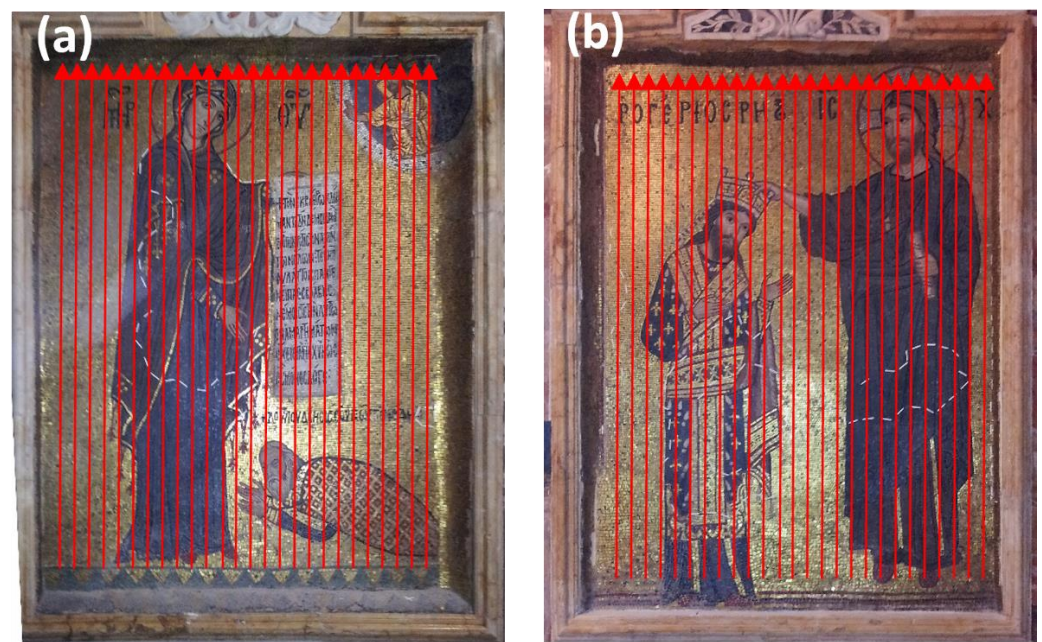
For this study all the GPR profiles were acquired in one direction. In particular, 26 parallel profiles were acquired for the *Dedication* panel and 25 parallel profiles for the *Coronation* panel, for a total of 88 m per antenna. The spacing between the profiles was 5 cm (Figure 6).

**Figure 6.** Palermo, St. Mary of the Admiral. Location of GPR profiles: (a) *Dedication* mosaic panel; (b) *Coronation* mosaic panel. The hatched lines indicate the areas affected by the risk of detachment of the tesserae, as previously indicated by the restorers.

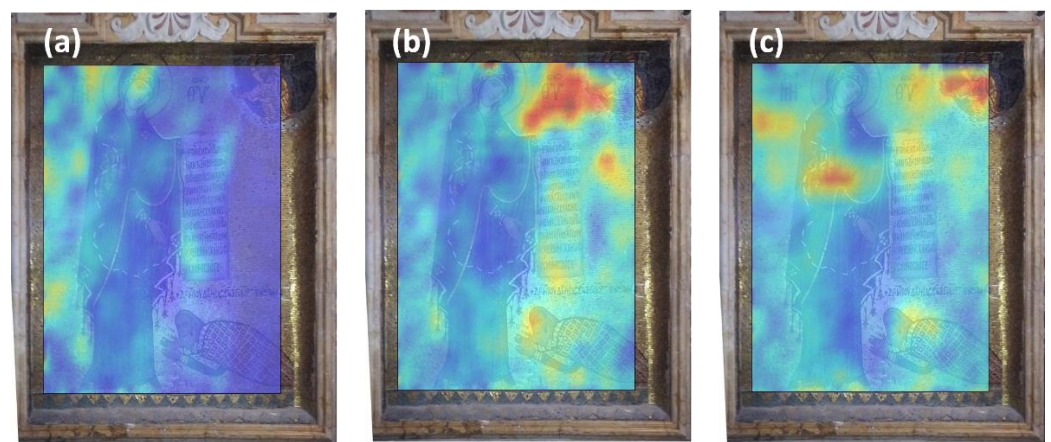
In the Dedication to the Virgin mosaic the calculated depth-slices do not seem to show a correspondence between the high amplitude anomalies and the areas identified by the restorers as possible detachment zones of the mosaic tesserae.

The depth-slice relating to the thickness between 0 and 2 cm (Figure 9a), does not show substantial anomalies, with the exception of small areas on the left side of the panel and in correspondence with the face of the figure of the Virgin.

**Figure 9.** Palermo, St. Mary of the Admiral, *Dedication* mosaic panel. Depth-slice of the normalized reflection amplitudes relative to the following depths from the acquisition surface: (a) between 0 cm and 2 cm; (b) between 2 cm and 4 cm; (c) between 4 cm and 6 cm.

On the other hand, in the depth-slice between 2 and 4 cm of thickness (Figure 9b), some anomalies are highlighted that could be linked to a detachment of the tesserae not identified by the restorers. In particular, there is a strong anomaly in the upper part of the panel with a considerable extension.

Finally, in the depth-slices relating to the thickness between 4 and 6 cm (Figure 9c), various anomalies are highlighted, which persist in the upper part of the panel. There is also an anomalous area in the Virgin's mantle, within the area identified by the restorers as a possible detachment.

In the Dedication to the Virgin panel, there is no correspondence between the hot thermal anomalies and the presence of high reflection amplitudes in the GPR data. Indeed, the thermal analyses show a good correspondence with the area delimited by the restorers as suspected of the presence of detachment. However, the presence of the golden tesserae could have compromised the results of the IRT, not highlighting sufficiently any other anomalous areas that are instead identified by the GPR.
