Assessment and strengthening of reinforced concrete bridges with half-joint deterioration

Abstract

Keywords: cantilever bridge, reinforced concrete, prestressing, Gerber saddle, half-joint, corrosion, structural assessment

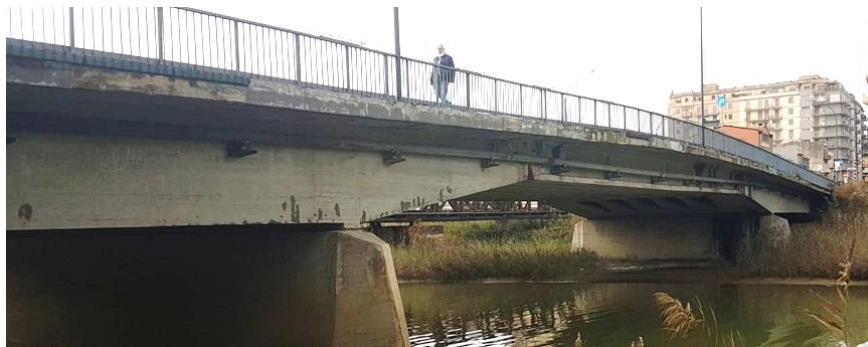
The first case is a bridge over the Salso river in Licata (Sicily, Southern Italy), designed by Riccardo Morandi. It is a three-span bridge with a Niagara-type cantilever girder scheme, with side spans of 33.10 m and a central span with a total length of 49.60 m, the central beam between Gerber saddle being 32 m long. The overall width of the deck is 19.00 m, while the total length is 115.80 m. A view of the bridge is shown in Figure 1.

Fig. 4 View of the bridge.

In the two side spans and in the cantilevers, the reinforced concrete deck is composed of eight side-by-side asymmetrical T-type beams with a web thickness of 400 mm, height variable from 1.40 m to 2.50 m and upper slab 200 mm thick. The girder has three transverse beams for each span and a bottom slab with thickness varying from 220 to 300 mm near the piers. The midspan is made up of eight prestressed reinforced concrete beams with variable height and double T section, completed by a reinforced concrete slab with a thickness of 200 mm and three transverse beams. The central beams are prestressed through Morandi's patent M5 type tendons. The materials are the following: concrete for side spans and cantilever with $f_{ck} = 25$ MPa; concrete for prestressed girder with $f_{ck} = 35$ MPa; reinforcement steel type ALE-TOR with yielding strength $f_{yk} = 440$ MPa; prestressing steel with tensile failure strength $f_{ptk} = 1700$ MPa.

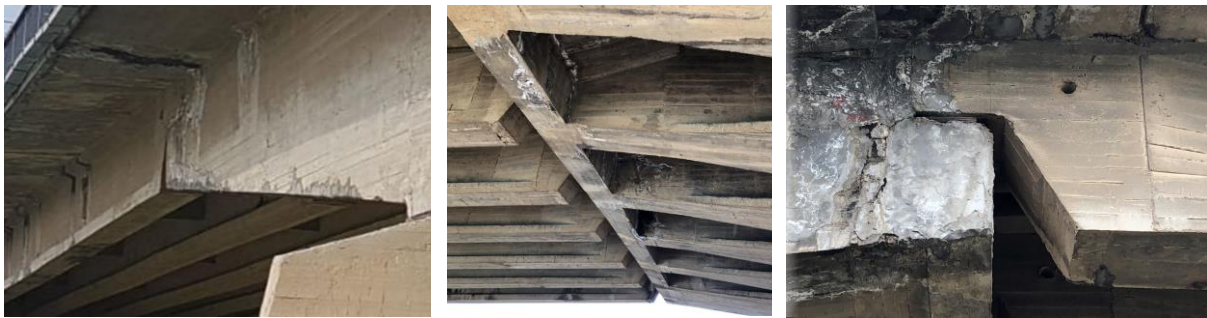
Figure 6. Deterioration of the Gerber saddles.

In the original design the saddle was well dimensioned and now it does not show a significant crack pattern with wide cracks, apart from a few superficial cracks due to concrete spalling (Fig. 6).

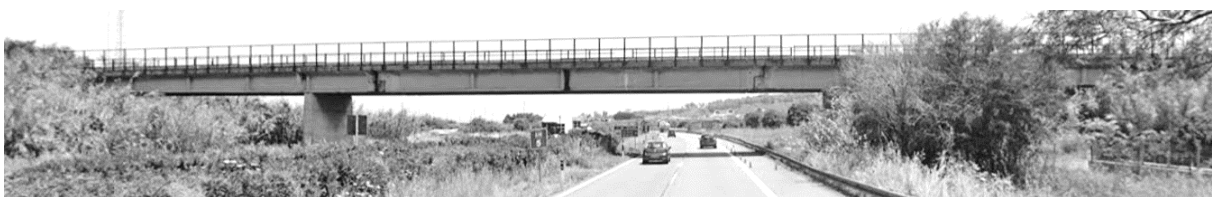
The second case-study is an overpass in Sicily on the motorway connecting Palermo to Messina. It has a classical Niagara-type scheme with the central beam between half-joints and two symmetrical cantilevers. The side and central beams are prestressed, as are the cantilevers; the deck is composed of four beams with three intermediate transverse beams, deck width 8.50 m, total longitudinal length of 89 m between abutments, side span length of 22.50 m, central span length 44 m between piers and central beam length 31 m between half-joints.

Figure 11. View of the overpass.

The double-T cross section of the beam is slightly variable in height, from 130 to 170 cm, with the upper slab 16 cm thick. Figure 11 shows a global view of the overpass, while Figure 12 shows views of the saddles.

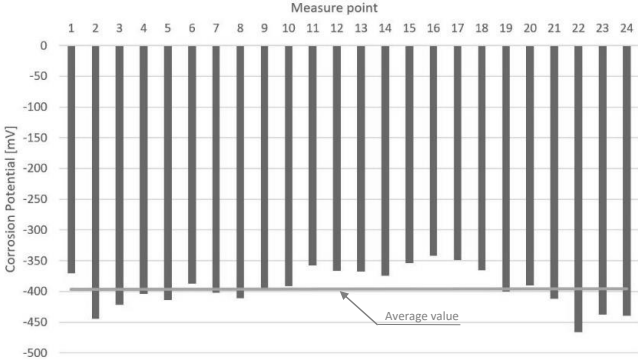
Figure 15. Results of corrosion potential on the most damaged saddle.

In this case it was possible to proceed to a more detailed investigation campaign. Initially the inspection was carried out through corrosion potential mapping, in order to evaluate the status of the reinforcements, i.e. whether the rebar was subjected to a generalized or localized corrosion attack or not. This method does not provide any quantitative information on the corrosion rate or the extent of the damage that has already been produced but is particularly suitable for a first definition of the corrosion potential of the structure, coupled with further investigations. The potential method is based on the fact that any condition of corrosion (non-corroded, generalized or localized corrosion) corresponds to a variation of potential within typical intervals [25,26,27]. In the case study, some Gerber saddles showed a corrosion potential much lower than -300 mV , with minimum values of -450 mV , indicating a high risk (fig. 15). In other saddles of the same bridge, on the other hand, a moderate potential between -50 and -300 mV was found, with a more limited risk. The overall situation still highlights risks from moderate to high due to the exposed reinforcements of the Gerber saddles.

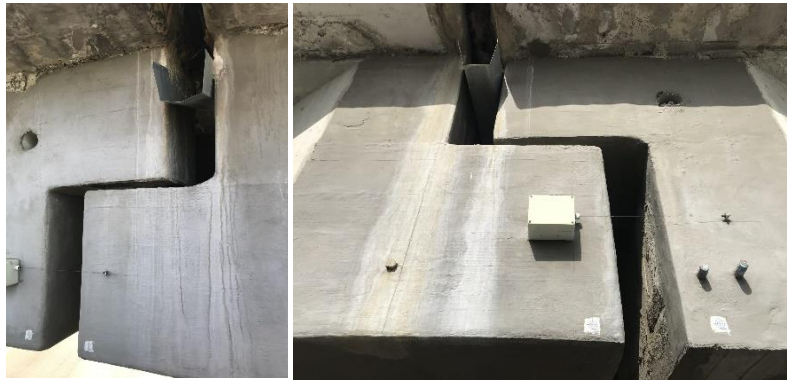
Figure 17. Concrete jacketing of Gerber saddle with CFRP fabrics.

- 1) Concrete jacketing with or without FRP, which is aimed at improving the concrete properties, restoring the cover and inserting new reinforcing bars (fig. 17).
- 2) Steel plating for external strengthening [12]; it provides a higher degree of reinforcement than the previous interventions but is very invasive and requires adequate spaces for rehabilitation works (fig. 18).
- 3) Strengthening by inserting vertical or inclined Dywidag bars [13], which limits diagonal cracking and increases the overall strength through local prestressing of the saddle (fig. 19).

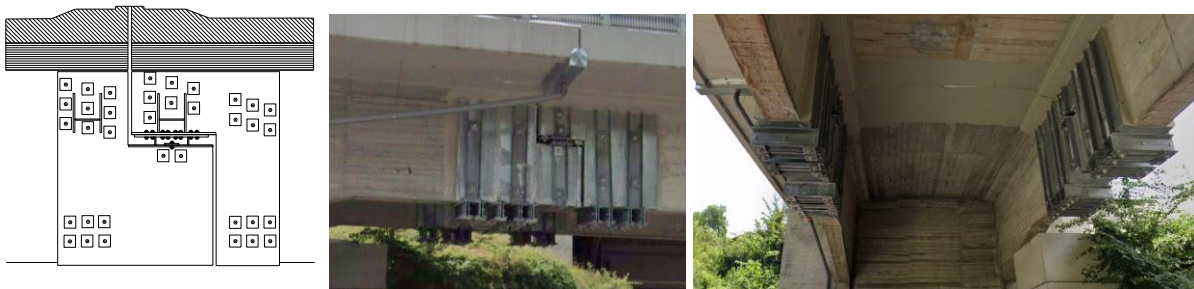
Figure 18. Steel plating of Gerber saddles of Sabbione and Generale Franco Romano viaducts (Italy) [19]
