First lamina hybridization of high performance CFRP with Kevlar fibers: Effect on impact behavior and nondestructive evaluation

Lamina hybridization in high performance CFRP: effect on impact behavior and non-destructive evaluation

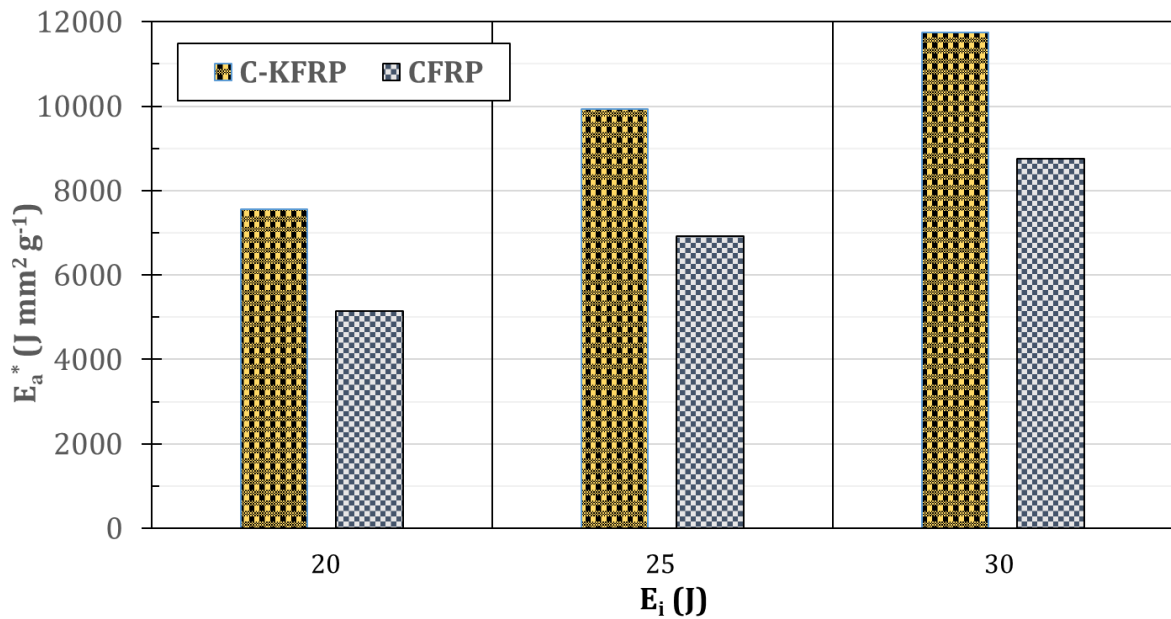
Plotting the values of specific energy absorbed, shown in Table 2, by means of a bar graph (see

Figure 4), it is more easy to notice how for a fixed impact energy the specific energy absorbed by the C-KFRP is always appreciably superior to that absorbed by the CFRP with increment that vary from about 40% to about 30% when the impact energy pass from 20 to 30 J.

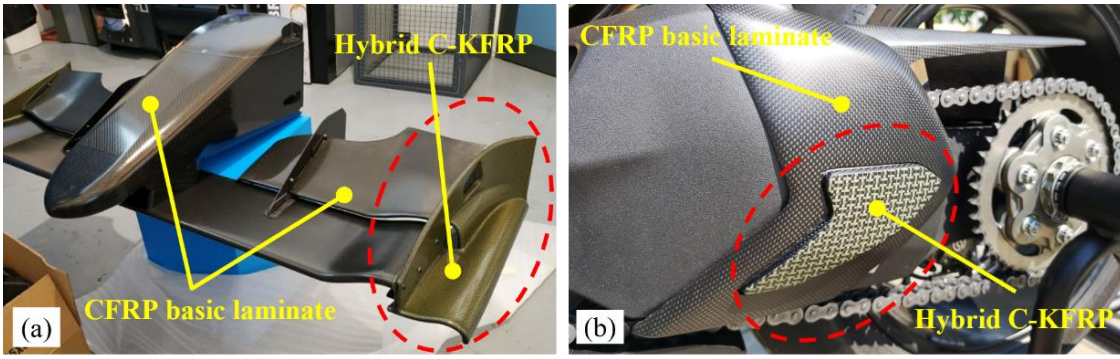
Figure 1

In this experimental study, the effect of hybridisation in composites on static and impact mechanical properties has been evaluated. In more detail, a hybrid cross-ply fabric, made of carbon fibre and kevlar, has been introduced on the surface of a CFRP laminates used to the manufacturing of mechanical component which are mainly subject to impact loading. Tensile test, 3-point bending test and impact tests have been carried out in order to assess the effect of hybridisation in such highly performing composites used for applications characterized by possible impact events (ailerons (Figure 1a), bumpers (Figure 1b), etc.).

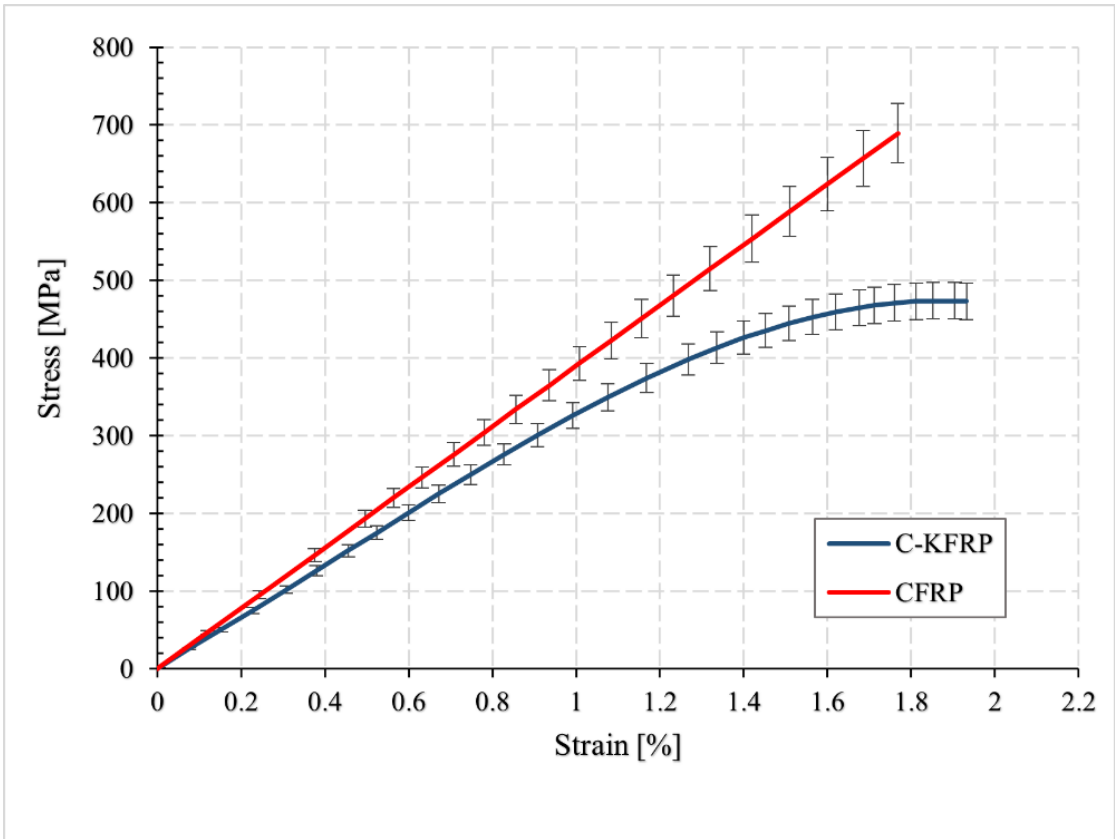
Figure 3

In Figure 14, the tensile curves of both the analyzed composite laminates, are depicted in detail.

From the Figure 14 it is seen how the substitution of the surface carbon lamina with the carbon-kevlar lamina leads to an appreciable reduction of the tensile strength (about -30%): approximately equal to 700 MPa and 480 MPa for the carbon-fibre reinforced composite and the hybrid composite, respectively. As expected also in terms of stiffness, the hybridization leads to a reduction of the Young's Modulus, from about 39 GPa for the CFRP laminate to about 33 GPa for the hybrid C-KFRP laminate (about

-15%). As expected too, the hybrid laminate exhibits a progressive damaging associated to the different mechanical behavior of carbon and aramid fibers, with a consequent nonlinear trend of the second part of tensile curve. This progressive damage (aramid fibers fail after carbon fibers) explains also the reduction of the tensile strength. In the basic CFRP laminate, in fact, the damage is concentrated at the failure load which is reacted with a linear elastic behavior (brittle failure).

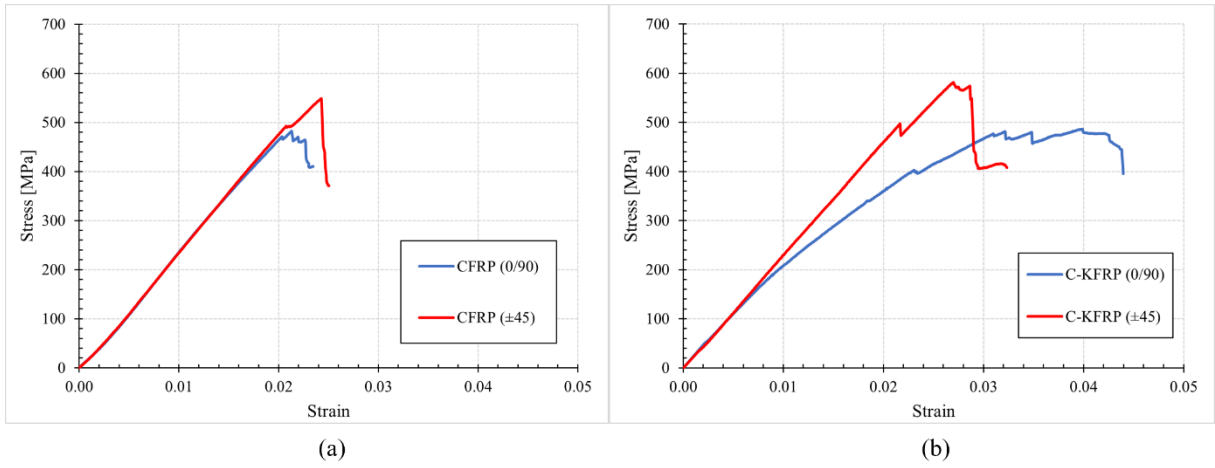
Figure 4

Three-point bending tests have been carried out on the analyzed composites in order to assess also the influence of the hybridization on the bending strength of the CFRP laminate. Figure 15 shows the bending curves relative to the two laminates, considering the two different load conditions corresponding to the load applied into the (0/90) first lamina and the load applied to the ultimate (± 45) lamina. Such two different bending configurations have been considered in order to examine in detail the expected different behavior of the non-symmetrical laminates considered (actually, used in car manufacturing).

In more detail, Figure 15a shows how the basic CFRP laminate exhibits better performance when, as expected, 0° fibers are subjected to tensile load, with a bending strength increment respect to the opposite configuration of about +15% (from about 480 MPa to about 550 MPa); in other words, although this configuration with the lamina (0/90) subject to the extensive compressive loading is that used in practice by the car manufactures for component subjected to impact loading, it is that which leads to the lower static bending strength. Similar results are obtained from Figure 15b for the

hybrid laminate: the configuration with hybrid lamina subjected to the tensile load leads to the higher strength (the 0° carbon fiber are subjected to tensile load) whereas the actual service configuration selected by the manufactured in which the hybrid lamina is subjected to the compressive load leads to the lower strength (appreciable reduction of about -18%) but at the same time to more progressive damage mechanism with higher failure strain and, most important, higher failure energy. Taking into account that to improve the impact strength it is necessary to reduce the maximum force and to increase the maximum failure strain and consequently the maximum energy to failure, such result corroborate that hybridization of the surface lamina (0/90) is the best way to obtain impact strength improvements.

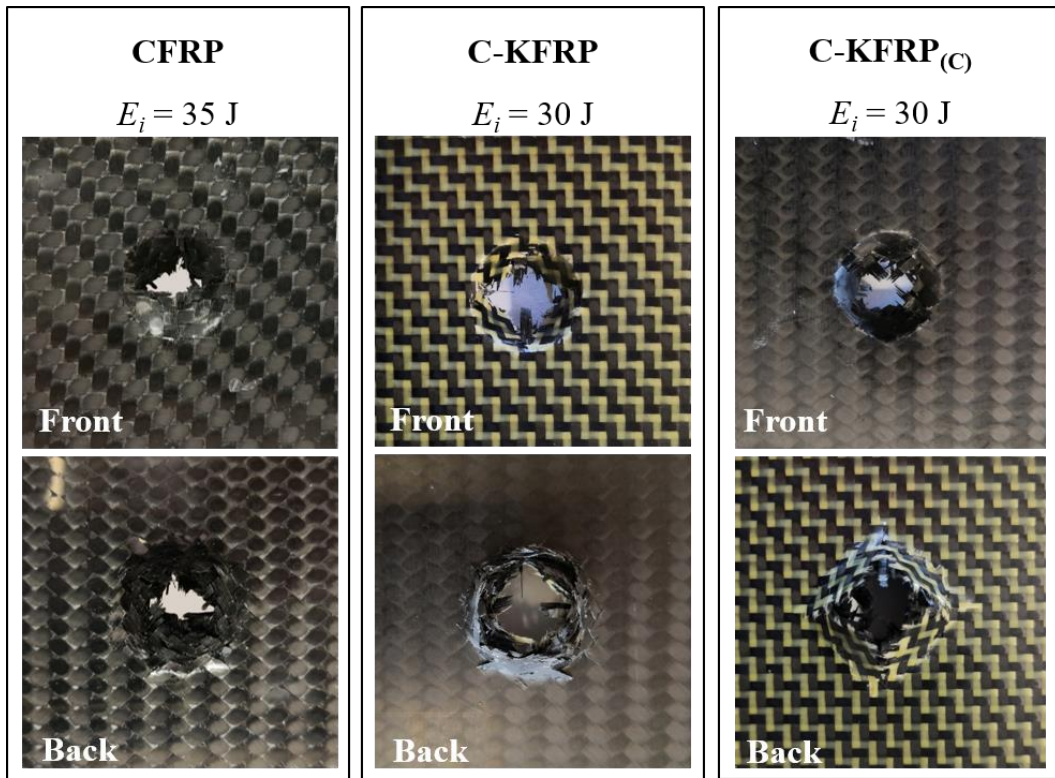
From the visual inspection of the specimens after the impact tests, the progressive increasing damage can be highlighted as the impact energy reaches complete perforation. Figure 5 shows the damaged surfaces, both front and back sides,

Analyzing the front view of each damaged surface shown in Figure 5, the circular imprint left by the striker can be easily detected. The back surfaces show instead different types of damage, based also on the face exposed to the impact. In more detail, the C-KFRP(c) hybrid composite impacted on the carbon side shows a larger damaged area characterized by diamond-shaped fracture in the back face. Hybrid laminate C-KFRP(c) if compared to the C-KFRP laminate impacted on the hybrid side, it shows a circular fracture made of several radial cracks with delaminations mixed with fibers breakage. From such mechanical response it can be deduced how the damage to the surface in the lower face of the specimen is influenced by the type of lamina which is subjected to the impact event.

As shown in visual inspection analyses (Figure 5), the low velocity impact event in CFRP laminates causes a barely visible damage, which can be easily detected by all the non-destructive techniques proposed in this research. Nevertheless, only PAUT was capable to reveal that the detected delaminations were sub-superficial (Figure 10) and were mainly due to the very limited out-of-plane displacements ability of carbon laminae, if compared to the K-CFRP specimens (Figure 8).

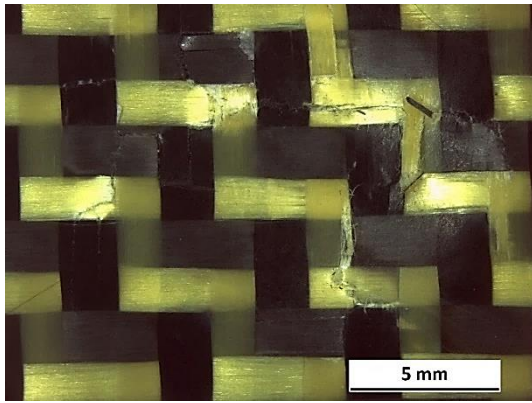
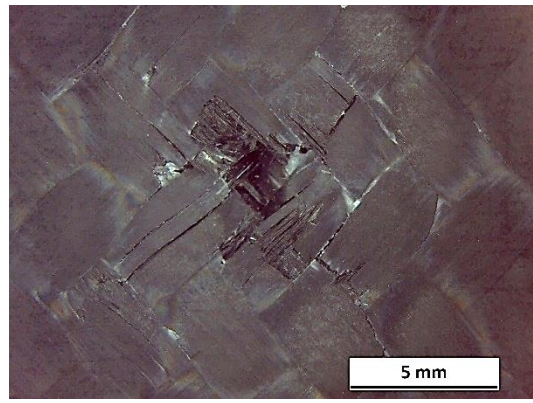
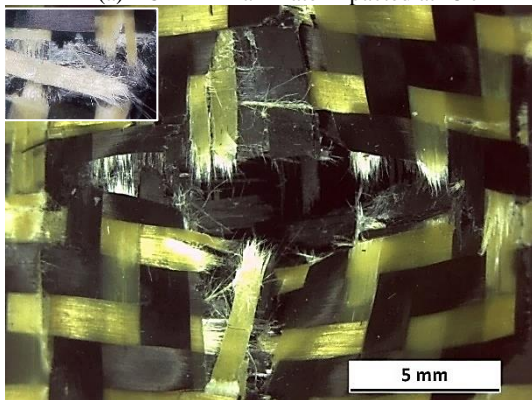
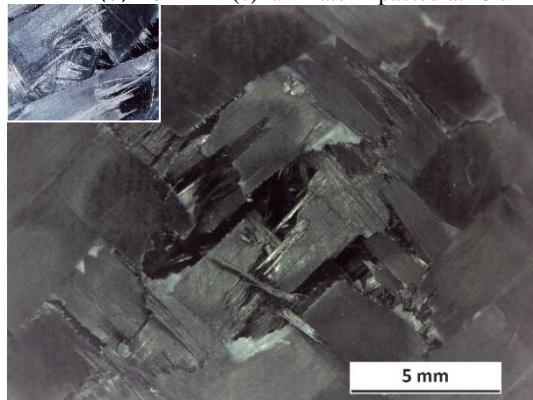
Figure 6

A deeper visual inspection of the mechanical damage in hybrid laminates subjected to impact energy far from perforation, highlights that the damage is different if the impact occurs from the side of the hybrid lamina rather than from the side of carbon one. As an example, the optical microscopies at a magnification of 7.5X of the impacted area for an energy of 15 J are shown in Figure 6a and b. As expected, the extent of the impact damage is more limited for the hybrid side and the damage involves both kevlar and carbon fibers. There is a tensile failure along the two orthogonal directions. For the specimen subjected to impact from the side of the carbon lamina,

being the is latter at an orientation of $\pm 45^\circ$, the damage follows the direction of the fibers, with breaking due to tensile load (Figure 6b).

For energies close to total perforation (25 J), the detected damage consists in significant fracture due to tensile load in the 0/90 directions for aramidic fibers (Figure 6c); the carbon fibers are instead mainly subjected to intra-laminar failure in the direction parallel to the fiber itself (Figure 6d). The carbon lamina has the same modalities detected for impact energy equal to 15 J, with evident fracture of the matrix (the images were acquired with a polarizing lens to highlight the fractured parts of the matrix). Furthermore, the fracture of the fibers appears very brittle (with clear interruption of the single filaments) for the carbon fibers, if compared to the aramid ones, which shows mechanical damage distributed in a wider area.

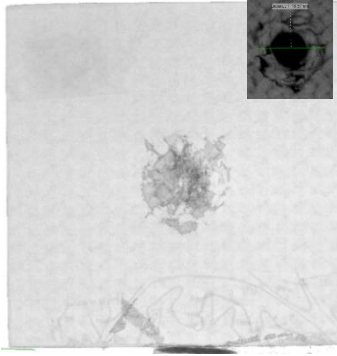
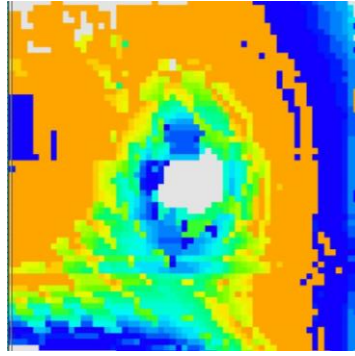
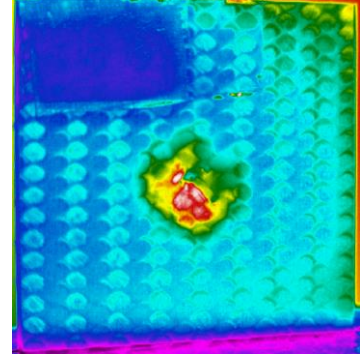
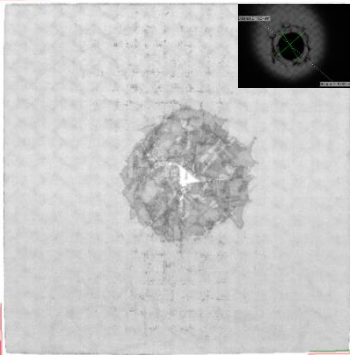
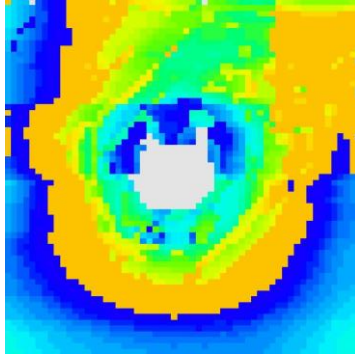
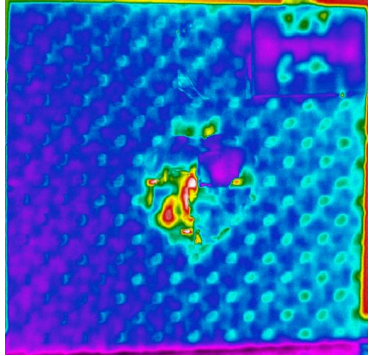
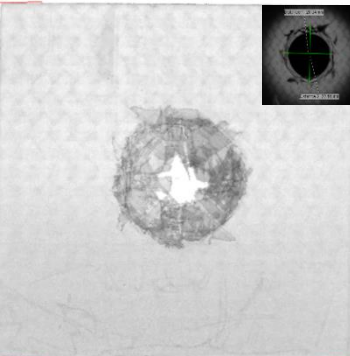
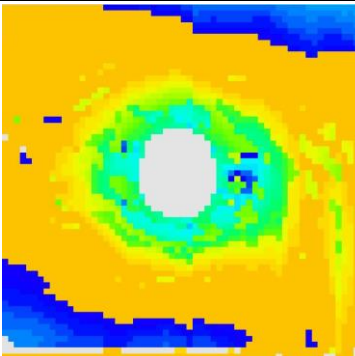
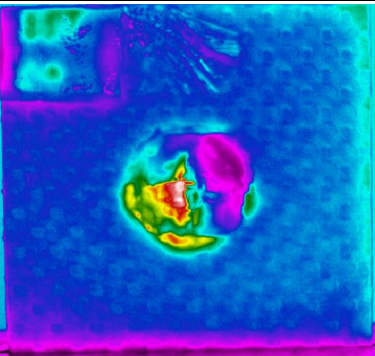
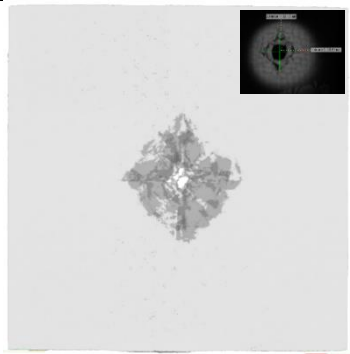
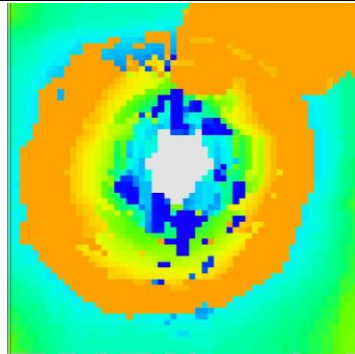
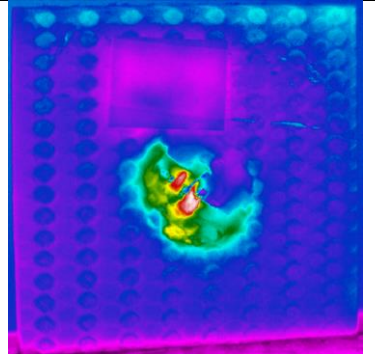
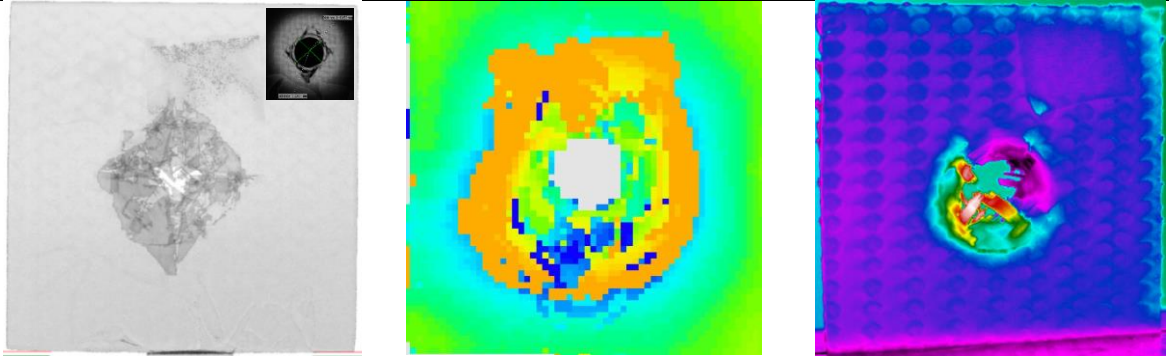
Figure 7

In Figure 7, 3D reconstruction by CT, PAUT C-scans and PT thermograms are reported for impact damaged C-KFRP specimens at 15 J (a), impact damaged C-KFRP specimens at 20 J (b), impact damaged C-KFRP specimens at 25 J (c), impact damaged C-KFRP(c) specimens at 15 J (d) and impact damaged C-KFRP(c) specimens at 25 J (e). As above mentioned, the specimens identified as C-KFRP(c) were subjected to impact test on the side of carbon lamina, which is the lamina on the opposite side for C-KFRP specimens. All the images are referred to the side in which the impact event occurred (front view).

Analyzing the results obtained by the different techniques, for the specimens subjected to increasing impact energy (15, 20 and 25 J) from the side of the carbon/kevlar hybrid lamina, it is evident that the damage revealed through such techniques is more extensive than that observed by visual analysis. This is a typical behavior of laminates, which require volumetric inspection techniques to quantify the damage due to impact loading in a reliable way. The extension of the damaged area increases as the impact energy increases (Figure 7a, b and c) and the damage entity becomes more severe.

Regarding the specimens that were exceptionally subjected to the impact on the side of the carbon lamina (Figure 7d and e), the damaged area has a diamond shape, with the faces parallel to the orientation of the fibers at $\pm 45^\circ$, which are firstly involved in the impact damage mechanisms (as reported in **Errore. L'origine riferimento non è stata trovata.**). Thus, the damaged area is strictly dependent on the arrangement of the fibers lying on the face where the impact occurs.

Even though, at the same impact energy, the diameter of the damage can have similar values, the extension of the damage is greater for the specimen that has been subjected to the impact on the side of the carbon lamina, which gives rise to a cross-shaped fracture mode. Such behavior is due to the inability of carbon layer to withstand flexural strains, as its bending modulus is slightly higher than hybrid lamina one (Table 1). It is important to observe how all the considered non-destructive techniques supported the above reported considerations. However, the PAUT-C Scan seems the technique that shows the better sensitivity giving more detailed damage maps.

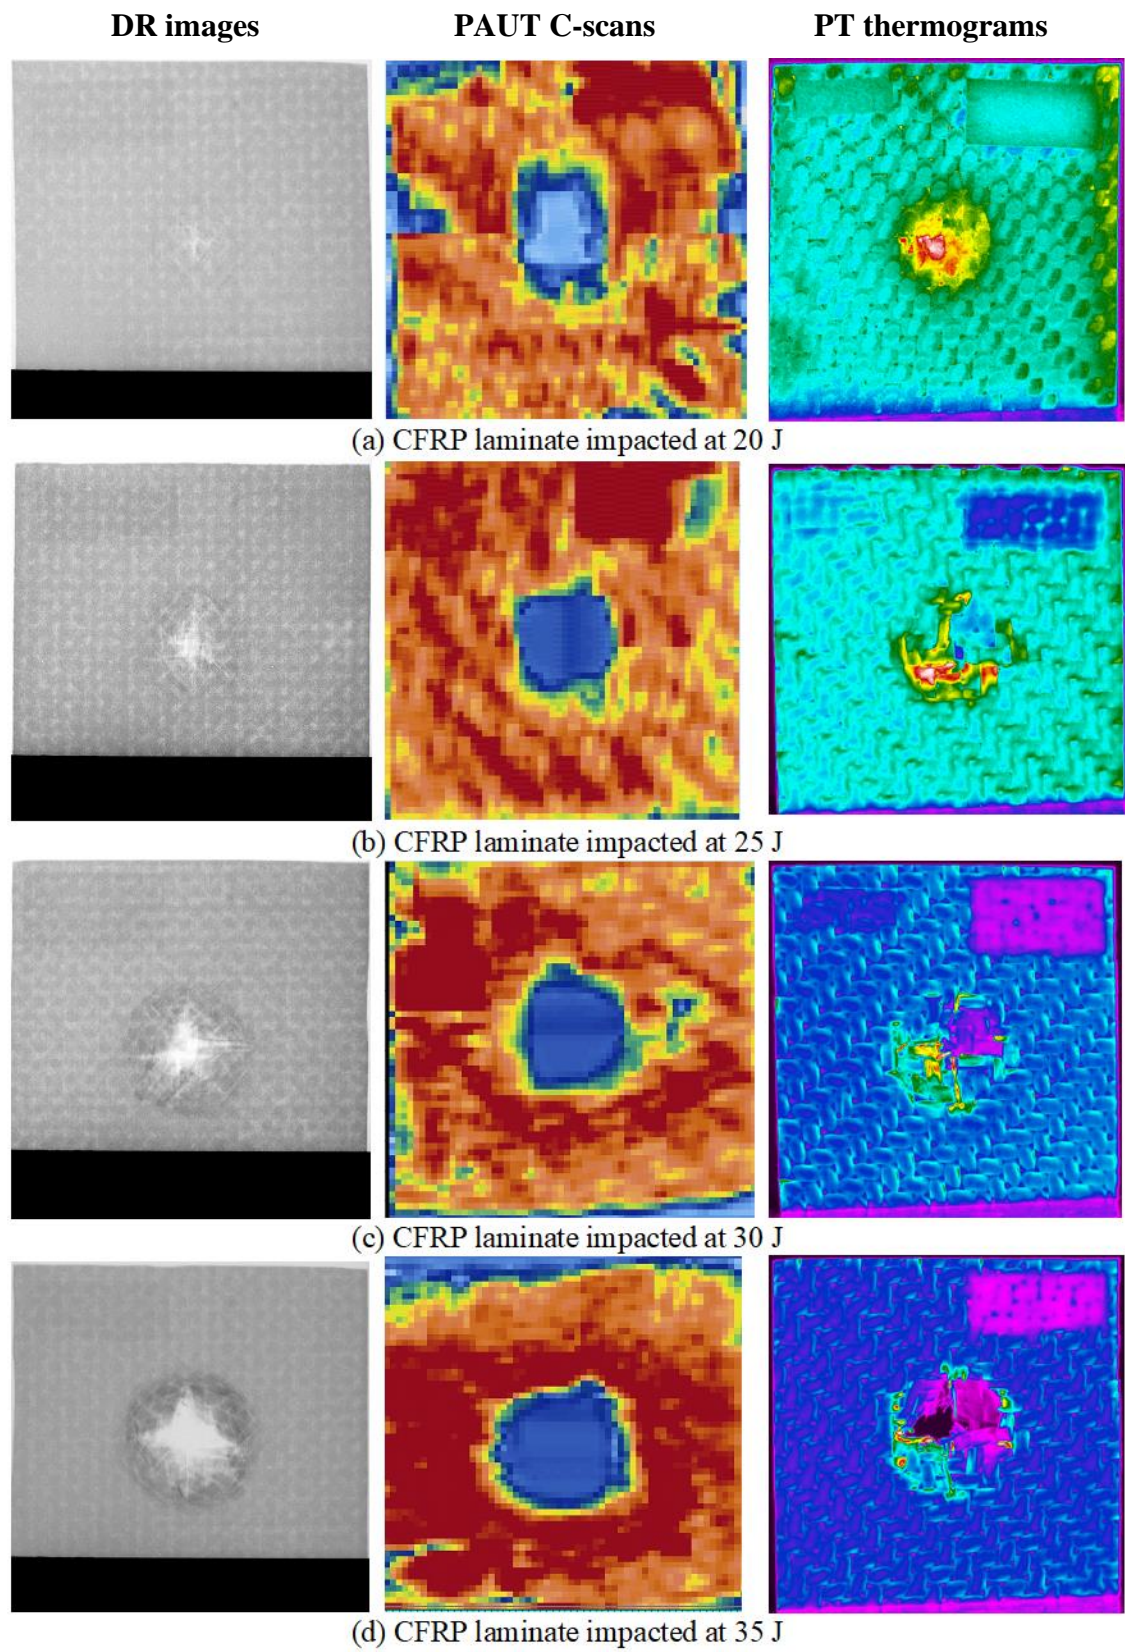
Figure 9

In Figure 9, DR images, PAUT C-scans and PT thermograms are shown for impact damaged CFRP specimens at 20 J (a), at 25 J (b), at 30 J (c) and at 35 J (d). All the images are referred to the front view of the specimens, which is the face subjected to the impact test in the actual service loading.

The comparison between of the DR images with that obtained by the CT for the CFRP laminate shows how DR have lower sensitivity to the surface damage. Better sensitivity is instead shown by the PAUT-C scan: the shape of the damaged area of CFRP laminate is similar to C-KFRP one. This behavior is mainly due to the same stacking sequence. In particular, C-scans reveal that the damage is equally distributed in the perimeter of the damaged area. Such behavior can explain the rapid load loss, after the peak, shown in the impact curves in Figure 1b and d. Intermediate results have produced by the PT thermograms.

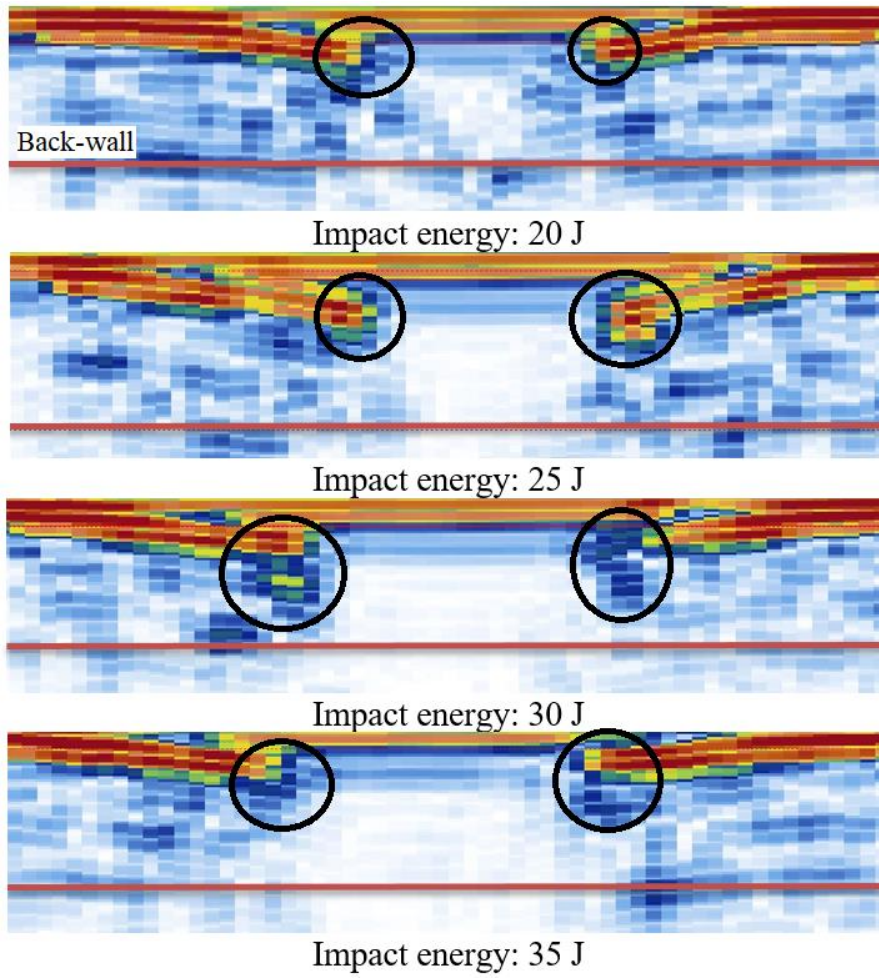
Figure 10

In Figure 10, PAUT S-scans of the CFRP specimens are shown and are referred to the section of the specimens where higher indentation depth and out-of-plan displacement were evaluated. Thus, the global residual deformation of the specimen due to bending can be evaluated. Carbon fiber laminates have higher stiffness, which leads to more severe damage due to shear occurring during the impact event. On the other side, higher modulus allows CFRP laminates to withstand high stresses, but the impact event has a lower time duration (Figure 1a and c) if compared to C-KFRP laminates. The results of such behavior of CFRP specimens deal to smaller extension of the

damaged area, to deeper indentation and less displacement than C-KFRP ones. Such results are consistent with literature [38].

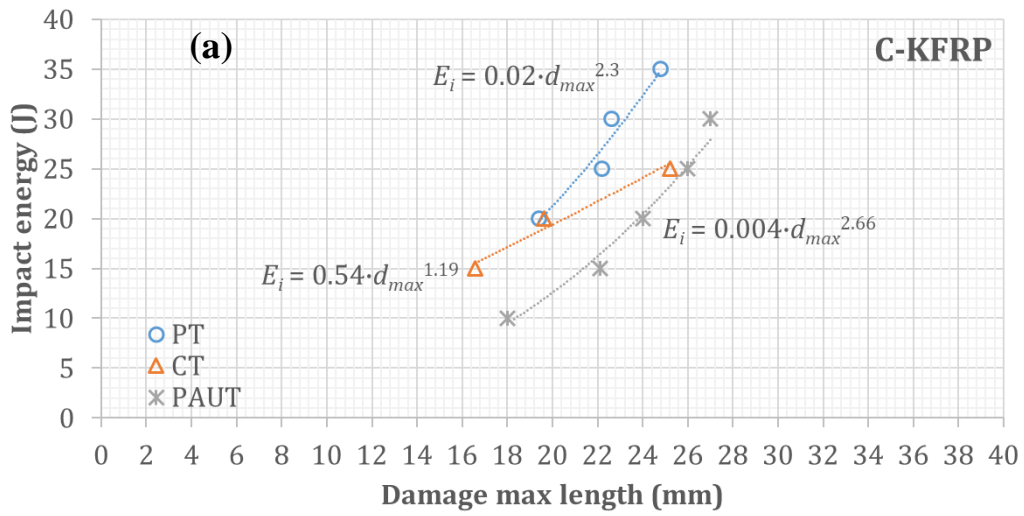
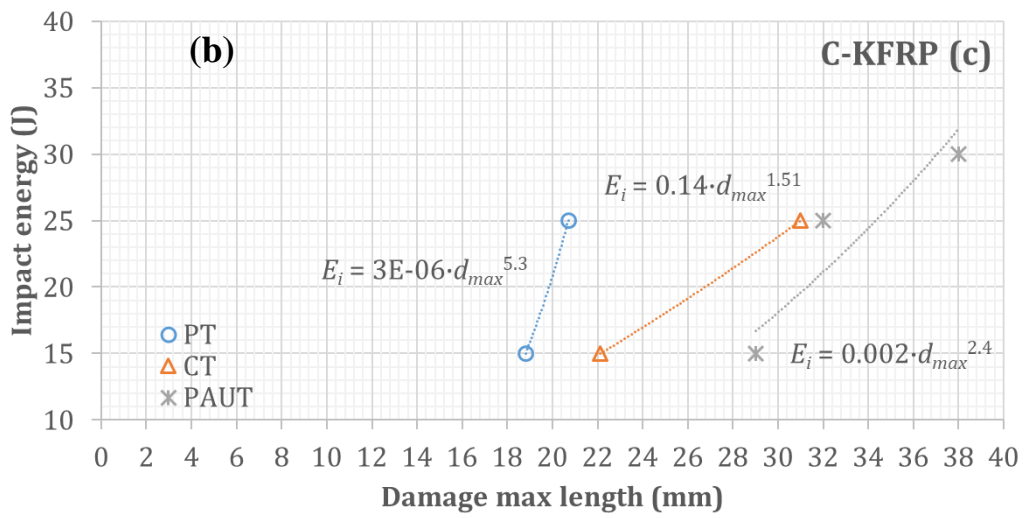
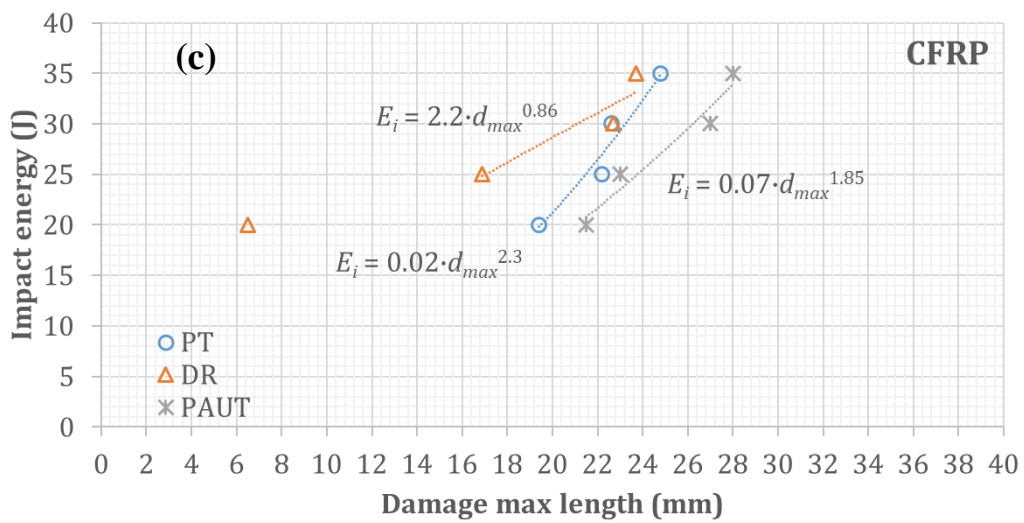
Figure 11 shows the measurements of the damage extension in the impacted laminates by using the different techniques. If CT (Figure 11a, C-KFRP laminates) can be considered the most reliable technique (considered as reference one), it can be assessed that flash thermography slightly underestimates the damage; whereas ultrasonic phased array gives a slight overestimation. Considering that the estimation difference among the techniques is not considerable, for this kind of specimens, the reliability of the different techniques is in general very high. Anyway, the practical application of PAUT was more difficult respect to other techniques, due to the high deformation of the specimens, which causes a not perfect contact with the probe (see Figure 7b). The damage extension is fitted by exponential laws (Figure 11a, C-KFRP laminates), which could be useful to estimate the damage length in case of impact in working conditions or in the design phase.

KFRP(c)). CT has highlighted severe delaminations at early impact energy (15 J), due to the intrinsic stiff behavior of the carbon lamina. Even though the data are limited, if they are compared to that evaluated in the hybrid lamina, the measurements in Figure 11b can be a useful tool to have an idea of the mechanical performance if this kind of laminate is put in working conditions on the wrong side. In Figure 11c, the damage extension measured with DR at 20 J of impact energy is reported but not considered in data interpolation because clearly unreliable.

For what concerns CFRP specimens (Figure 11c), the x-ray technique used to measure the extension of the damage was digital radiography, which is obviously easier to use with a portable equipment if on-site inspections are required to estimate impact damage. The results can be compared to the CT ones, as the latter are presented in the form of sum along x-rays (Figure 7); even though is worthy of mentioning that the focal spot size of the tube is 400 μm (for CT was 250 μm). As a consequence, low damage cannot be correctly detected with this technique, due to an underestimation of the impact damage of about 1/3 respect to PAUT results. The measurements become reliable approaching an impact energy of 25 J and more. Thus, DR technique gives a smaller estimation of the damage, if compared to PT and PAUT, which gives the highest values. Such findings can be explained as follows: in CFRP specimens the most frequent damage mechanism is referred to extensive sub-surface delamination, which DR is not capable to reveal in one shot. In this paper, CT results derive by the superimposition of 1444 projections (can be considered 1444 radiographs) which obviously can catch all the damage mechanisms occurred in each section of the specimens. The trend – and the exponential laws – referred to PAUT and PT are very similar. Thus, it can be assessed that the higher values of damage length measured by

PAUT become more evident for higher impact energies, which cause a deeper damage, difficult to detect with thermal techniques.

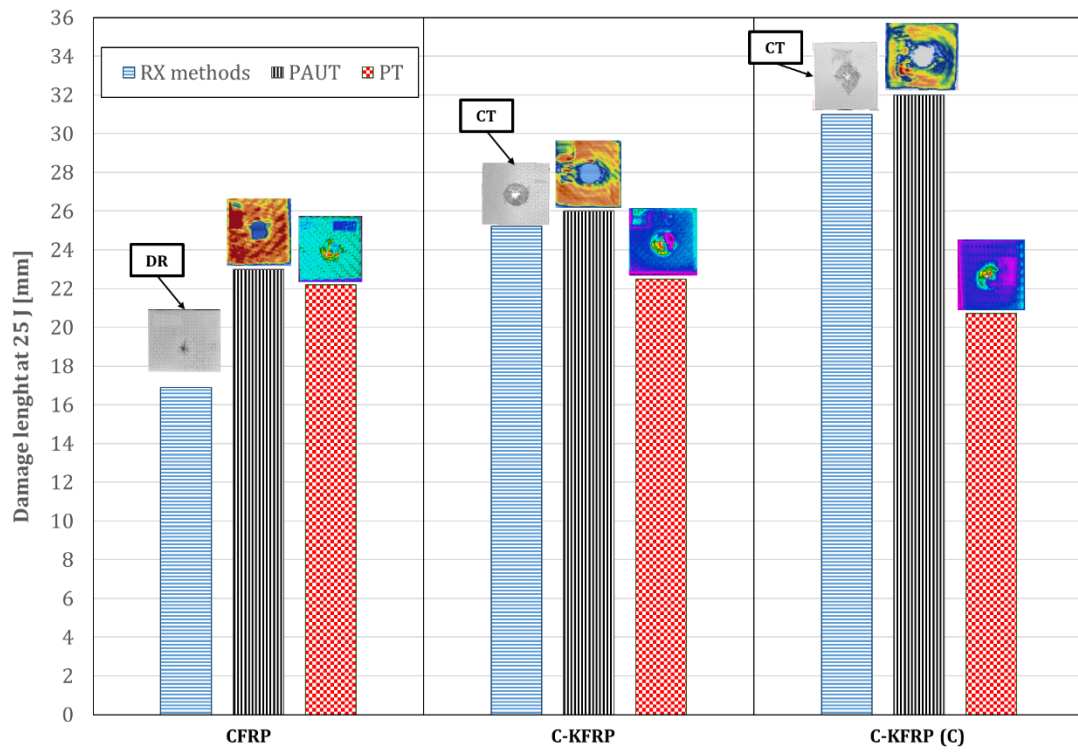
Figure 12

A direct comparison among the three different approaches (RX methods, PAUT, PT) techniques is reported in Figure 12, whose results are referred to the extension of damage in the specimens impacted at 25 J. It is seen how PAUT gives always higher values of damage extension, due to the high sensitivity of this technique, which can be considered the most appropriate for this kind of materials. The lower sensitivity of pulsed thermography technique, mainly if the damage is very deep, puts in evidence that the underestimation can become remarkable. On the other side, it is worth mentioning that pulsed thermography is very fast, contactless, applicable also for complex geometries and can be considered very useful for giving an immediate idea if impact damage occurred. Digital radiography can be used coupled to another technique, used for confirm damage estimation, and computed tomography can be considered the best technique for this type of material, mainly if the equipment has an adequate focal spot size. Obviously, is not possible to apply such technique for on-site inspections, and its principal use is for laboratory / R&D applications. Thus, PAUT is the best compromise between reliability and time required to obtain quite accurate quantitative results for the hybrid composite considered in the present study.
