Historic Mortars and RILEM TC 203-RHM Final Workshop HMC2010

Mortars and Plasters under the Mosaics and the Wall Paintings of the Roman Villa at Piazza Armerina, Sicily

Abstract The Roman Villa at Piazza Armerina in Sicily, built in many successive steps over the 2nd and 3rd centuries A.D., is renowned all over the world for both the wealth and the refinement of its mosaic floors. In February 2007 the Regional Government of Sicily started a restoration project of the whole archaeological site. The systematic survey and study of all decorative elements highlighted the value of wall paintings, which until then were almost unknown except for casual approaches to specific problems of conservation, carried on without any relation to the far and away famous mosaics. This paper shows the results of a physical chemical investigation of the mortars used for both floors and walls, which were extensively sampled both indoor and outdoor, including the crushed brick mortars of the basins at the monumental front entrance of the Villa. The mineralogical petrographic study of mortars and plasters was performed by XR diffractometry and by optical microscopy using polarized light through thin sect

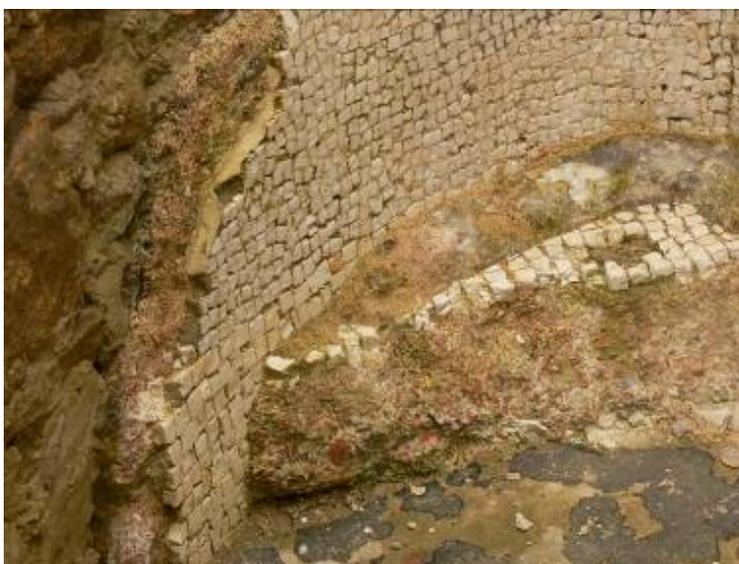
Fig. 1 joint mortar of the internal mosaic lining of the tank at the monumental door

The joint mortars of the internal mosaic lining of the tanks, see figure 1, are crushed brick mortars, they also contain granules of vitrophires, quartz grains (600-1500 micron) and more rarely carbonate ones, even of bioclastic origin and sporadic feldspar ones. The inert ones have very variable dimensions, from some mm to the dimension of a silt. The ratio Inert/Binder (I/B) varies between 0.4 and 0.7. Macroporosity is less than 5%. In the binder around the inert one there are thick spherulitic concretion (100 micron) and fringes of radiate calcite. In these concretions, the analysis by means of Microraman spectroscopy has revealed the presence of strontianite. The setting of this mortar has been realized in various levels.

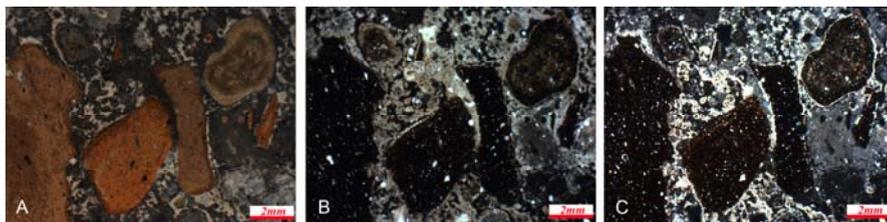
Fig. 2 micrographs of the thin section of the sample 09PA14: A reflected light, B ppl (plane polarized light) and C xpl (cross polarized light)

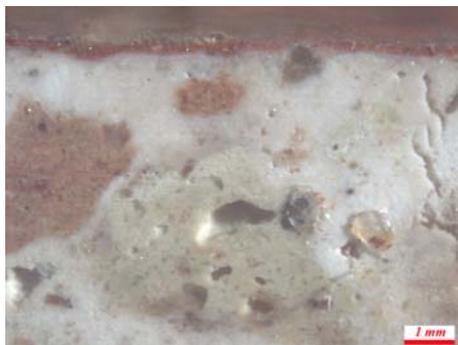
Fig. 3 Polished cross section in reflect light of the crushed brick mortar with a red painted layer coming from the external wall of the octagonal hall

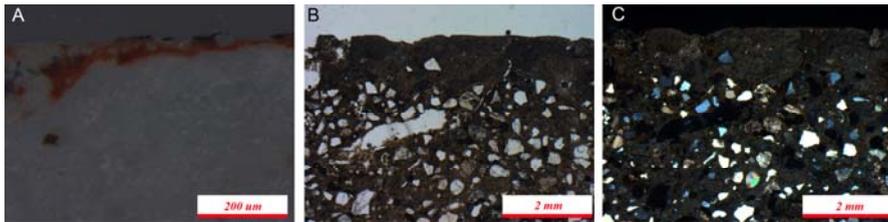
Fig. 4 micrographs of the thin section of sample 09PA12: A reflected light, B ppl and C xpl

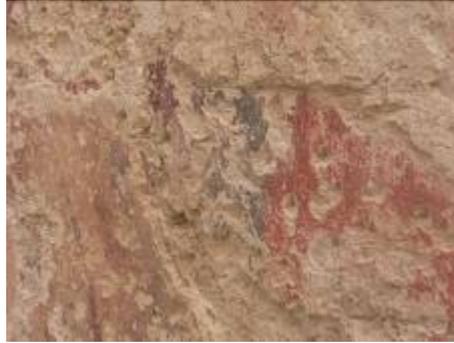
Fig. 5 the two pictorial layers on the four-sided portico wall

The in situ observations on the frescos of the four-sided portico have revealed the overlapping of two pictorial series, as shown in figure 5, applied on substrate mortars, whose characteristics do not essentially differ from the ones already described.

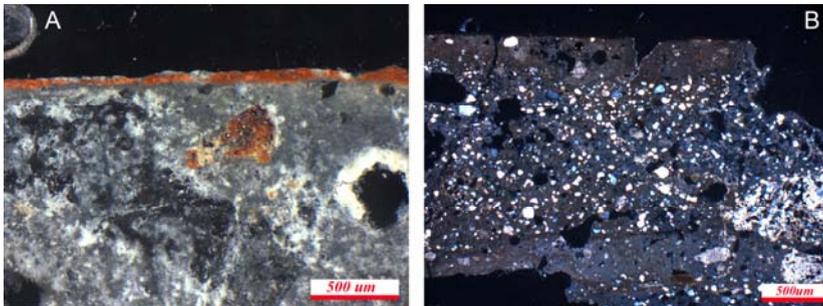
Fig. 6 Micrographs of the sample 09PA23 taken from the oldest pictorial layer. A reflected light and B xpl.

The thickness of the pictorial film goes from 100, sample 09PA24, to 20 micron, sample 09PA23, each pictorial film is applied on a layer of plaster that is almost completely composed by binder superposed on the reinforcing mortar. Yet, it is evident that the reinforcing mortar of the most recent pictorial series is a lot richer in binder, i.e. $I/B=0,2$, than other samples. Also in this case the aggregates are mostly composed by quartz grains and less by carbonate rocks, sparitic and microsparitic, by rare feldspars, even rarer muscovite lamellae and casual bioclasts, this highlights that the material comes from local arenaceous outcrop. The binder has a collophorm texture also in this case.

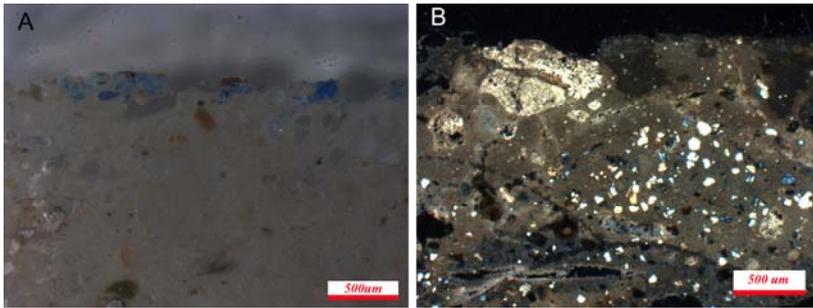
Fig. 7 Micrographs of the sample 09PA24 taken from the most recent pictorial layer, A reflected light and B ppl

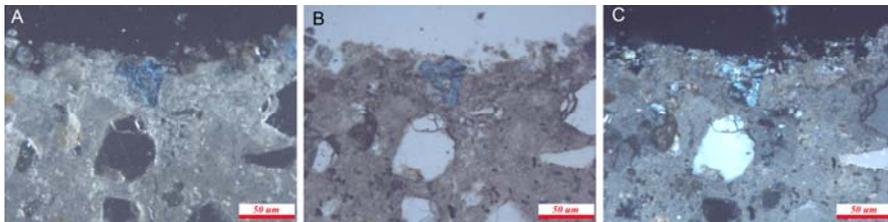
Fig. 8 Sample 09PA24 micrographs of the grains of the Egyptian blue: A in reflected light, B ppl and C xpl. In the latter it is evident the birefractivity of the crystals.

The painted layer, brown in colour as observed on thin section in ppl, is 100 to 20 micron thick and has generally a colloidal texture, excluding Egyptian blue that is birefractive in xpl. Except for some fortuitous cases, in presence of microfracture of the layer of “pure binder”, is not observed any diffusion of the pigments towards the inner layers, in fact there is, in general, a marked line of boundary. Two overlapped layers of paintings separated by a thin veil of lime were found in the peristyle and in the external wall of the Villa, which testify repainting of the wall.
