# Scan-to-BIM Process and Architectural Conservation: Towards an Effective Tool for the Thematic Mapping of Decay and Alteration Phenomena

## 2. The Case Study of the Church of “Santa Maria della Grotta” in Marsala (Italy)

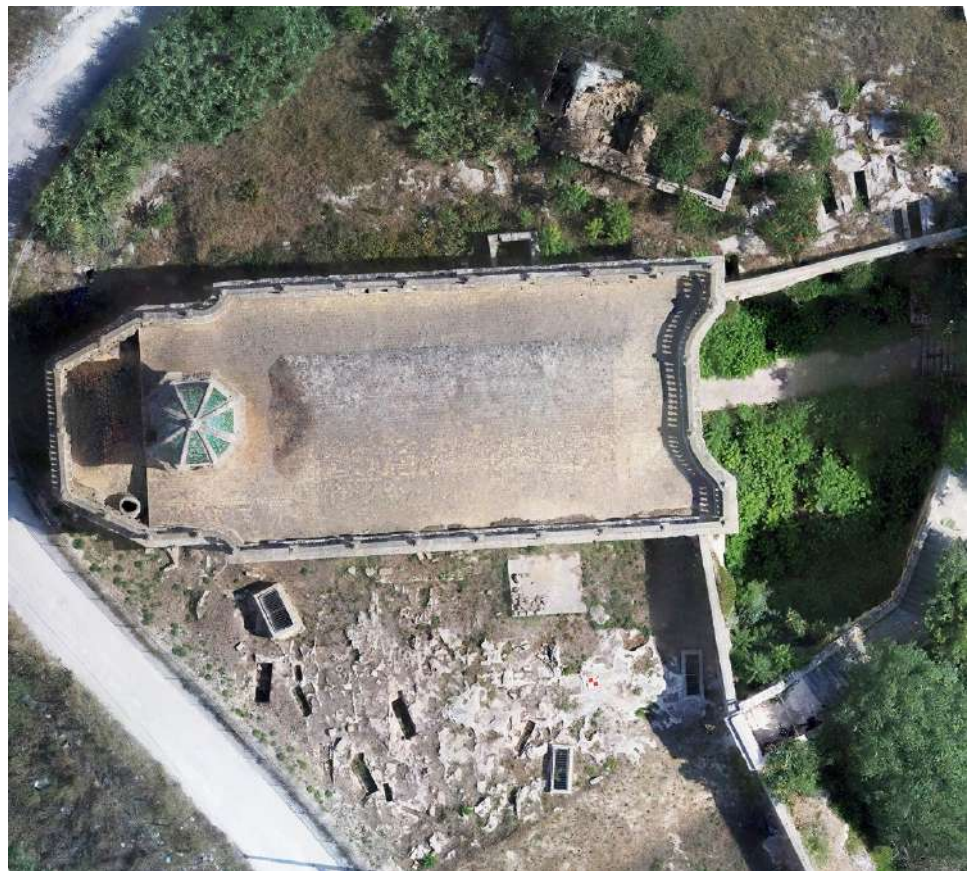
**Figure 2.** Nadir picture of the “Santa Maria della Grotta” site and building.

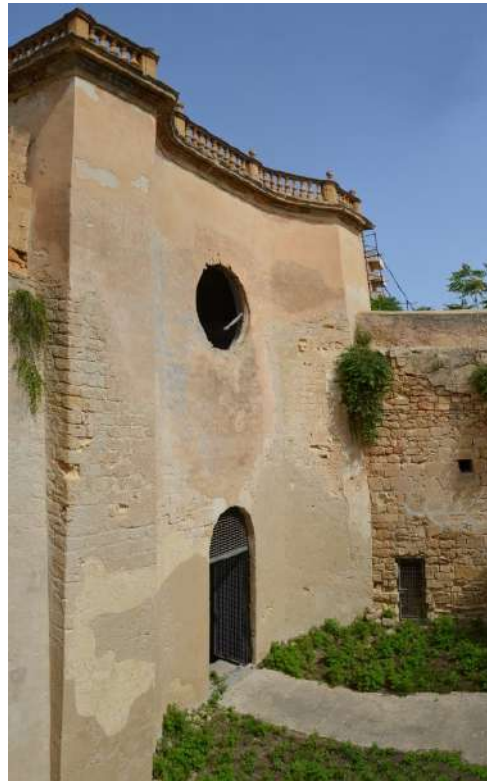
**Figure 3.** View of the main façade of the church of “Santa Maria della Grotta”.

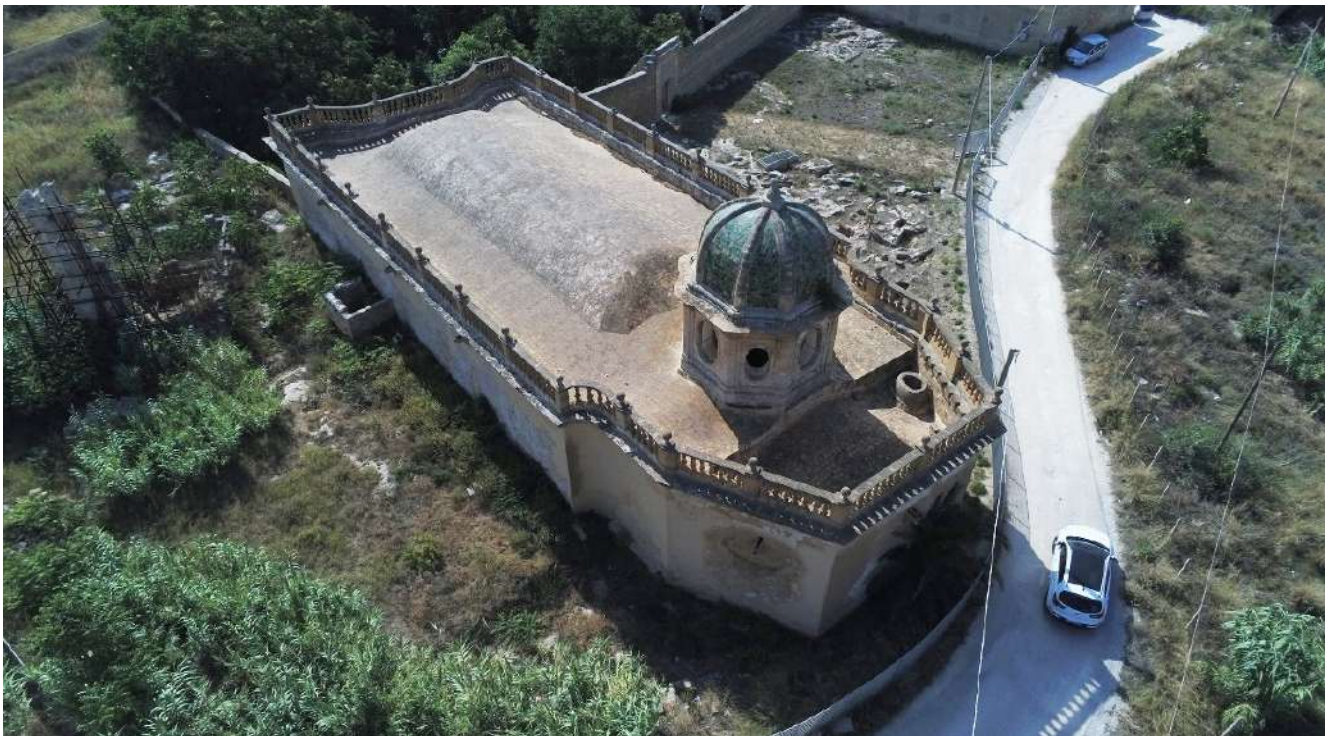
**Figure 4.** The green tile hemispherical dome of the church of “Santa Maria della Grotta”.

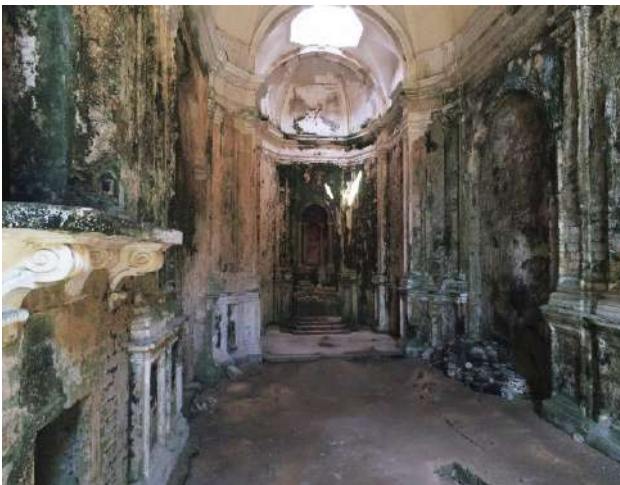
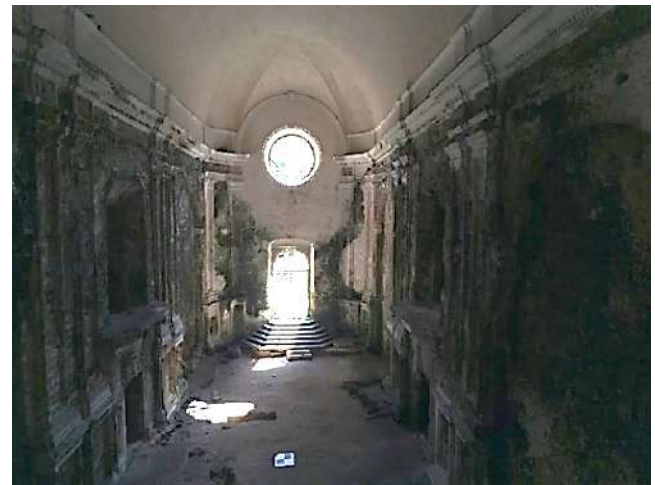
**Figure 6.** Interior of the church of “Santa Maria della Grotta”: (a) view towards the apse, (b) view towards the entrance. The decay and alteration phenomena are visible all over the walls.

The whole internal surfaces show an evident state of degradation, attributable to the lack of maintenance and the strong humidity linked to its specific underground conformation. In fact, the contact between the walls of the church and the sandstone bank led the monument to a constant presence of humidity along the vertical surfaces of the building.

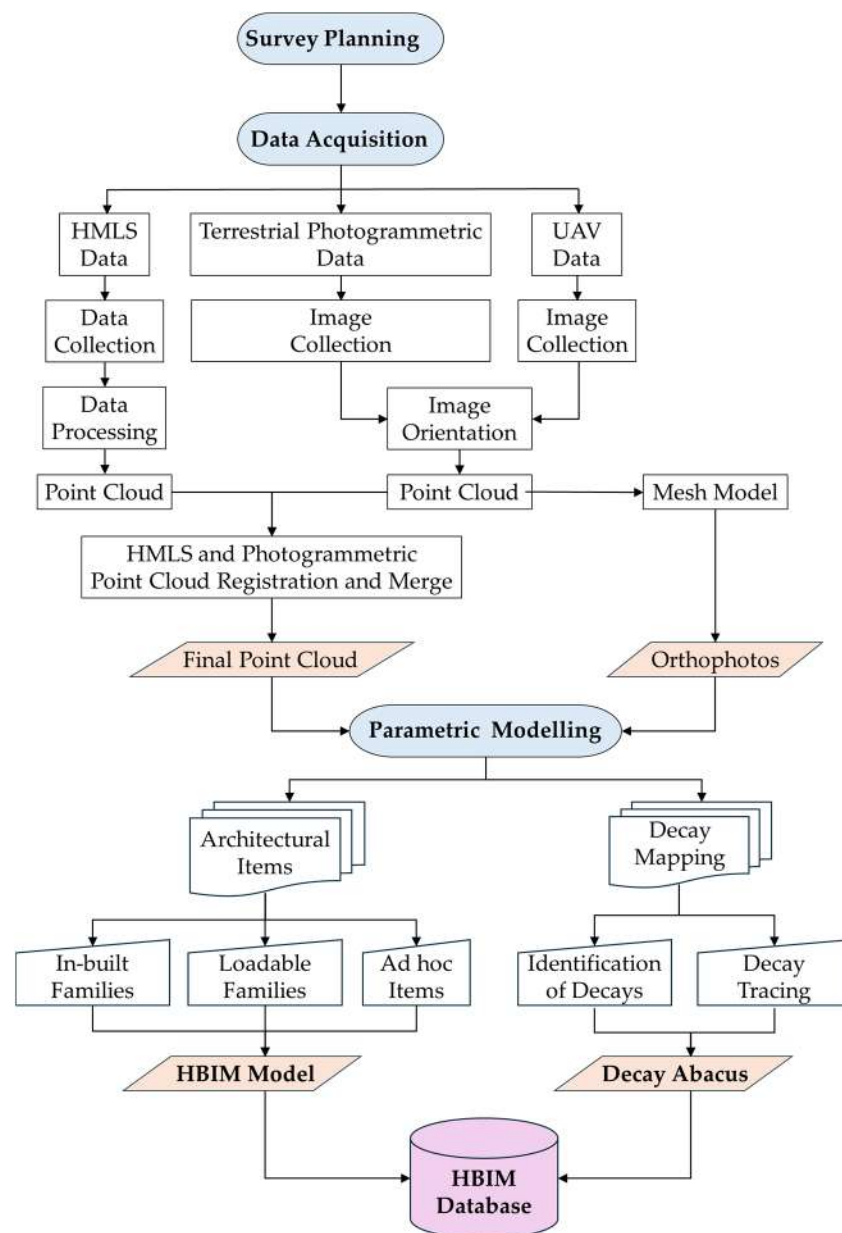
Figure 7. Scheme of the workflow.

The digitization of the monumental complex needed the design of an operative workflow for the management and the coordination between the single phases of the work. Since the 3D data were also used for other research activities [37], a detailed 3D survey (integrating laser scanning technology and photogrammetry) was planned to acquire a complete documentation of the site in its as-is conditions, analyzing the relationship among its different parts. Before the survey, it was essential to identify any critical issues and the preferable approach to obtain the best result in the acquisition phase. After the survey operations, the geospatial dataset was processed to obtain a complete 3D model of the whole church, necessary to obtain the geometric information to be used as a reference for the construction of the HBIM model. After that, the modelling process enabled the achievement of the parametric model of the monument. Finally, the decay maps were generated over the main surfaces of the HBIM model, based on an analysis of the degradations of the building. The whole workflow has been reported in the flow chart in Figure 7.

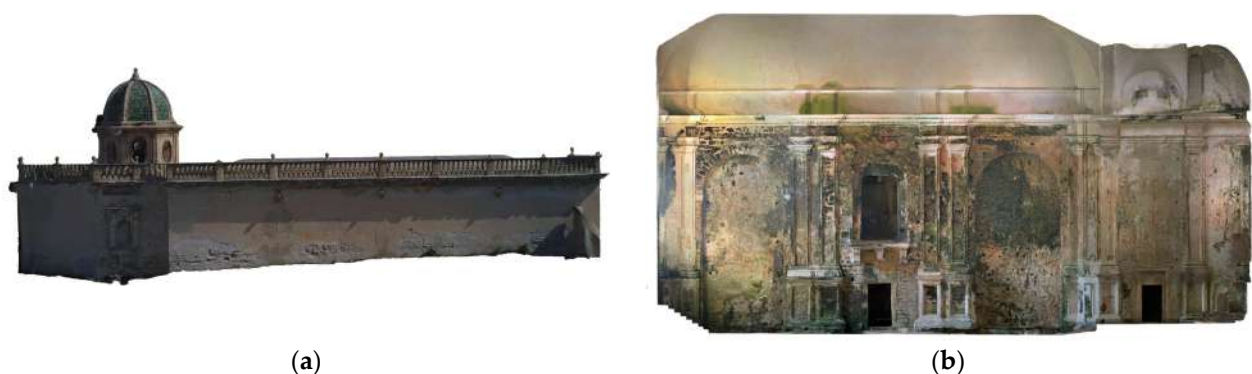
**Figure 11.** Orthophotos of the external (a) and the internal (b) wall of the left side of the church.

Instead, the orthophotos of the internal walls of the church were obtained with a photogrammetric project (using SfM elaboration) in Agisoft Metashape ver. 2.1.2 software that involved different indoor acquisitions. A unique project was created integrating aerial indoor image acquisitions from an Unmanned Aerial Vehicle (UAV) with terrestrial indoor image acquisitions. Overall, four orthophotos were produced for the two long sides of the nave of the church: two for the external and internal parts of the right side, and two for the external and internal parts of the left side (Figure 11). These products were necessary to conduct a detailed analysis regarding the state of degradation of the interior of the church.

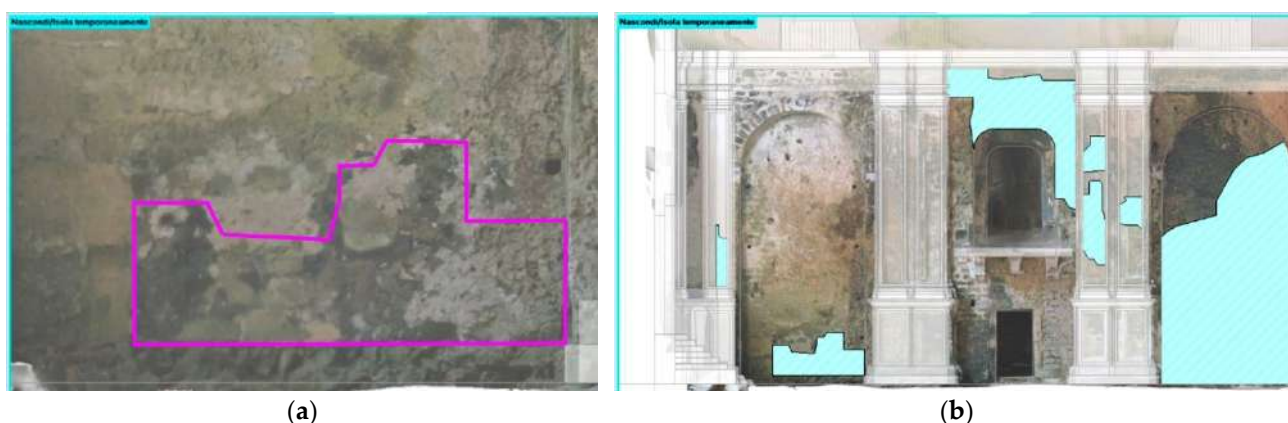
**Figure 23.** An example of contour tracing: (a) detail of fragmentation on surface layer; (b) the parametric families created accordingly.

As previously highlighted, the identification of the decays inside the church was carried out for the internal and external walls to obtain complete documentation and to reach the 3D representation of decay phenomena; the analysis was performed using the high-resolution orthophotos of the wall. The orthophotos were imported into Revit software and overlapped with the corresponding surfaces to create a mapping texture. The decays have been parametrically traced according to their actual shape starting from the 2D visualization (Figure 23).
