## Two stucco sculptures from the “Salone d’Ercole” in the Racconigi Castle (Cuneo, Italy): a case study

Non-invasive and micro-destructive diagnostic investigations were employed for the study of two stucco statues depicting Putti, from the “Salone d’Ercole” in the Racconigi Castle (Cuneo, Italy). The research made it possible to understand the construction technique, constituent materials, and the state of conservation of the statues. This information was useful for placing the artworks in the correct historical-artistic context and for conservation choices and restoration interventions. Different analytical investigations were applied, specifically: a) the internal metal structure was analyzed by cover meter relief combined with digital radiographic technique; b) the stucco composition and its stratigraphy were characterized by Polarized Optical Microscopy (POM), X-ray diffraction (XRD) and Electron Scanning Microscopy coupled with Energy-Dispersive X-ray spectroscopy (SEM-EDX); c) finally, the presence of organic compounds was observed by UV-Induced Visible Fluorescence (UUV) and then characterized by Fourier Transform Infrared Spectroscopy (FT-IR) analyses. The results show t

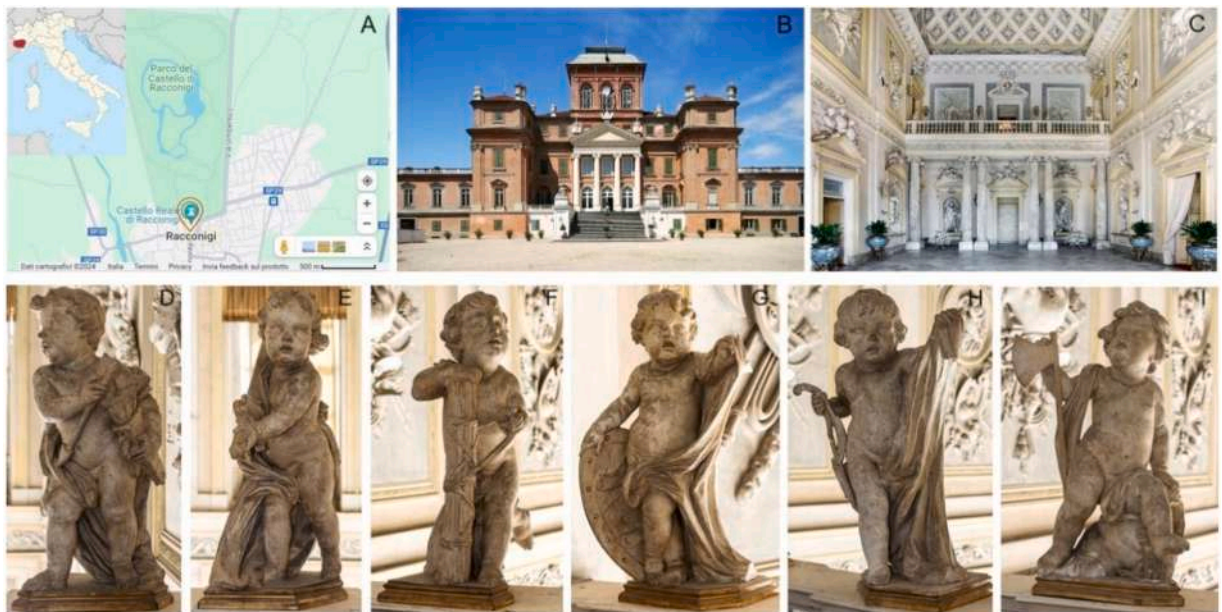
**Fig. 1.** (A) Location of Racconigi Castle in Italy and in the Piedmont Region; (B) Front view of the Castle and (C) of the Salone d'Ercole where a collection 6 Putti (D-I) is exhibited; (H-I) Putti as a case study of the present research. Notes: Images taken from <https://catalogo.beniculturali.it/detail/HistoricOrArtisticProperty/0100404954>.

A sculptural group featuring six allegorical Putti (Fig. 1D-I) in stucco embellishes the balustrade of the tribune in the Salone d'Ercole, each bearing an attribute representing warrior virtues (Fig. 1D-I). Historically credited to the sculptor Giuseppe Bolina due to his involvement in decorating the Salone d'Ercole, the sculptural style of the modeling could be traced back to the masterful techniques of Francesco Ladatte (Turin, 1706–1787) and therefore datable to the 17th century [2].

The Putto A (Fig. 1 A) depicts a naked child lifting a robe with the left hand while holding a bow in the right hand. The Putto B (Fig. 1 B) instead portrays a child seated on armor looking upwards and an axe in his right hand. Both the full-length sculptures, resting

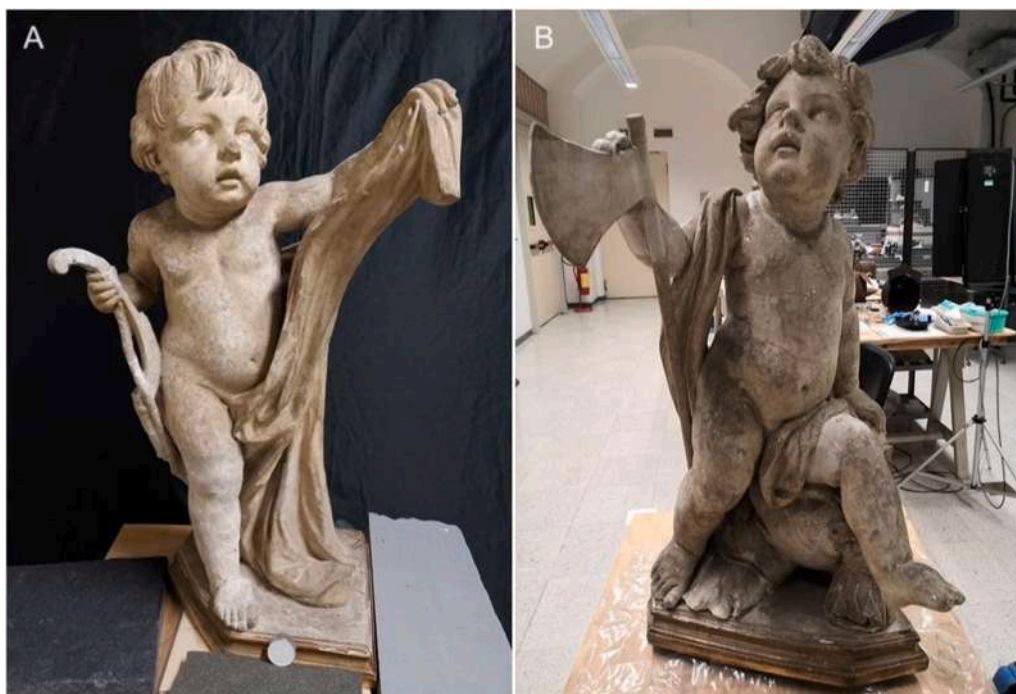
Fig. 2. Stucco's artworks from the Salone d'Ercole in the Castle of Racconigi selected as cases study: (A): Putto A; (B) Putto B.

The initial on-site investigations enabled us to assess the conservation state of the Putti and establish the most appropriate sampling strategy. These investigations provided crucial insights into the sculptures' condition (Figs. 2–3), allowing us to determine the best approach for further analysis.

Putto A (Fig. 2A) displays surface flaking and leafing near the nape of the neck, between the shoulder blades, on the buttocks, on the draped back, and, to a lesser extent, on the face. In addition, on the back of the sculpture there are widespread punctate flaking and detachments on the surface suggesting the presence of salt efflorescence. Moreover, incoherent deposits and absorbed dirt were widespread over the surface, especially on the horizontals and overhanging. The autoptic analysis also allowed to observe a thick layer of material on the surface, probably deriving from previous maintenance interventions, which also highlighted some lack and flaking on the drapery and putto's face. Careful observation of the surface highlighted various filling in the drapery, such as some modeling reconstructions made with gypsum plaster, less fine than the original stucco, used for rough structural reconstructions such as in the right foot or the upper part of the bow.

Even though the cleaning had not been completed, it was possible to observe the presence of further fillings and additions by modeling. Furthermore, in various areas physical decay phenomena such as micro-cracks were observed, especially in the arms and legs most subjected to mechanical stress, and in areas where the stucco was less thick, as in the case of the bow. A similar state of conservation was observed in Putto B (Fig. 2B) although with different severity. The surface showed flaking and lack of the surface layer, probably due to the aging of the protective compound applied in a previous conservative intervention, visible above all on the robe, inside the armor, and widely on the putto's body. Salt efflorescences, as in the Putto A, were also found in the hair and on the inner part of the armor. Unlike Putto A, Putto B showed many more lacks in the hands, feet, and armor. The lack of the big toe of the left foot allowed us to observe the remains of a plaster used to remodel the foot, which is now missing.

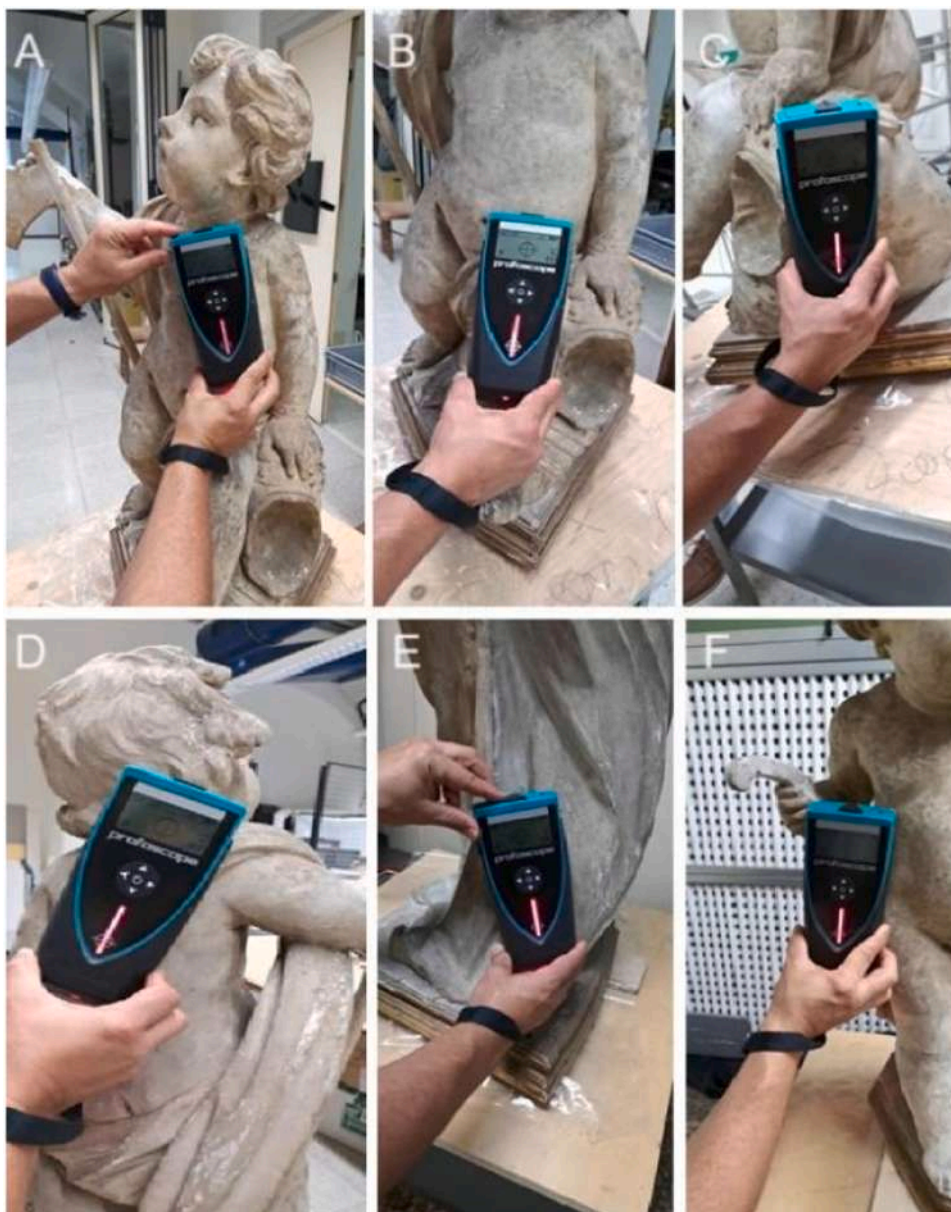
Fig. 4. Cover meter relief on Putto A (A-C) and Putto B (D-F).

The cover meter relief (Fig. 4) revealed an extensive and complex metallic structure for both stucco statues examined, corroborating initial observations made during the macroscopic inspection (Fig. 3).

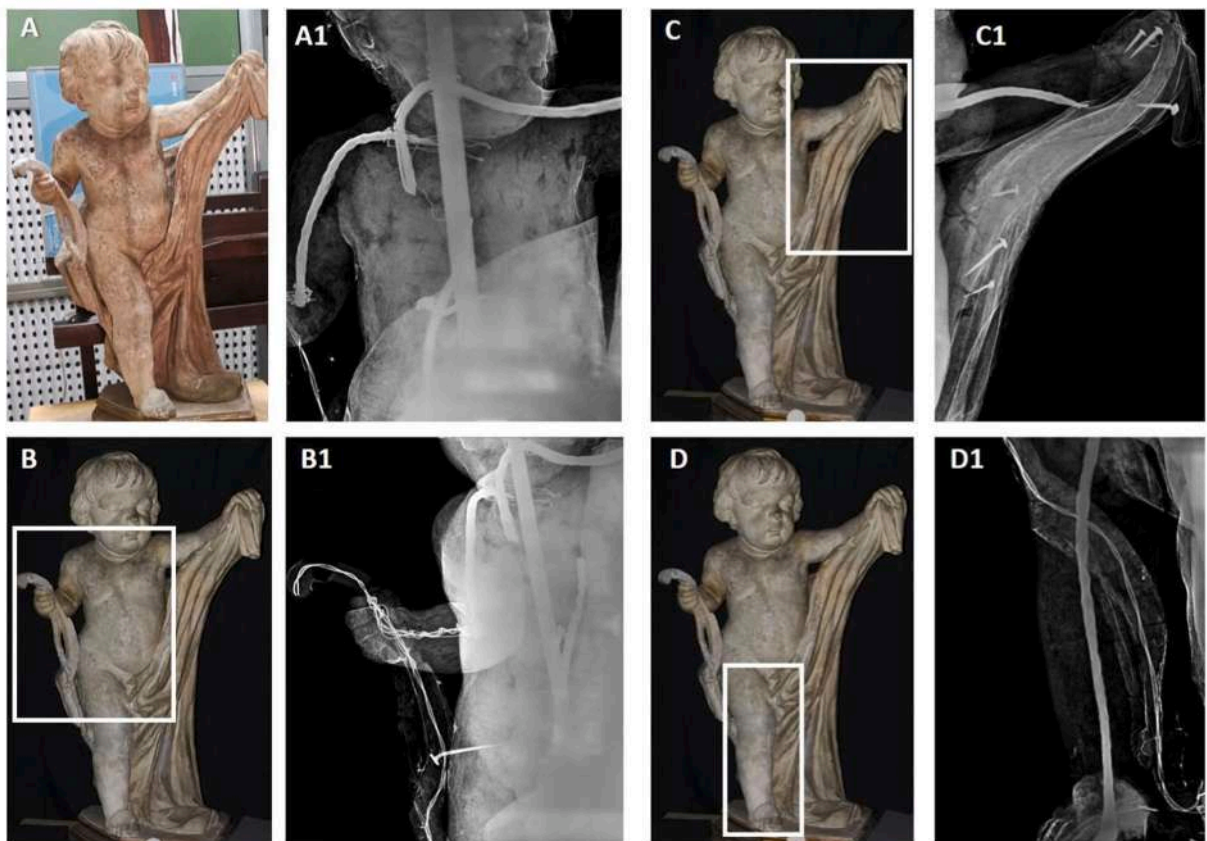
**Fig. 5.** X-ray Radiography: Putto A. Radiographic images and photographic detail of correspondent X-Rays four exposed area (A-A1, central part of body; B-B1, right arm and part of body; C-C1, part of drapery; D-D1, right leg) in which it is possible to see the use of wire rods employed as support for modelling the mortar and to achieve the desired volumes. A curved nail is also visible in the central part of the bust (A1), inserted from the back for anchoring the drapery and/or constructing the modelling. The portion of the leg up to the ankle shows less radiopacity than the foot (D1).

assembly of the components constituting the internal metal armor. Radiographic images highlight the precise positioning of the metallic elements thanks to the contrast between non-metallic (i.e., mortar: low radiopacity) and metallic elements (i.e., rebar: high radiopacity). The use of wire rods, iron wires, and nails for both Putti was ascertained. Individual metallic components appear to be assembled in various ways to create the internal structure, to which modeling was applied for the volumetric construction of the statues. The wire rods are forged iron bars of square section, riveted on the sides in an alternating direction, of different sizes from 6 up to 15 mm. Thanks to this special forging, they have sufficient rigidity and resistance to support protruding loads, guarantee better adhesion of the mortar to the bars, and satisfy the need for malleability during the construction of the structure [10]. The use of bended wire rods to model the arms, legs and drapery, was detected in both Putti (Figs. 5–6). Iron wires were used to tie together the wired rods and to make up the basic skeleton for fine elements [10]. In fact, in both statues, the thinner modeled parts have armor made up of iron wires, single or intertwined. Furthermore, it was possible to identify the use of nails, probably used to realize the perimeter bars of the blade (Fig. 5D-F).

The radiographic investigation also made it possible to document discontinuities in the internal volume of the stuccoes, mapping out fractures, lesions, and lacunae not directly observable from the surface, or past restoration work. The right leg of Putto A (Fig. 5G-H) shows a lower radiopacity than the foot, probably due to the different constituent materials applied to the leg and ankle during previous restorations.

These adjustments are also confirmed by the radiographic image (Fig. 5) due to the different radiopacity compared to the original stucco. Overall, there is no evidence of any traces of polychromy, or residues of ancient preparation and gilding. UV-induced visible fluorescence does not provide conclusive evidence but requires the use of complementary techniques, especially for material identification [12].

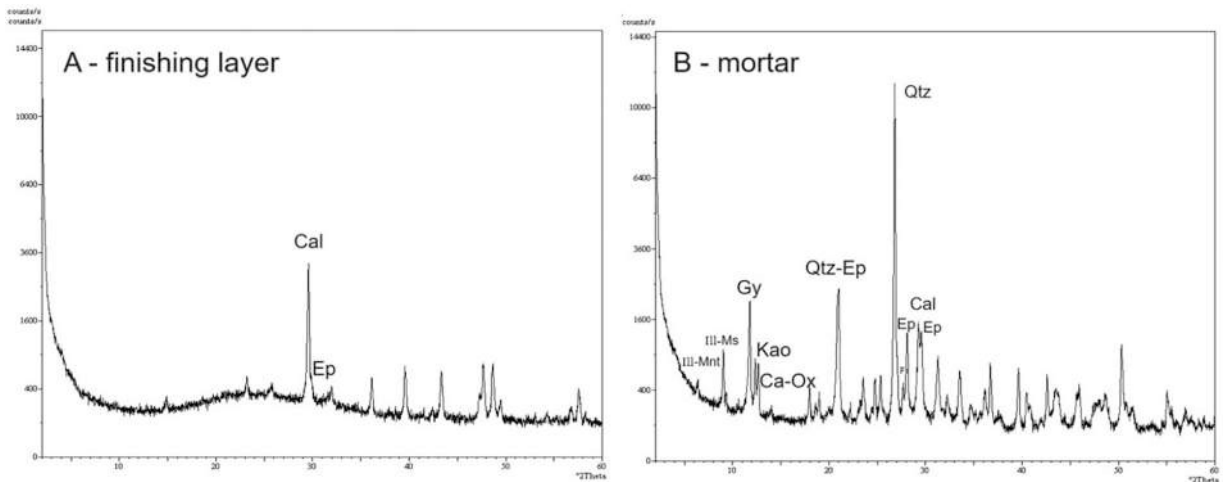
**Fig. 8.** (A) XRD spectra of mortar layer (sample 3); (B) XRD spectra of finishing layer (sample 2). Notes: Ill= Illite, Mnt= Montmorillonite, Ms= Muscovite, Kao= Kaolinite, Qtz= Quartz, Cal= Calcite, Gy= Gypsum, Ep= Epsomite.

The minero-petrographic characterization was completed by X-ray diffractometric analysis (Samples S2-S3, Table 1), performed on both the finishing layer and inner ones (i.e., mortar). The diffraction pattern of the inner layer (Fig. 8B) shows the following mineralogical phases, attributable to the aggregate: clay minerals (illite, montmorillonite, kaolinite), muscovite and quartz. The data are consistent with thin-section observations of S1. Furthermore, the presence of calcite and gypsum may be related to the binder. Finally, epsomite, i.e. magnesium heptahydrate sulfate ( $\text{MgSO}_4 \cdot 7 \text{H}_2\text{O}$ ), was detected. Epsomite is a salt approximately 300 times more soluble than gypsum and its formation is related to the combined presence of gypsum and Mg-lime in the mortar [5]. The finishing layer consists only of calcite and epsomite (Fig. 8 A). Gypsum was not found, probably due to the smaller quantity added to the finishing layer.

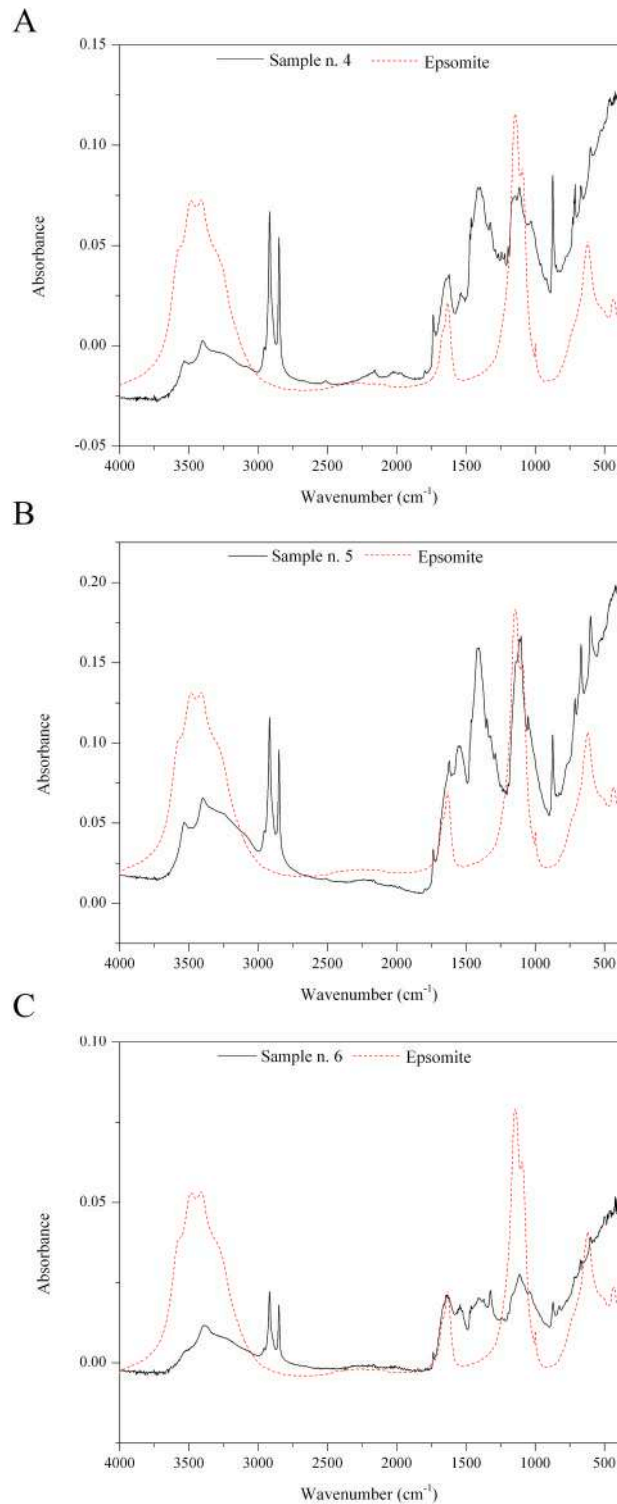
**Fig. 11.** FT-IR analysis of Putto B: (A) Sample 4: organic component: Lipid, inorganic compounds: Epsomite, Gypsum, Calcite; (B) Sample 5: organic component: Lipid; inorganic compounds: Epsomite, Gypsum, Calcite; (C) Sample 6: organic component: lipid and protein; inorganic compounds: Epsomite, Gypsum, Calcite and trace of Calcium Oxalate.

Samples 4 and 5 were taken respectively from the neck area and the pelvis area of the statue, where a yellow-orange fluorescence was observed. FT-IR analyses of these samples show the presence of bands attributable to a material of a lipidic nature identified by the presence of typical absorption bands (Fig. 11 A, B): methylene bands at  $2926\text{--}2855\text{ cm}^{-1}$  and olefinic C=C-H stretching band that occurs at  $3020\text{ cm}^{-1}$ , oil spectra contain also carbonyl band at  $1750\text{--}1740\text{ cm}^{-1}$  because of the ester group. Other bands characteristic

of the oils are aliphatic C-H bands at 1464–1379–725  $\text{cm}^{-1}$  and the C-O bands at 1240–1165–1013  $\text{cm}^{-1}$  [15].

Sample 6 taken from the area characterized by a slight bluish fluorescence weakened by a greater presence of surface deposits, shows an organic lipid and protein component (Fig. 11C).

The presence of amide is confirmed by N-H stretching bands near 3335  $\text{cm}^{-1}$  and by the presence of bands near 1650  $\text{cm}^{-1}$  (Amide I), 1550  $\text{cm}^{-1}$  (Amide II), and 1450  $\text{cm}^{-1}$  (Amide III) [15]. Moreover, trace of signal at 1323  $\text{cm}^{-1}$  attributable to calcium oxalate has been revealed on sample 6 FT-IR spectrum. Concerning inorganic materials, the FT-IR spectra showed for all three samples analyzed the co-presence of calcite with the most typical bands at 2515; 1424; 875; 712  $\text{cm}^{-1}$ , gypsum (3612–3556; 1622; 1152; 1116; 1093; 1007; 661; 599; 466  $\text{cm}^{-1}$ ) and epsomite (3509–3484; 1227; 1082; 1026; 680; 625; 599; 526; 426  $\text{cm}^{-1}$ ).
