# Combining High-Frequency GPR, Laser Scanning, and Digital Photogrammetry to Guide the Detachment of a Roman Mosaic in the Latomia dei Niccolini in Marsala (Italy)

## Abstract

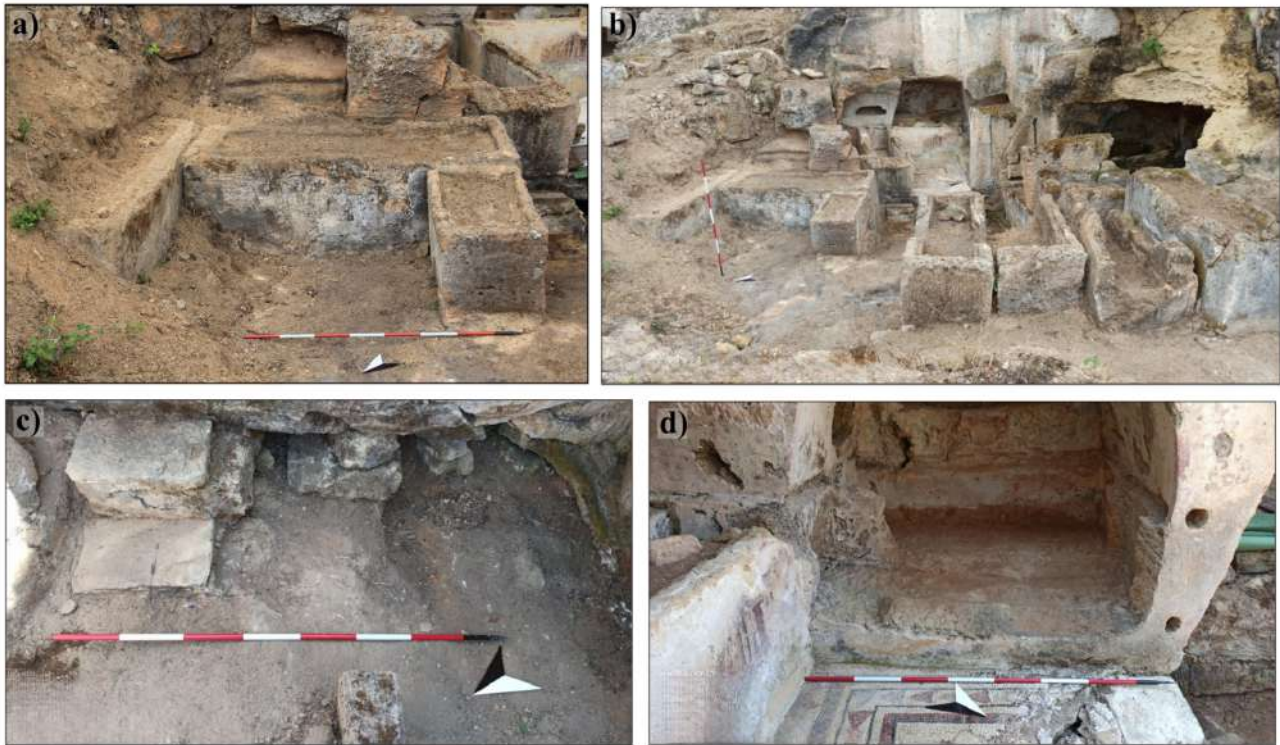
**Figure 5.** Archaeological site clearing: (a) North-eastern lithic chests after the cleaning; (b) Plot area subject to stratigraphic study; (c) The entrance stairs to the South cubiculum; (d) South cubiculum, arcosolium C after the intervention.

Near the entrance to the South cubiculum, 28 scattered polychrome mosaic tesserae—evidently detached from the main flooring—were recovered alongside the remnants of a plastered stone access structure (Figure 5c). Crucially, the internal cleaning of the South cubiculum provided direct evidence of the structural failures threatening the mosaic. The investigation revealed an alarming cavity between the lower mosaic preparation layer and the underlying earth fill, leaving the pavement severely unsupported. Furthermore, cleaning the adjacent arcosolia (A, B, and C) highlighted severe active subsidence [9]; a major crack in arcosolium A has profoundly compromised the walls and tombs, while arcosolium B was intentionally left filled with earth and stones to prevent further structural yielding of its decorated parapet. Arcosolium C was cleared of extensive roots, soil, and organic debris (Figure 5d), confirming the highly compromised and hollowed nature of the calcarenite supports beneath the mosaic.

In the north-eastern sector, two lithic sarcophagi (approximately  $2.20 \times 0.77$  m), previously documented [10] but reburied over time, were fully uncovered (Figure 5a). The sloping area in front of the cubicula (measuring ca.  $4.80 \times 5.86$  m) was excavated down to the original compacted sandstone pavement (Figure 5b). The removed overburden consisted of humus, ash, and soil deposits highly permeated with modern waste and invasive shrub roots. The presence of these active root systems represents a significant mechanical decay factor for the underlying calcarenite structures.

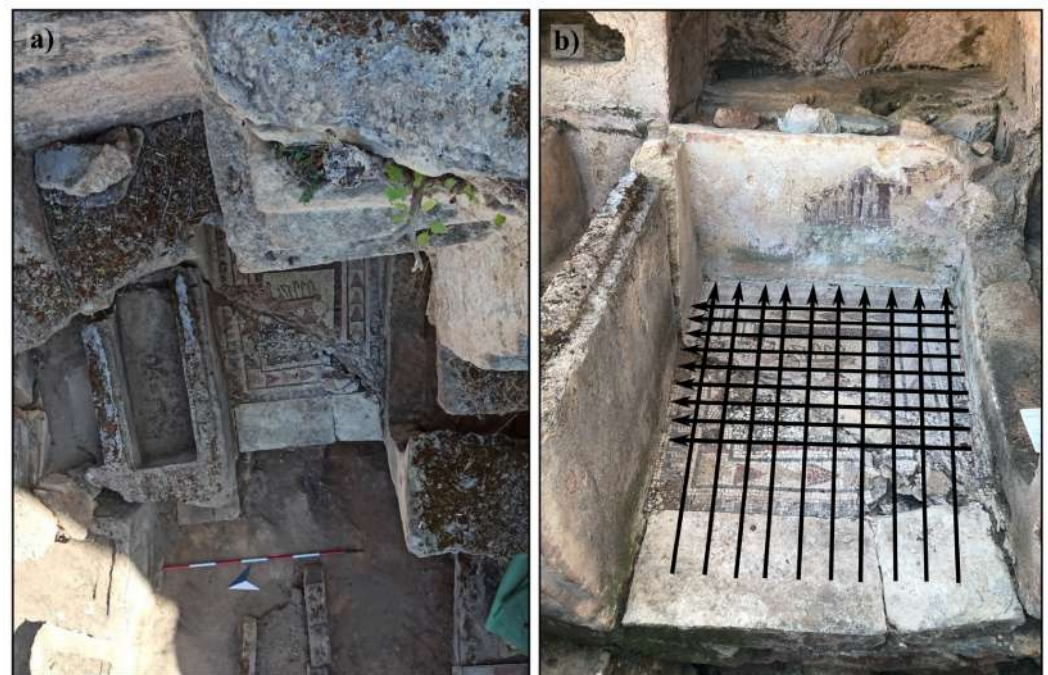
**Figure 7.** (a) Overview of South cubiculum after clearing; (b) View of the floor mosaic, the black arrows are the acquired GPR profiles.

In total, 19 profiles were recorded (Figure 7): 10 along the longest dimension of the mosaic (each approximately 1.4 m long) and 9 orthogonal to the previous profiles and approximately parallel to the shortest dimension of the mosaic (each approximately 0.9 m long).

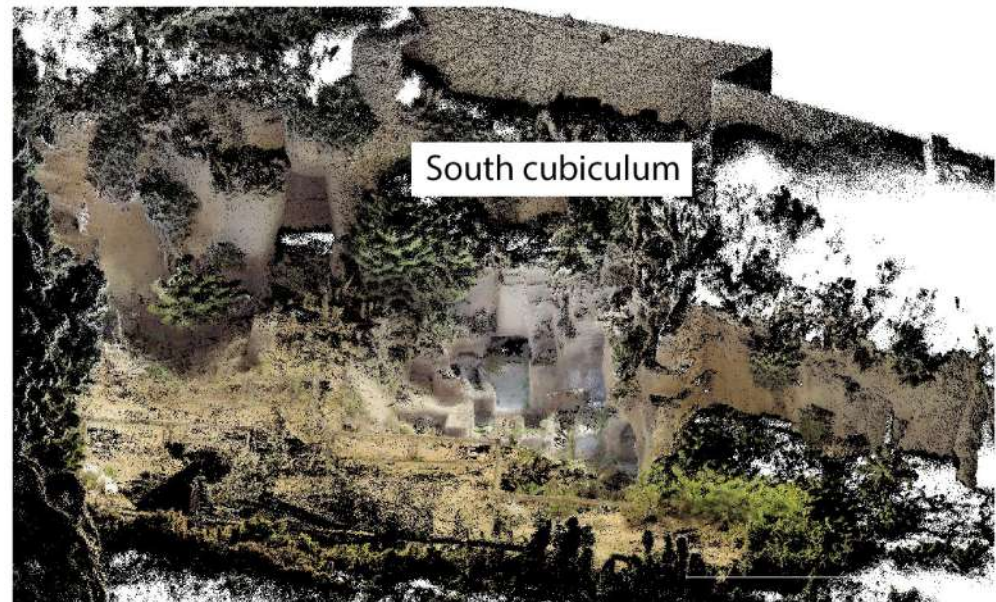
**Figure 9.** GeoSLAM Zeb Horizon RT point cloud of the Latomia dei Niccolini.

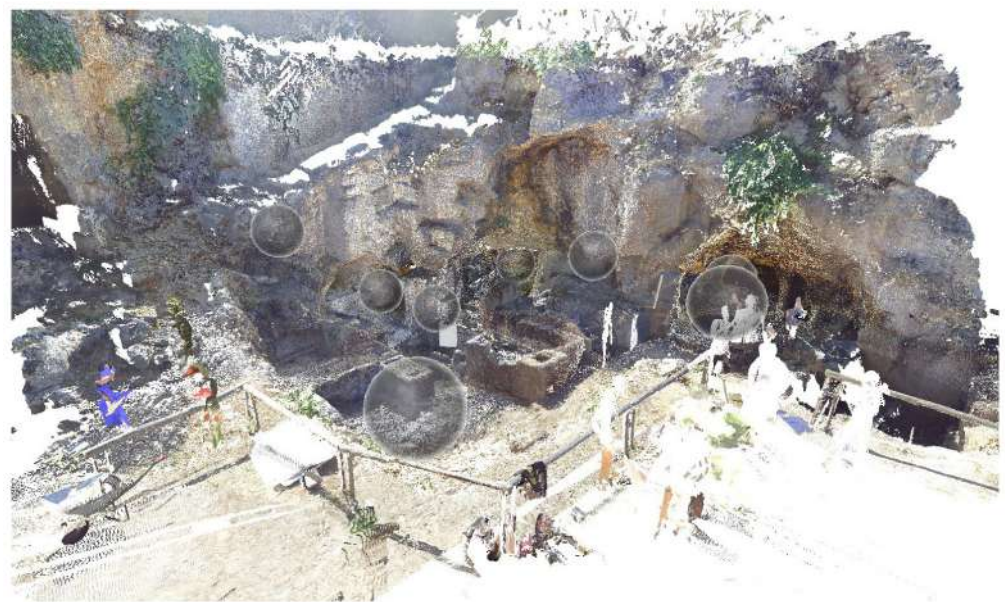
**Figure 10.** Faro Focus 3D S120 point cloud of the Latomia dei Niccolini; the gray spheres show the eight scanning positions.

total of eight scans were carried out, with two perimeter scans limiting the horizontal field of view and six full-dome scans performed within the area of interest. The resolutions of the acquisitions ranged from 12 mm at 10 m to 6 mm at 10 m. The use of a static laser scanner provided an extremely detailed point cloud with significantly less noise compared with the mobile laser scanner data (Figure 10).

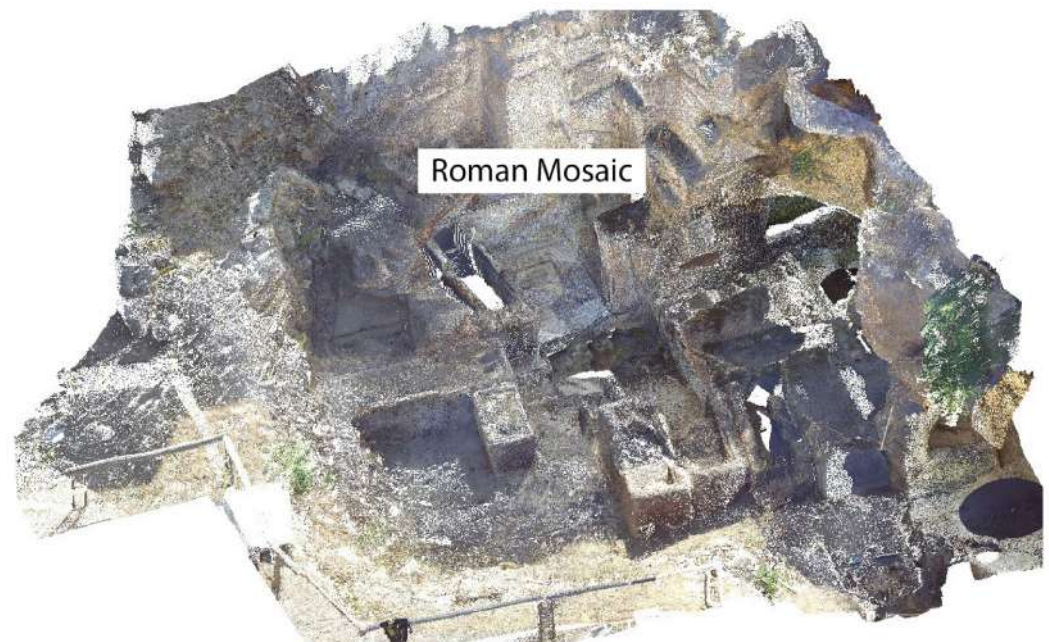
**Figure 11.** 3D view of the segmented Faro Focus 3D S120 point cloud of the area of interest.

to remove all areas outside the zone of interest. Given the acquisition resolutions, the average scanning distances (a few meters), and the high overlap percentage between scans, this point cloud consisted of approximately 15 million points with an average resolution of a few millimeters ( $\sim 5$  mm) (Figure 11).

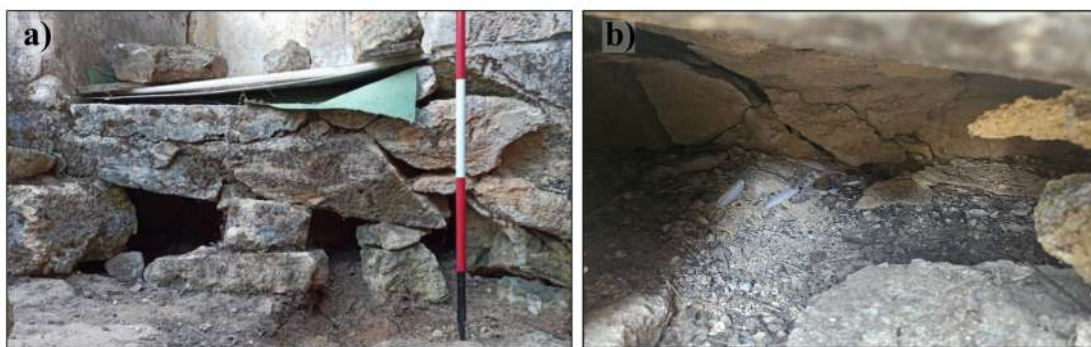
**Figure 14.** Video inspection of the South cubiculum subsurface: (a) Section view of the entrance area showing the borehole access for the camera; (b) View of the cavity under the floor mosaic.

On the open side of the cubicle, not against the wall, some openings in the underlying masonry allowed a camera inspection to visually investigate the excavations beneath the mosaic. The visual analysis (Figure 14) confirmed, at least in the directly accessible areas, the presence and spatial extent of the cavities; there is a strong correspondence between the high-reflectivity areas and the voids under the mosaic, visible through the side openings.

The video inspection images show machined surfaces compatible with an anthropic artefact, the extent of which is mapped by GPR investigations. The anomalies are concentrated mostly in the central portion of the mosaic, which coincides with the structural fracture, while the northern and peripheral sectors are more stable, with no evidence of significant voids or detachments. The 3D GPR model and camera inspection have the same pattern in terms of high-reflectivity areas, confirming the accuracy of the geophysical results.

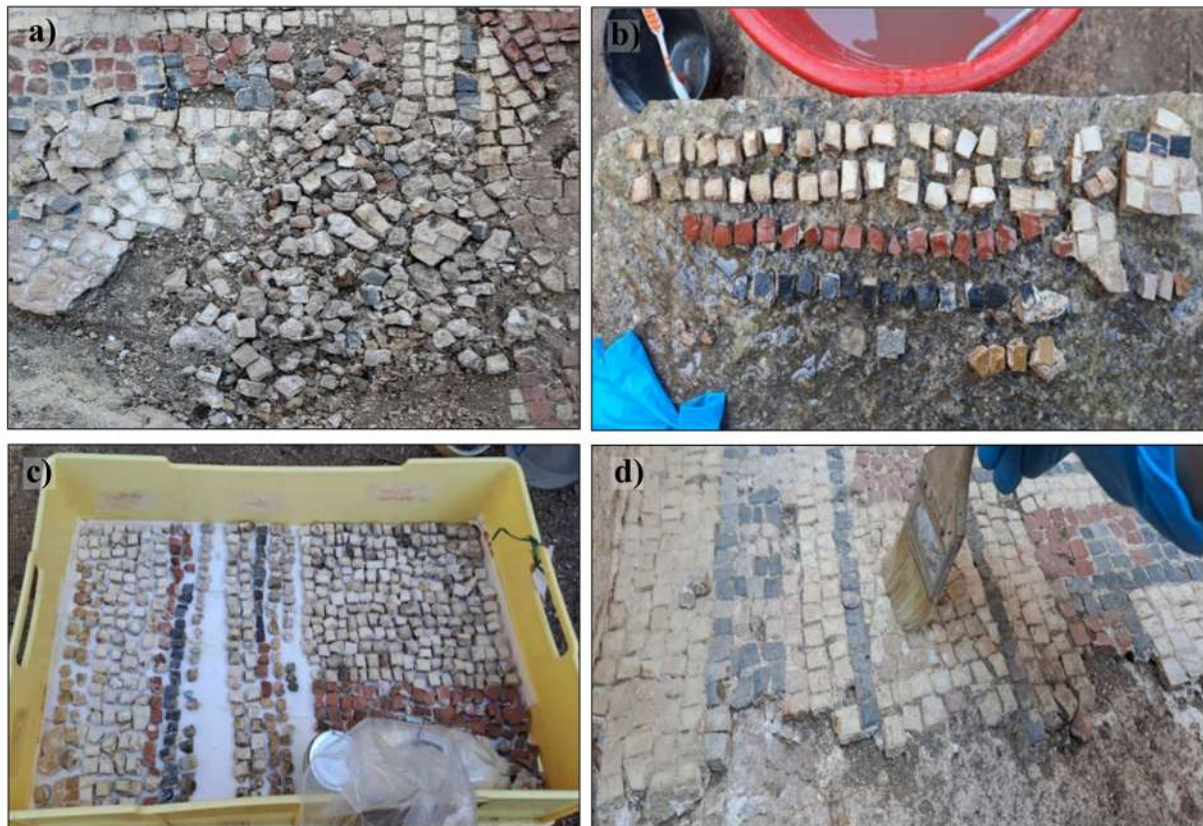
**Figure 15.** The initial phase of archaeological restoration: (a) The detachment of several tesserae; (b) Collection and color classification of erratic tesserae; (c) Cleaning the tesserae with water; (d) Preliminary dusting.

The Roman mosaic was in a very critical state of conservation. The collapse affecting the stone floor plan on which it is placed caused, in fact, the big fracture that exposed the mosaic bedding mortar and the limestone below to the rainwater runoff. This physical

weathering involved the disaggregation of the mortar and stone and, as a consequence, further cracks, deformations, and the detachment and loss of several tesserae from their bedding (Figure 15a). This situation also resulted in the presence of evident gaps and lacunae.

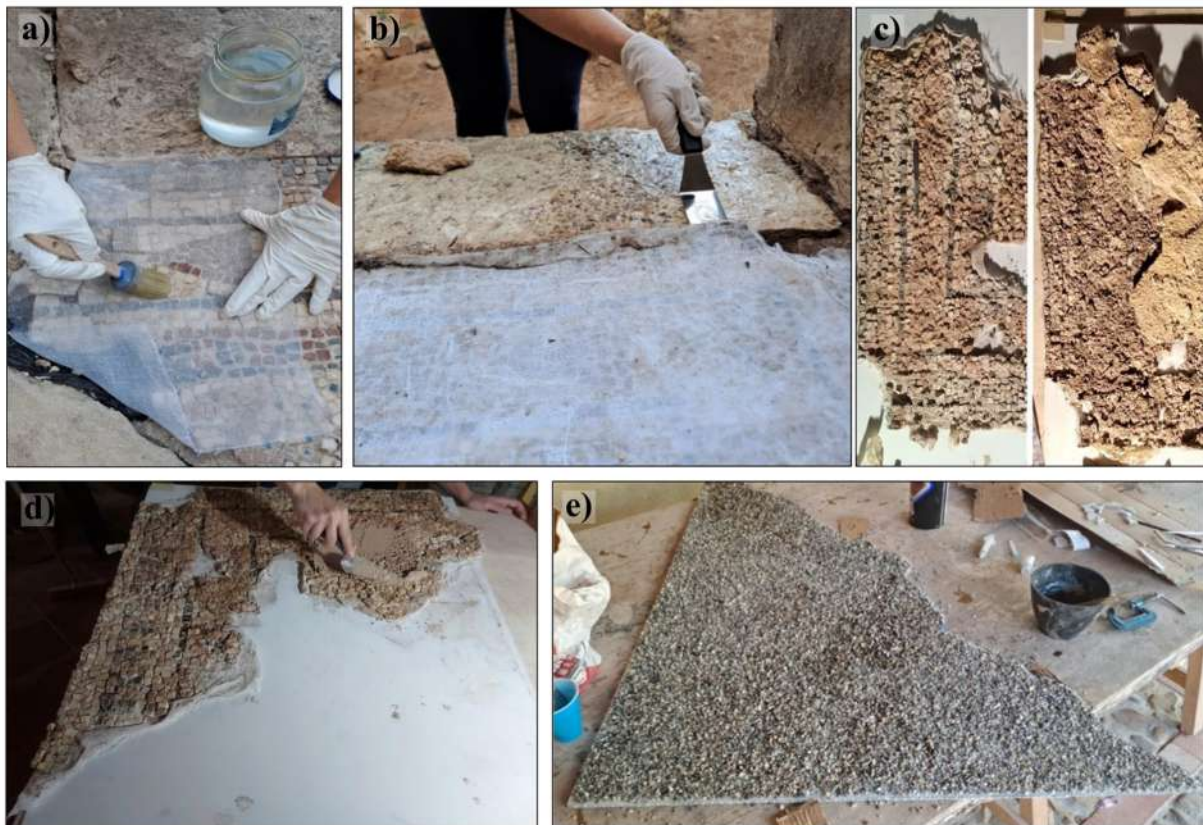
**Figure 16.** The archaeological restoration: (a) Coating with cotton gauze to carry out the removal of the fragment; (b) Detaching of tessellatum; (c) Mechanical removal of the deteriorated mortar; (d) Application of a new hydraulic mortar; (e) Relocation of the mosaic on new support.

The removal of the fragment began by covering the surface with cotton gauze adhered using a reversible acrylic resin (Figure 16a). This step protected the tesserae, secured any that might loosen during the operation, and allowed the surface to behave as a single, homogeneous layer. In order to prevent the risk of additional distention of the mosaic rug, the detachment of tessellatum with its preparatory layer was preferred to the lifting of only the tessellatum (Figure 16b).

The detached mosaic fragment was transported to the museum repository, where mechanical removal of the deteriorated backing mortar (Figure 16c) was carried out using chisels and hammers and micro vibrating pneumatic tools, to proceed with the application of a new hydraulic lime-based mortar similar to the original bedding layer (Figure 16d) and the relocation of the mosaic on a new support. It consisted of a cut-to-measure panel made of an aluminium honeycomb core between two layers of fiberglass-reinforced resin, whose surface was preliminarily treated with a grit-based gripping layer (Figure 16e) fixed with epoxy resin to allow adhesion of the new bedding layer. The millimetric geometric compliance of this custom-built support was ensured by the precise spatial coordinates extracted from the diagnostic models. These coordinates allowed the restoration team to accurately outline the exact perimeter of the detached structural portion south of the fracture, which had an approximately triangular shape with legs measuring 100 cm and 85 cm, and a hypotenuse of 130 cm.

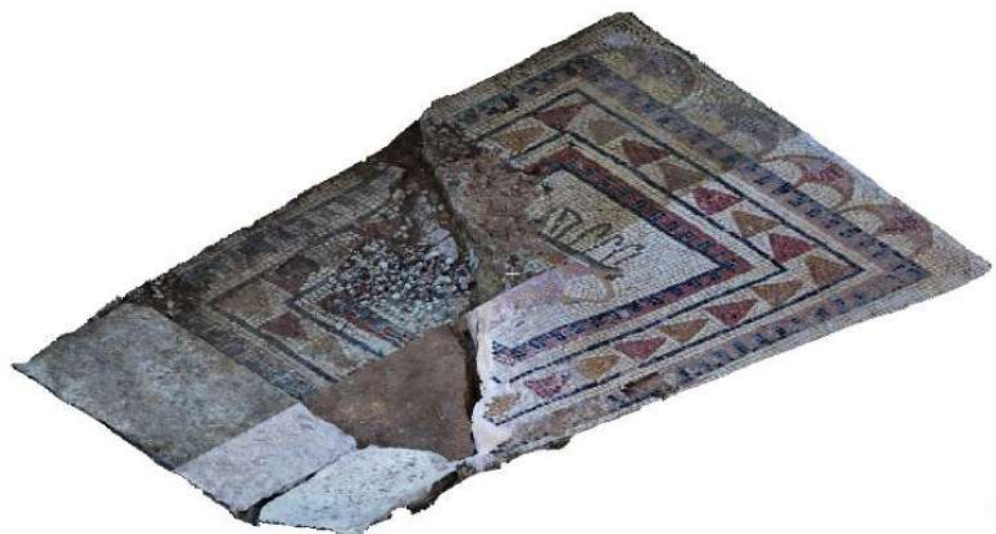
**Figure 20.** View of 3D models of the mosaic before (on the left) and after (on the right) restoration.

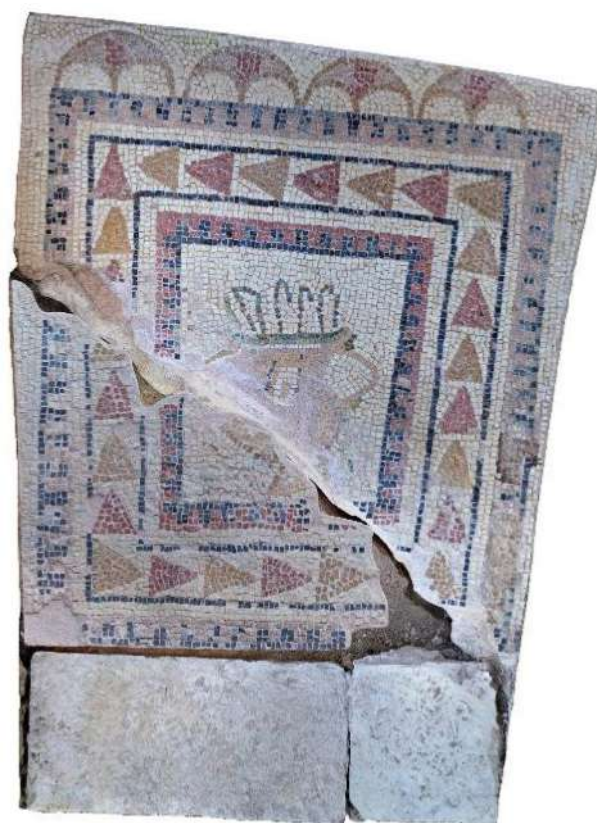
**Figure 21.** View of the orthophoto of the mosaic in situ after restoration with virtual relocation of the removed and restored fragment.

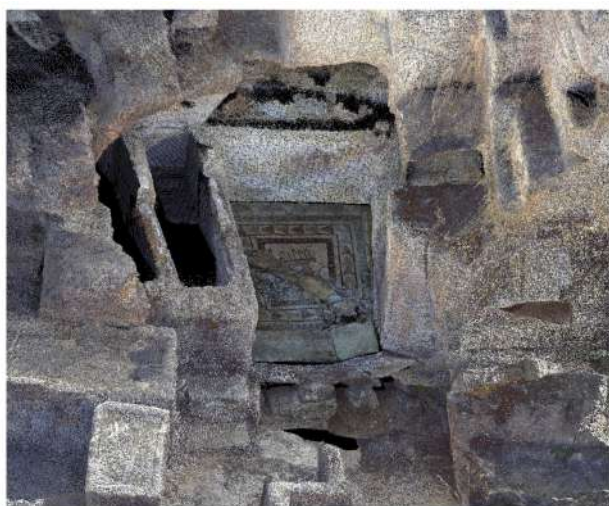
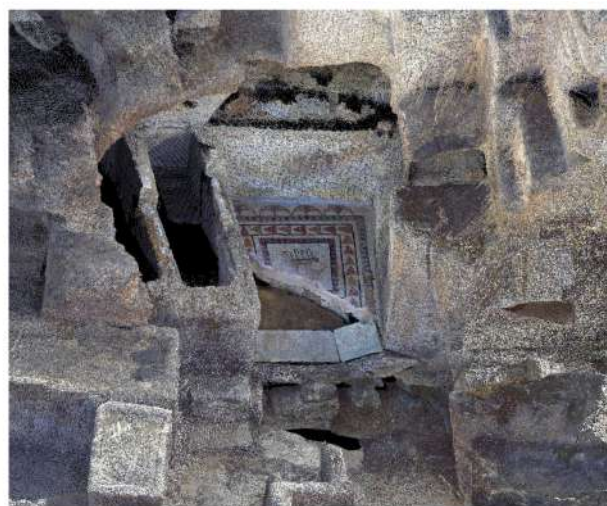
**Figure 22.** 3D reconstruction of the site: (a) before the restoration of the mosaic; (b) after the restoration of the mosaic.

The subsequent virtual reconstruction process was carried out by overlaying the 3D model of the mosaic onto the 3D model of the site. This operation was made by registering the mosaic point clouds with the laser scanner point cloud in CloudCompare. This allowed for the digital 3D reconstruction of the area before and after the restoration of the mosaic (Figure 22).
