A SCAN-TO-BIM PROCESS FOR THE MONITORING AND CONSERVATION OF THE ARCHITECTURAL HERITAGE: INTEGRATION OF THEMATIC INFORMATION IN A HBIM MODEL

A. Ferro¹, M. Lo Brutto^{1,*}, G.M. Ventimiglia²

KEY WORDS: Scan-to-BIM, HBIM, Point Cloud, Parametric Modelling, Conservation, Decay.

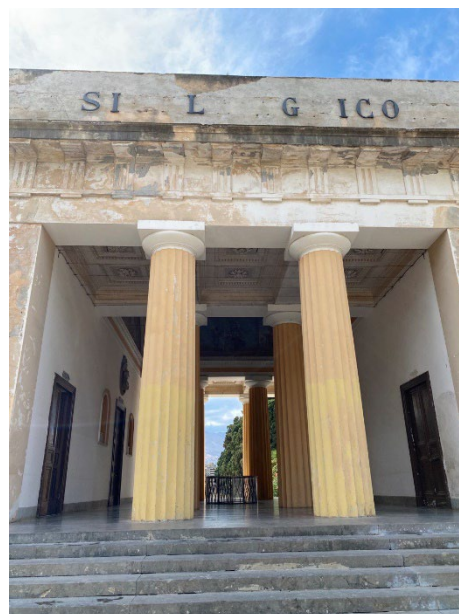
Figure 2. View of the central vestibule and the Doric columns.

The building rises on a rectangular base measuring about 19 x 40 metres and consists of two symmetrical parts connected by an open vestibule that constitutes the entrance to the Gymnasium. (Figure 1). Eight Doric columns, whose height is equal to five times the diameter of the base, are in the central part of the vestibule and support a hemispherical dome on pendentives. (Figure 2).

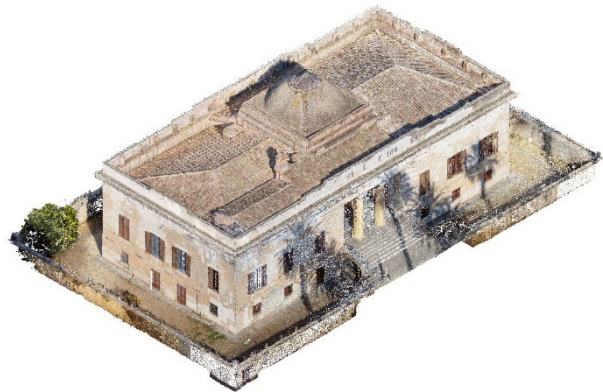
Figure 6. Point cloud of the external parts of Villa Castelnuovo.

After image orientation, an overall point cloud of the external parts of the building was obtained (Figure 6). This point cloud had about 22 million points and an average resolution of about 0.003 m. The photogrammetric processing was also aimed to calculate the orthophotos of the façades. For this process, only the terrestrial images, that had a better resolution, were considered.

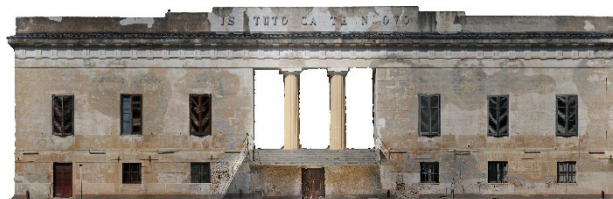
Figure 8. Orthophoto of South-West façade.

The study was first concerned to the South-West façade of Villa Castelnuovo (Figure 8), which appeared to be the most compromised; then the procedure was extended to all the other façades of the building. This step was the basis for increasing the knowledge and expanding the information of the building.

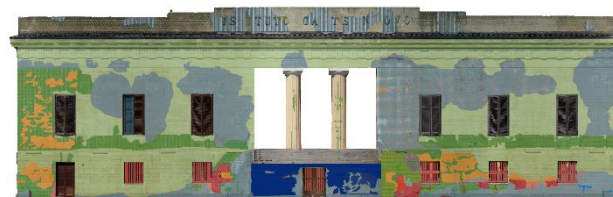
Figure 9. Decay mapping on South-West façade.

Using the orthophotos it was possible to obtain the supporting documentation for mapping the decay; this information has been integrated into the mapping referring to the international ICOMOS glossary released in 2003 (Figure 9).
