Case Report

Procedure for Safety Assessment and BIM Modelling of an Historical Complex Structure through a Macroelement Approach: The Building “Molino-Pastificio Soresi” of Partinico (Italy)

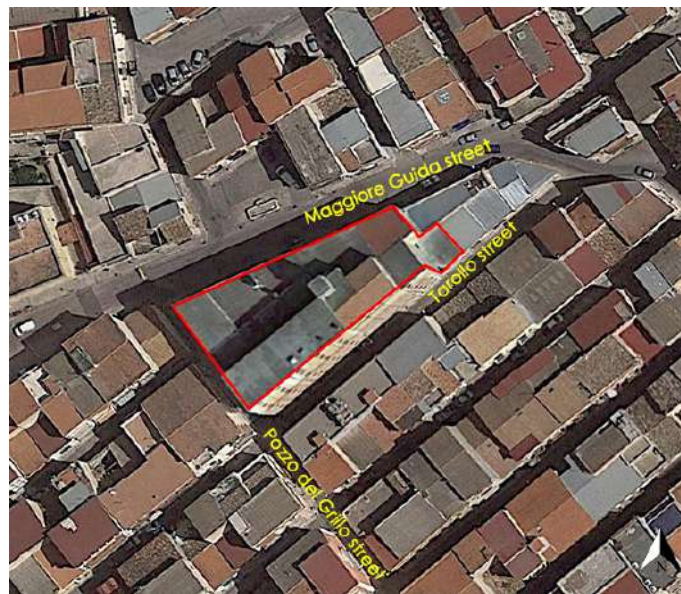
Figure 1. Site plan of Molino-Pastificio Soresi (today).

The owner transformed a first stock of buildings, with an oil mill inside, received in inheritance, located at the corner between the Maggiore Guida street and the Pozzo del Grillo street (Figure 1).

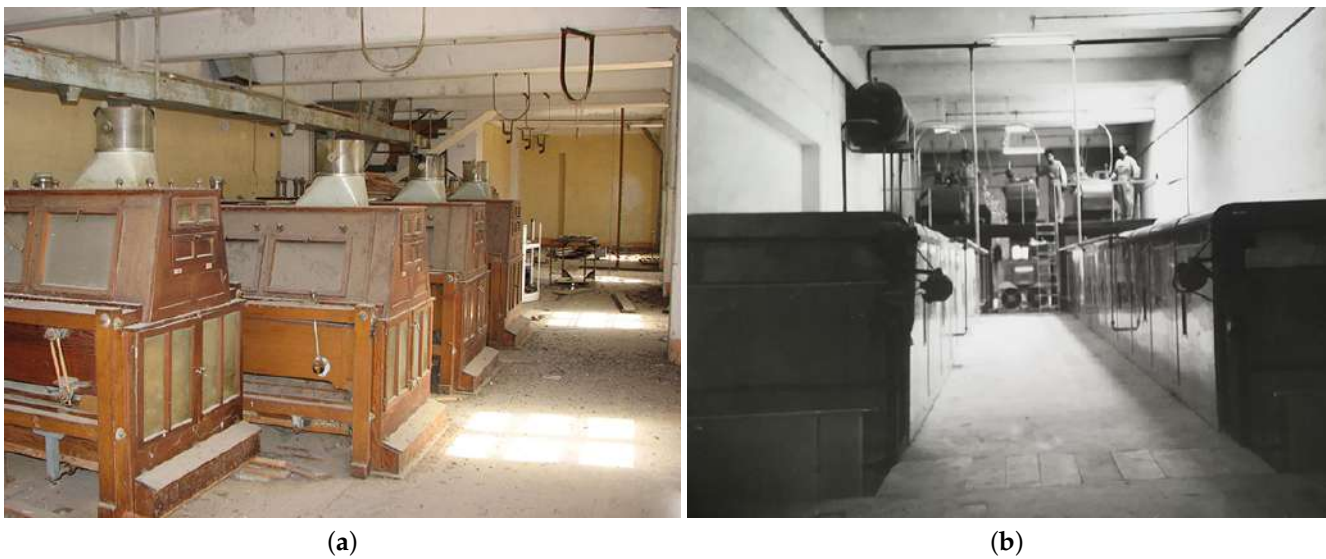
Figure 3. Historical photos of Molino-Pastificio Soresi. (a) Semolator machines; (b) Machines for the production of short pasta.

Around the 1960s, the company faced a great development with the installation of new and heavy machines and introduced new production processes (Figure 3).

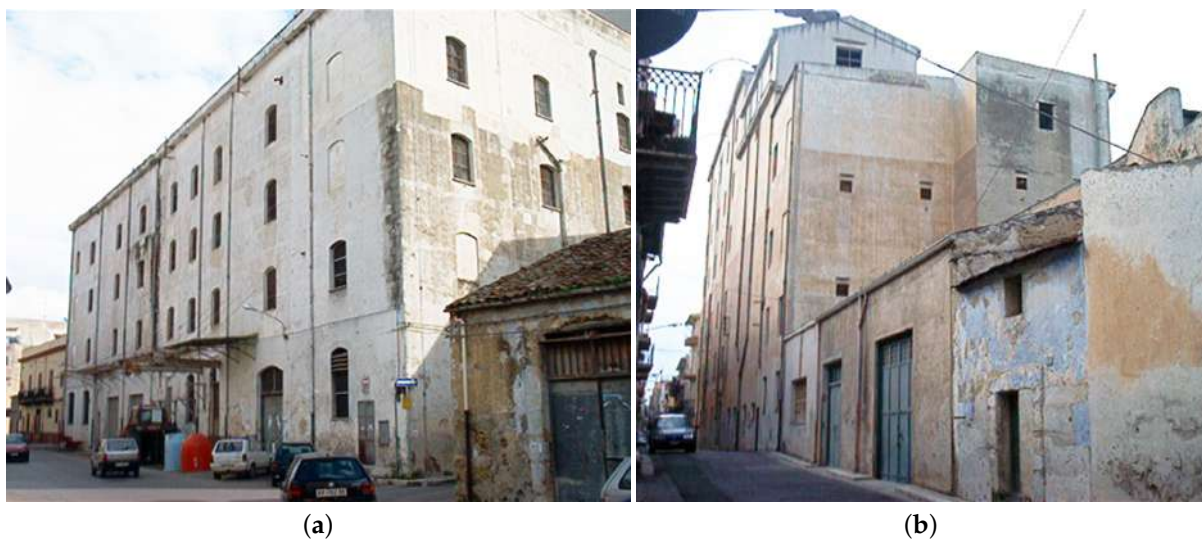
Figure 7. Building exterior views. (a) Main front; (b) Secondary front.

The complete architectural survey of the first floor is reported in Figure 6, while Figure 7a shows the main front on Maggiore Guida street and Figure 7b the rear front along Tarollo street.

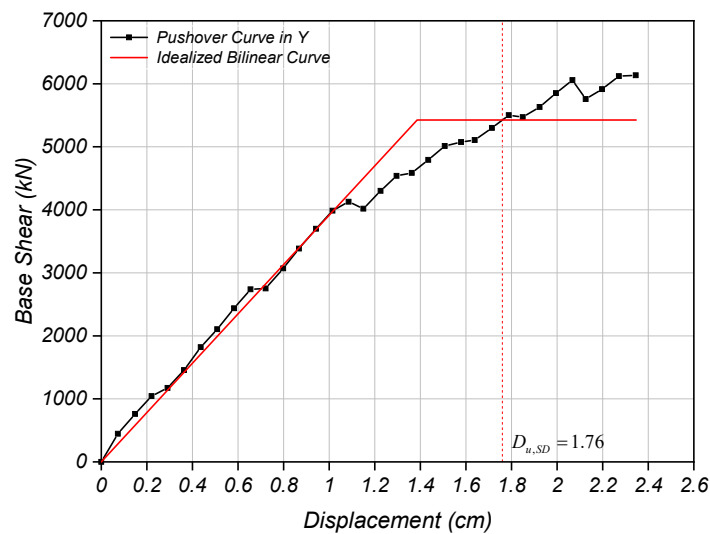
Figure 19. Pushover curve of seismic analysis n.21, direction Y (Uniform).

Similarly, Figure 19 shows the capacity curve of the structure for analysis n.21, i.e., uniform distribution of loads and Y main direction of the forces.
