Non-contact detection of interlaminar defects in titanium-graphite FMLs using laser ultrasonics and thermography

ABSTRACT

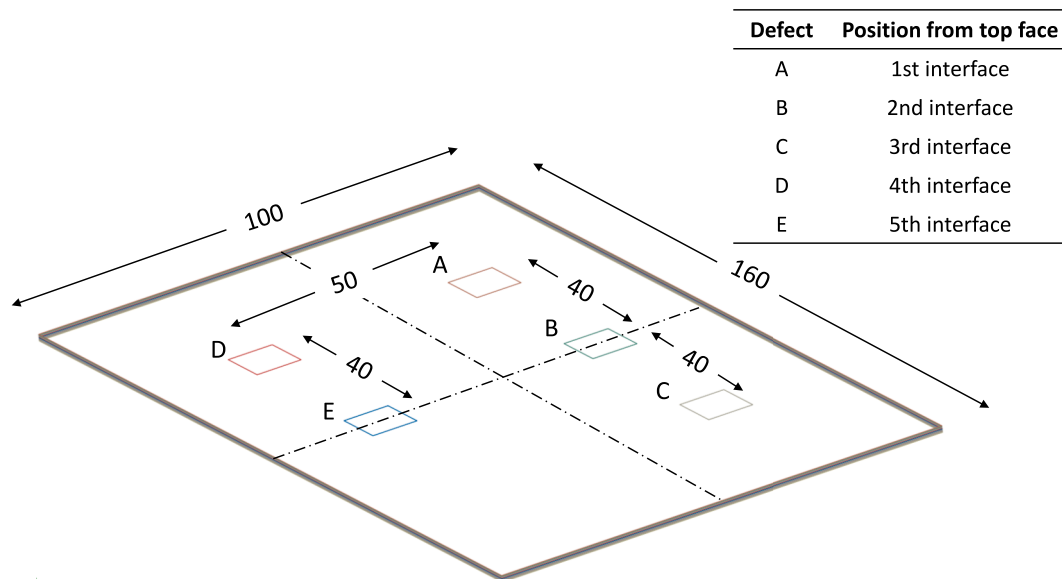
Fig. 1. Schematic representation of the Ti-Gr sample with an overall thickness of 1.4 mm. The nominal positions of the five square-shaped defects are indicated in mm.

It should be noted that defects from A to E are located at progressively deeper interfaces from the inspected surface (see Fig. 1); therefore, the difficulty in detecting defects D and E located at the fourth and fifth interfaces, respectively, was expected. The central positions of defects A, B, C, and D can be extracted from the B-scan of scanline 2 and scanline 3 and are respectively 30 mm, 70 mm, and 100 mm for A, B and C, while it is 100 mm for defect D; all the defect linear extensions have a ± 2 mm tolerance (comparable with the linear step resolution). Comparing the detected defect positions with the nominal reported in Figs. 1 and 3, a discrepancy of 10 mm (100 mm detected instead of 110 mm of the nominal) on the defect A and D positions emerges. This difference will be further explored by comparing these outcomes of the pulsed thermography (see next section 3.4).

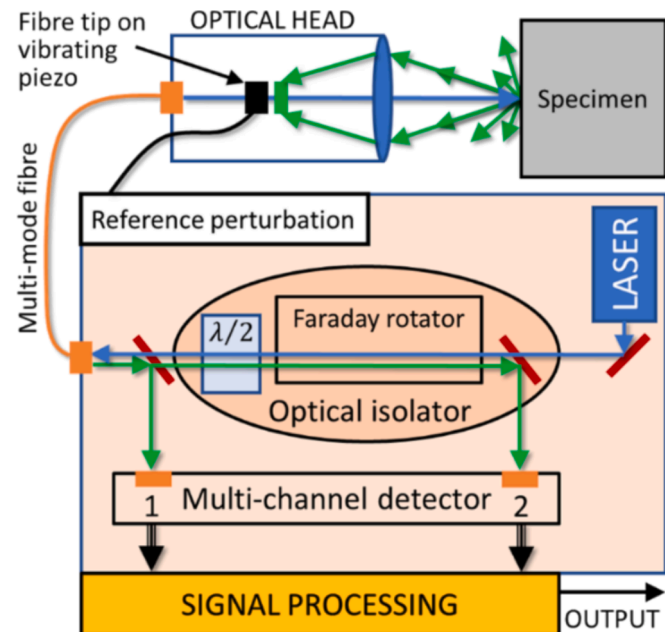
Fig. 4. Schematic representation of the laser interferometric device adopted in the LUT system [37,38].

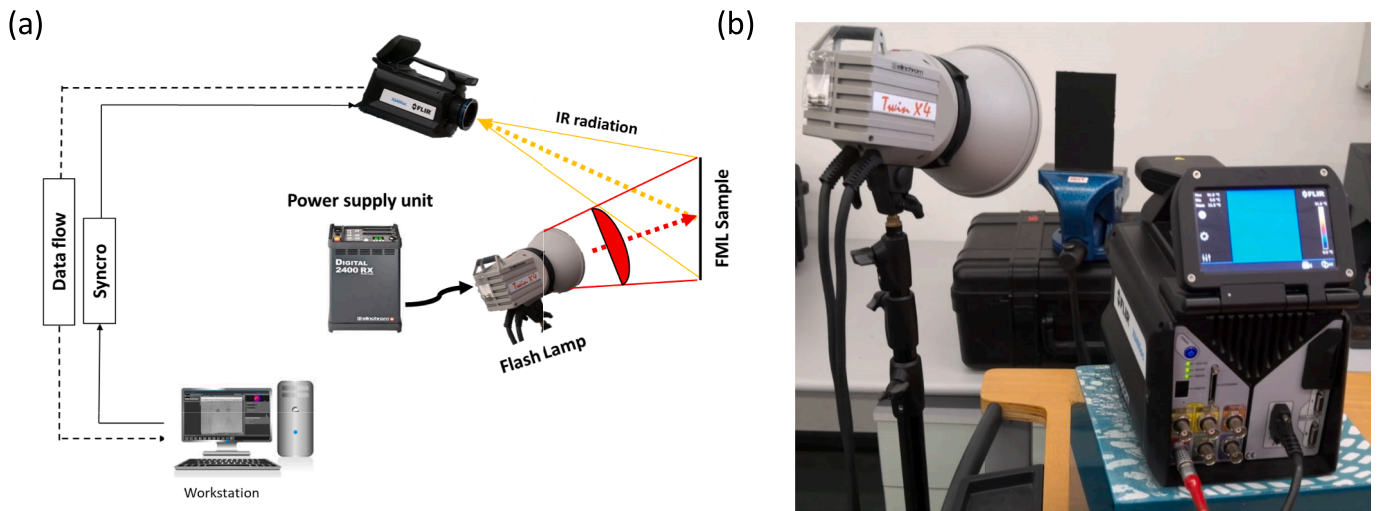
Fig. 5. Schematic representation of the experimental IRT setup (a); picture of the setup taken from the laboratory (b).

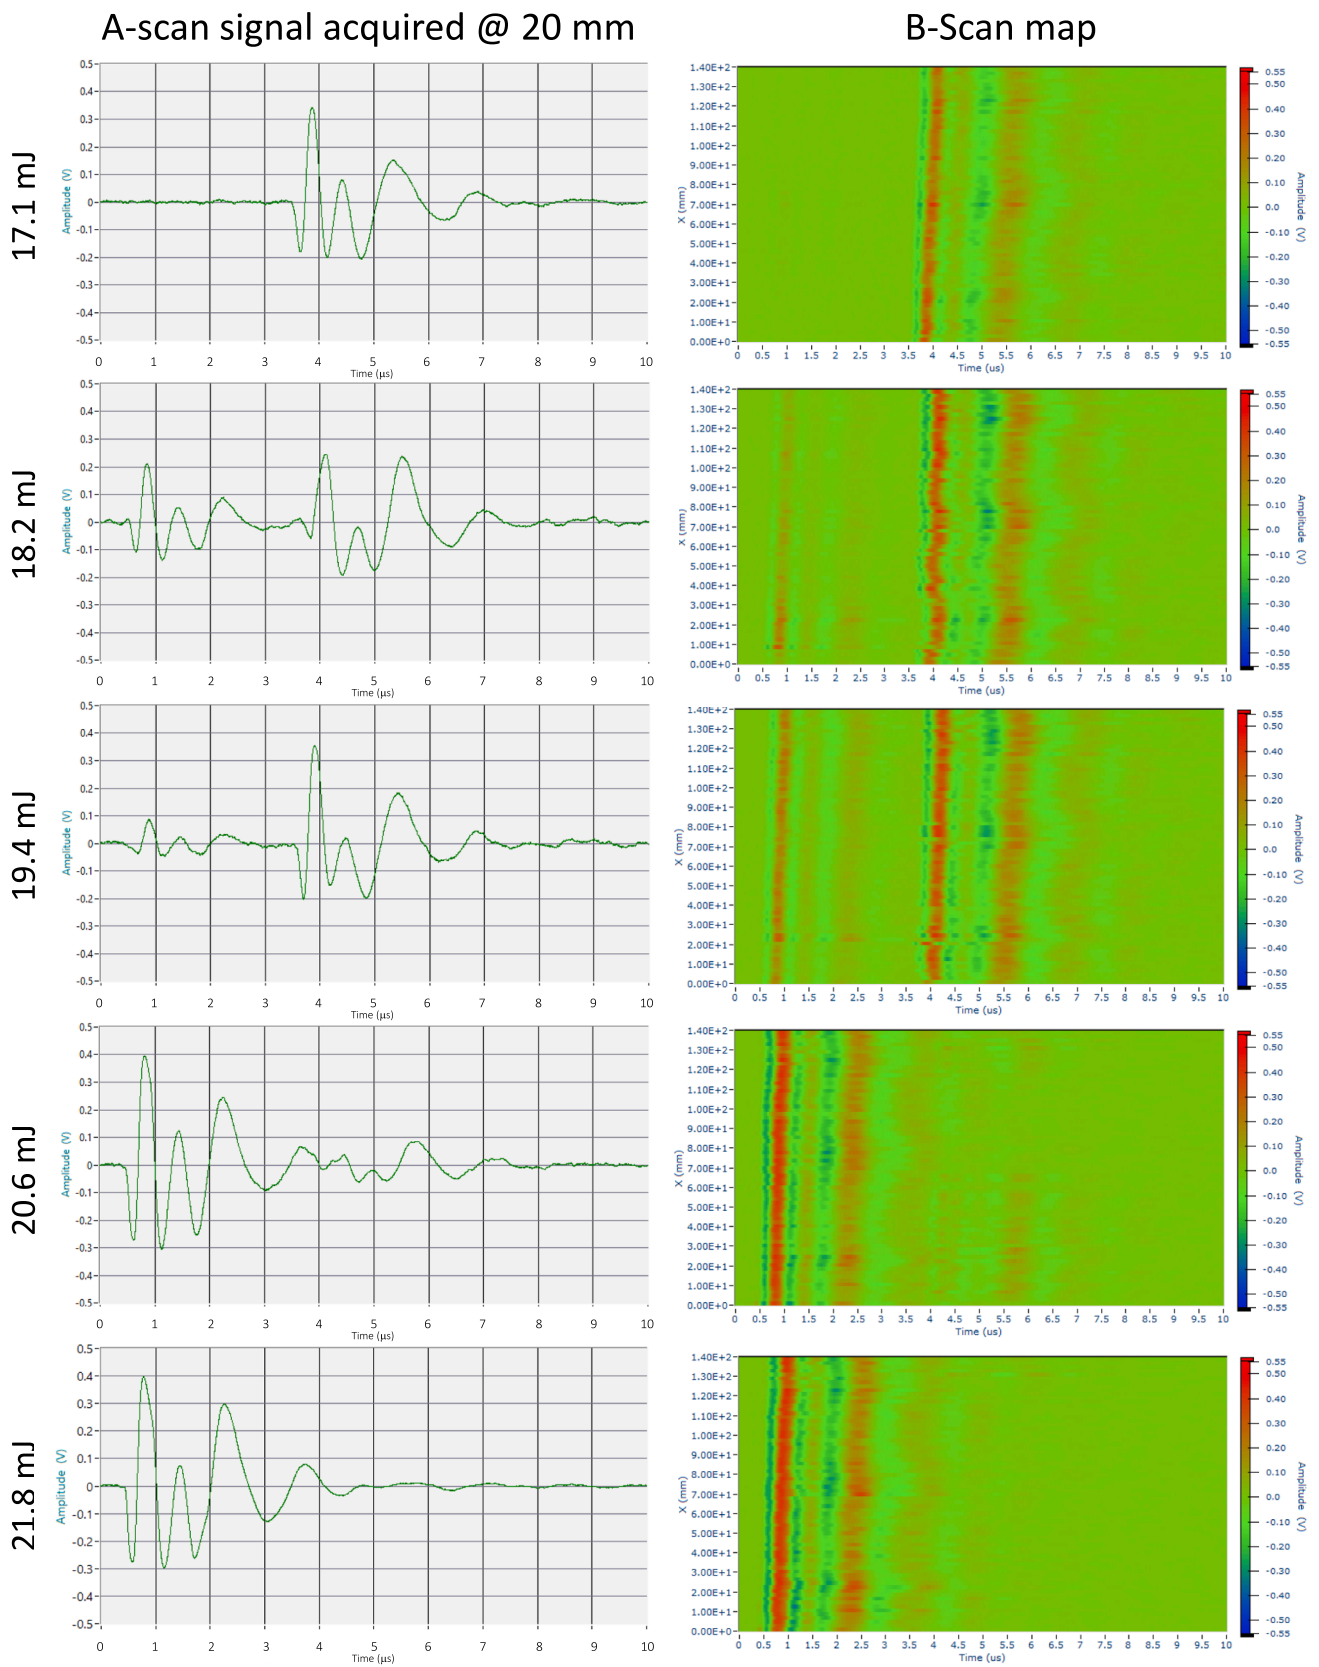
Fig. 6. A-scan signals (on the left) acquired at 20 mm distance from the scanline start and B-scan maps (on the right) for laser power levels ranging between 17.1 mJ and 21.8 mJ at fixed S-R distance on a sound zone.

From the maps a peculiar trend in the energy distribution between the two wave packets is observed. Two distinct wave packets can be identified by observing the signals generated in the intermediate power range between 18.2 mJ and 19.4 mJ. The first one (the quickest) can be identified between 0.5 μs and 3 μs, while the second, resembling a slightly stretched echo of the first, is found between 3 μs and 8 μs. The amplitude of the first wave packet strongly attenuates for lower injected

power (< 18.2 mJ), as can be seen in the first row of Fig. 6. At higher laser power, above 19.4 mJ, a similar attenuation is observed in the second wave packet (the echo), with an increased intensity of the first wave packet, on the contrary. It's worth noting that the first wave-packet shape remains the same regardless of the injected power, confirming that the UT generation regime does not change. In order to preserve the information contained in the UT wave, intermediate power levels (between 18 mJ and 20 mJ) have been adopted in all the acquisitions.

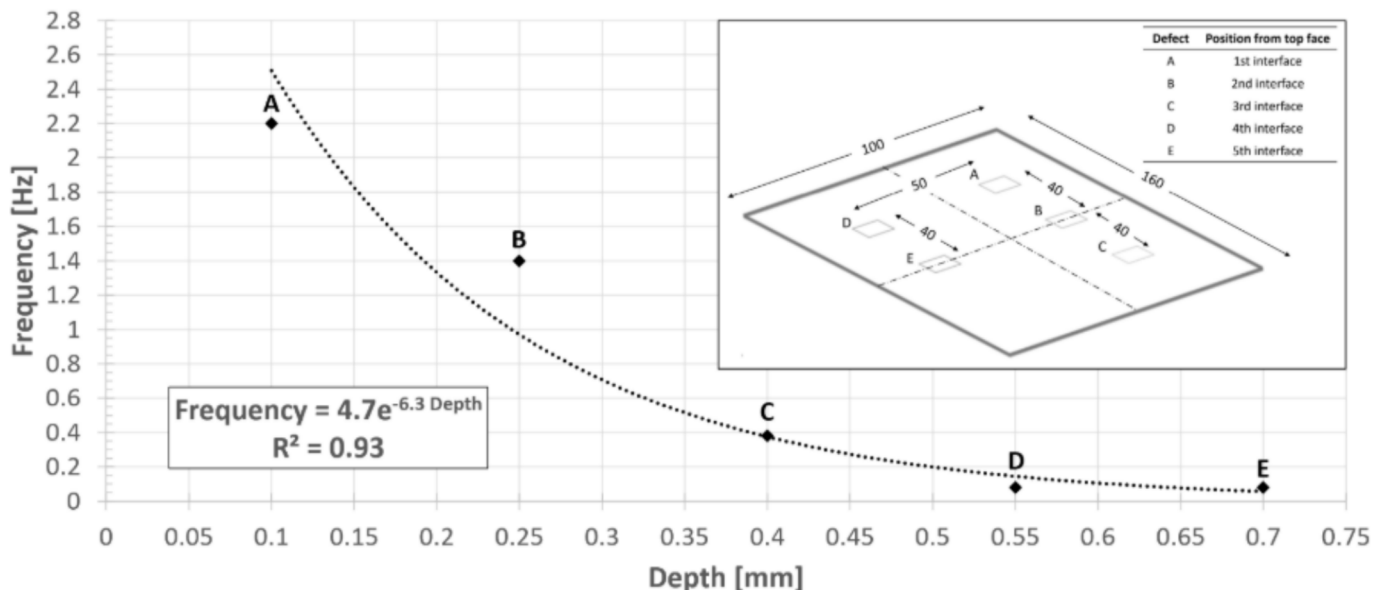
Fig. 10. Correlation between defect depth and the frequency-domain phasegrams.

The observed correlation is well described by an exponential law, yielding a coefficient of determination (R^2) equal to 0.93.
