XIV Forum Internazionale di Studi

WORLD HERITAGE and DEGRADATION
Smart Design, Planning and Technologies

Wooden churches in Lithuania Analysis of failures and degradations, guidelines for restoration

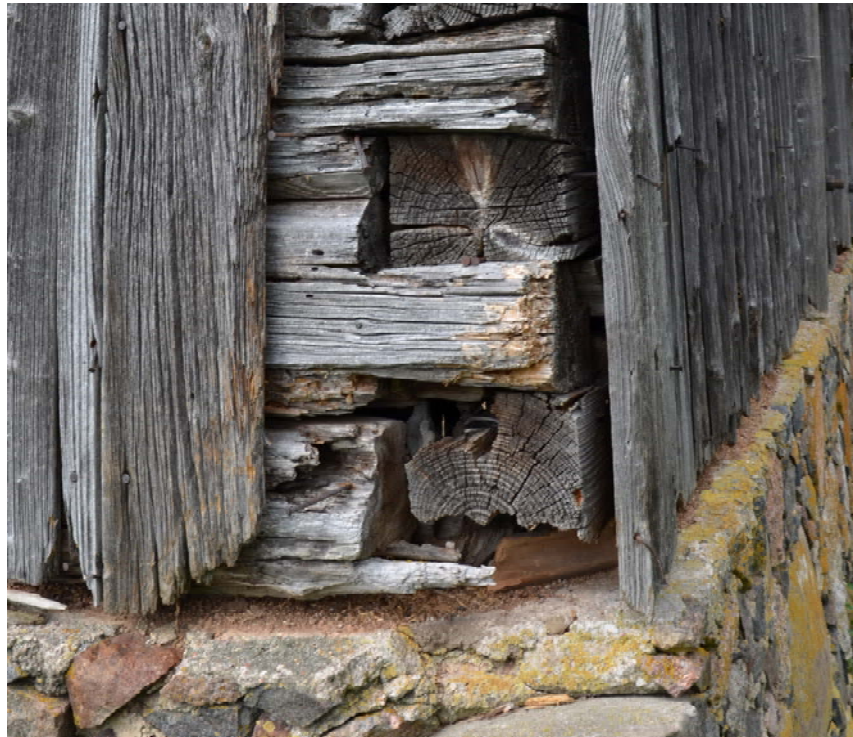
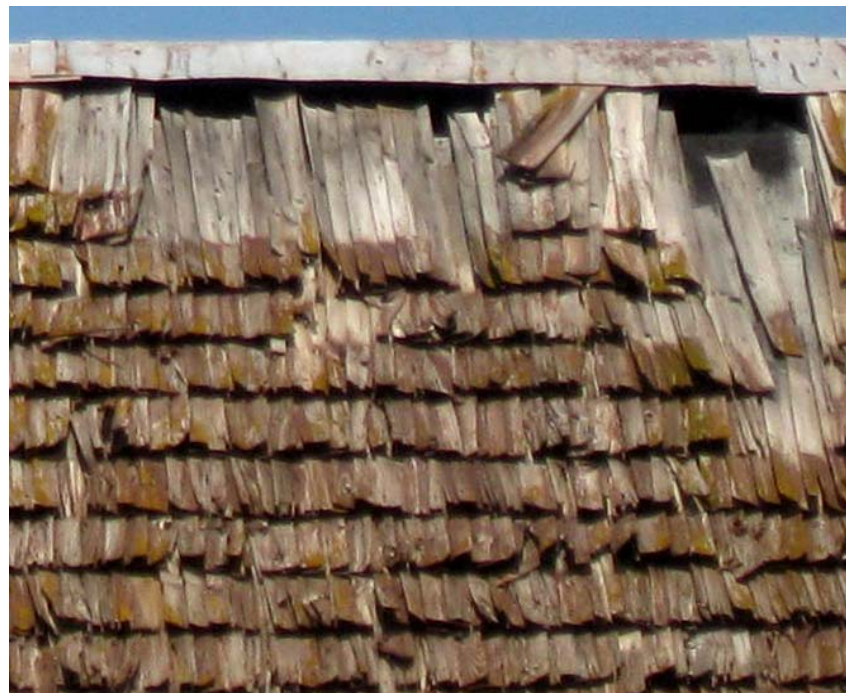
Figg.2,3: On the left: the walls cladding of the wooden boards is one of the most frequently replaced elements. Lack of maintenance of the external cladding can lead to irreversible degradations. On the right: damage to the outer covering of the roof accumulates water into the attic area, increasing the moisture level (over 20%). This disruption can cause fungal attacks to the roof structures.

The part of the building facing the South is always the most vulnerable; the effects of temperature changes can also bring a damage not only to the wooden elements of the building but also to the stone structures, such as foundations, which also suffer from contact with the water resulting from melting snow or from intense summer rains. This kind of water exposure can also affect the stability of the ground on which the stone structures are located [3]. (Figg.2,3).

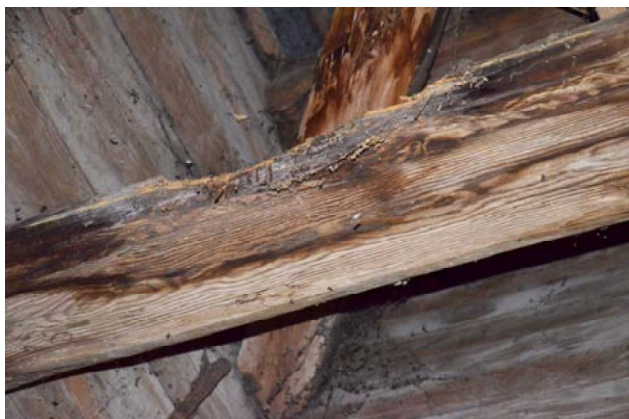
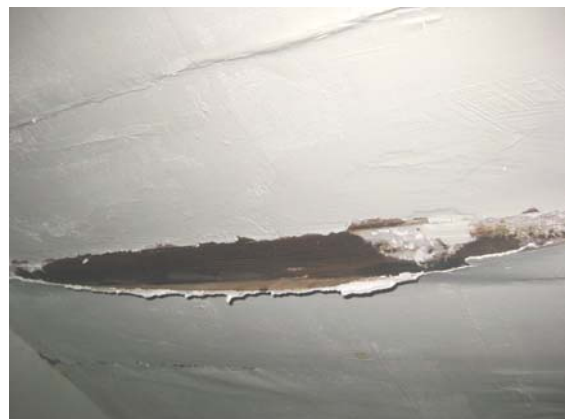
Figg.4,5:On the left: logs in direct contact with the water which penetrates the old coating of the cover. In this image it's possible to see not only the discoloration, but also reduction of the volume.

On the right: the first consequence of fungi attack, with the alteration of the natural color of the material. In this example, the plaster and paint are detached from wooden elements because of fungi emergency.

The areas of the building where it's more difficult to detect a fungi attack are those that lie under the paint coating: the damage appears only when the fungi are already well developed, and the paint tends to peel off. Usually, under the paint coat, the white rot develops; in this case, it's necessary to remove all the paint layers, to protect the wood from fungal attack and to ventilate.(Fig.5)

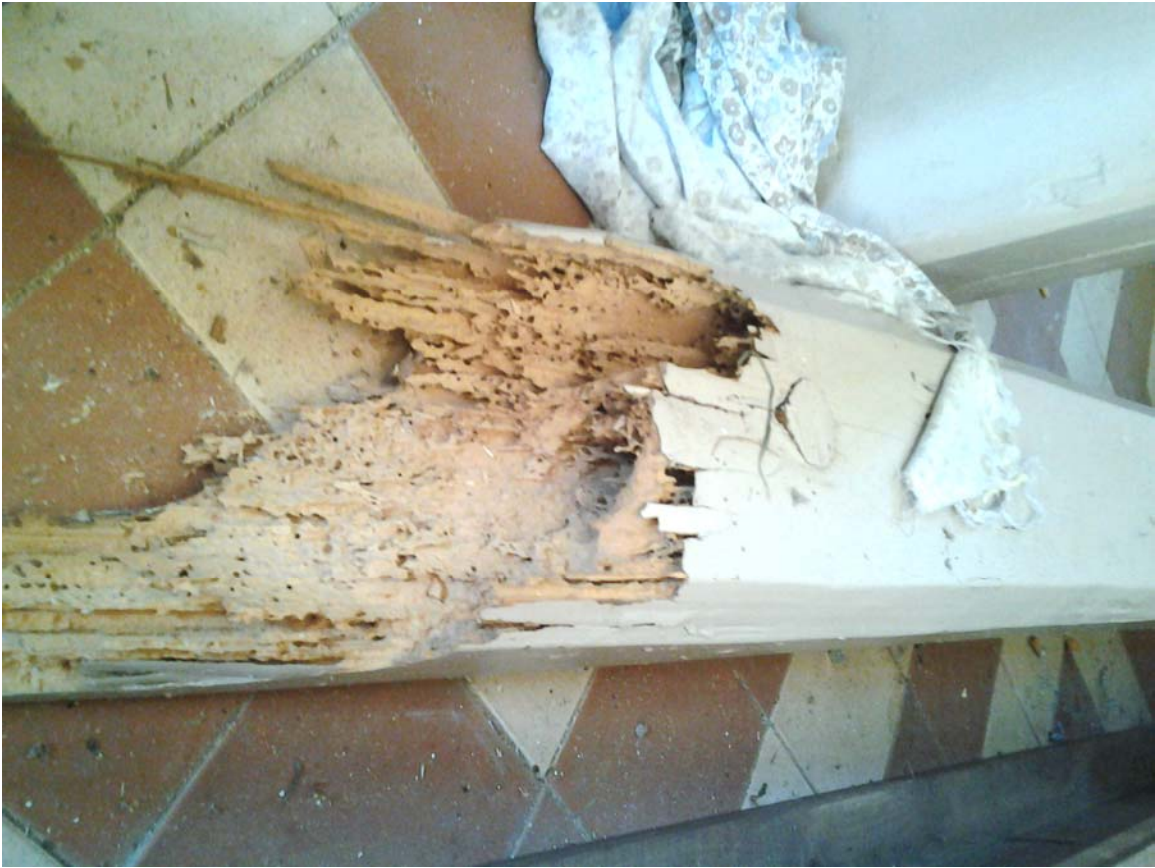
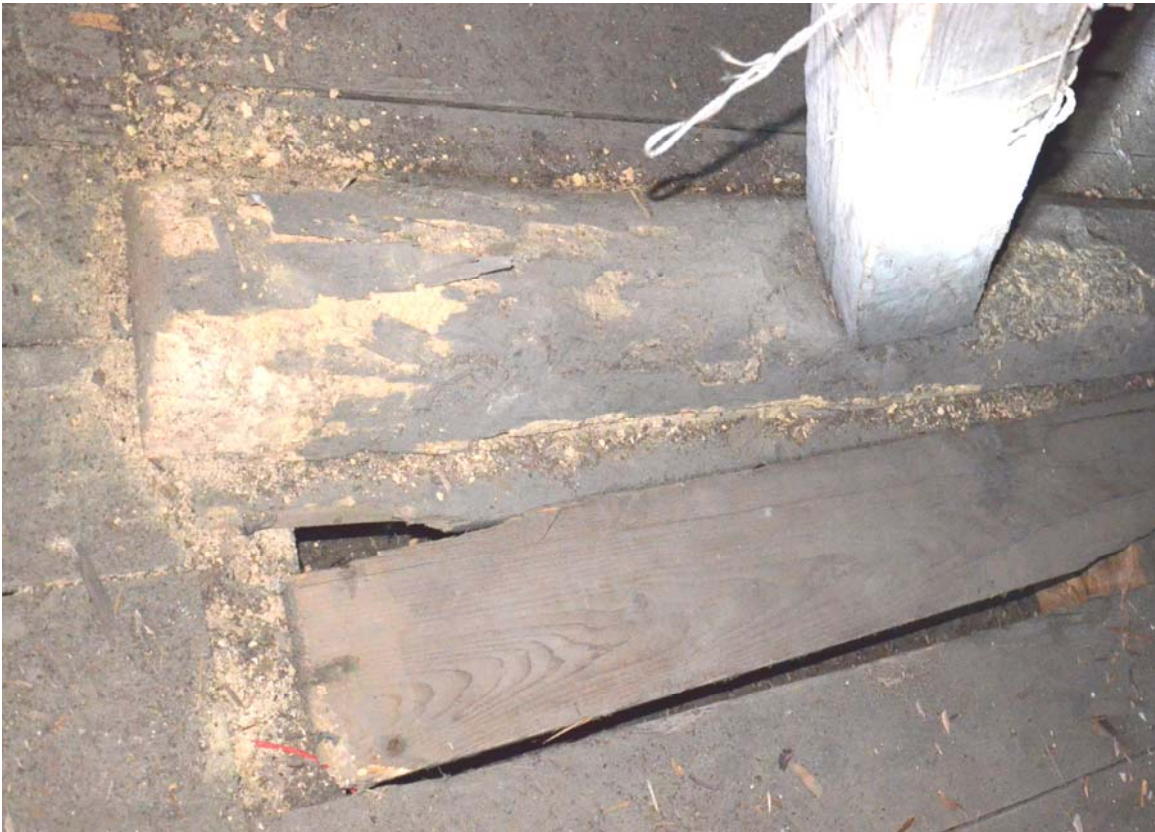
Fig.6,7: Example of wooden beams irreparably damaged; even a small number of holes can hide a very serious state of deterioration.

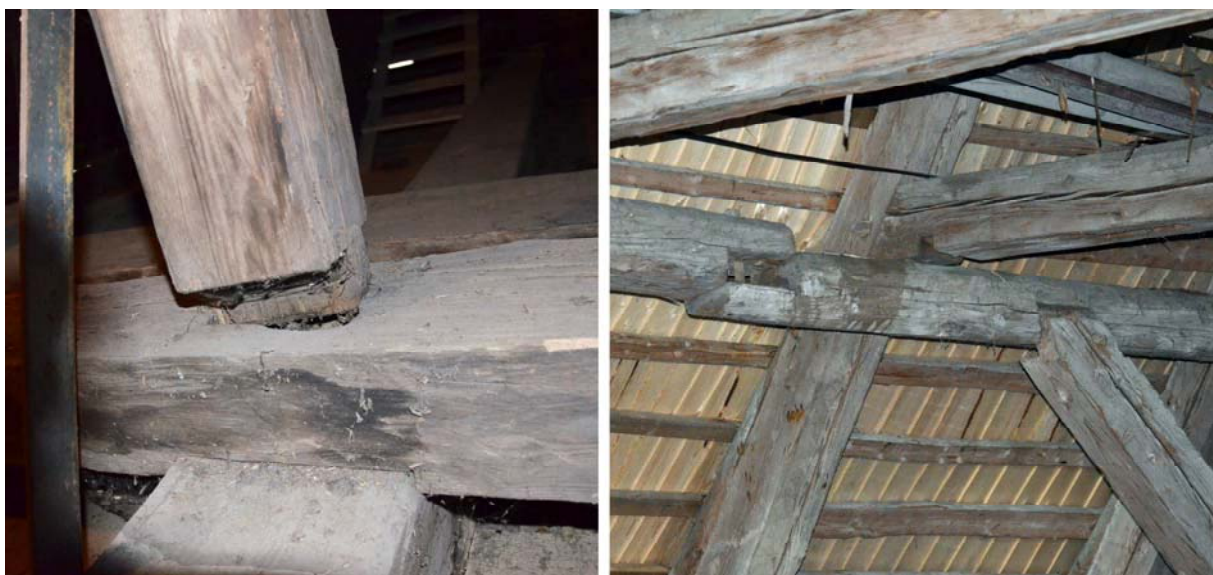
Figg. 8,9: On the left: a disconnection between the king-post and the tie beam. On the right: all nodes of the roof structure are disconnected, due to the shrinkage cracks.

All nodes require a visual analysis, as in case of disruption the structure can tend to get out of wooden nails and pins, that must be reinserted in their housing with the hammer [9]. (Figg.8,9).

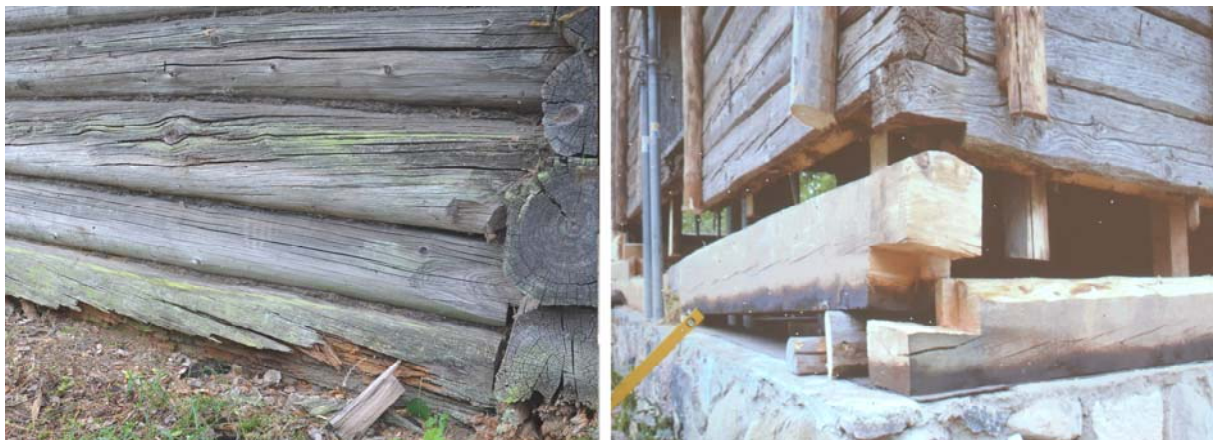
Fig. 10,11: On the left: the lower wooden wall trunk is in a direct contact to the ground, deteriorating by soil moisture. On the right: in case of total damaged logs, trunks can be replaced raising the wall structure and removing the damaged parts.

The lower logs of the wall are usually damaged at the outside part, while the interior part remains healthy (Fig.10). In such case, it is preferable to operate the partial replacement of the deteriorated trunk by cleaning the surface, removing the decayed parts and disinfect the remaining residue of the trunk with antiseptic products and insecticides.

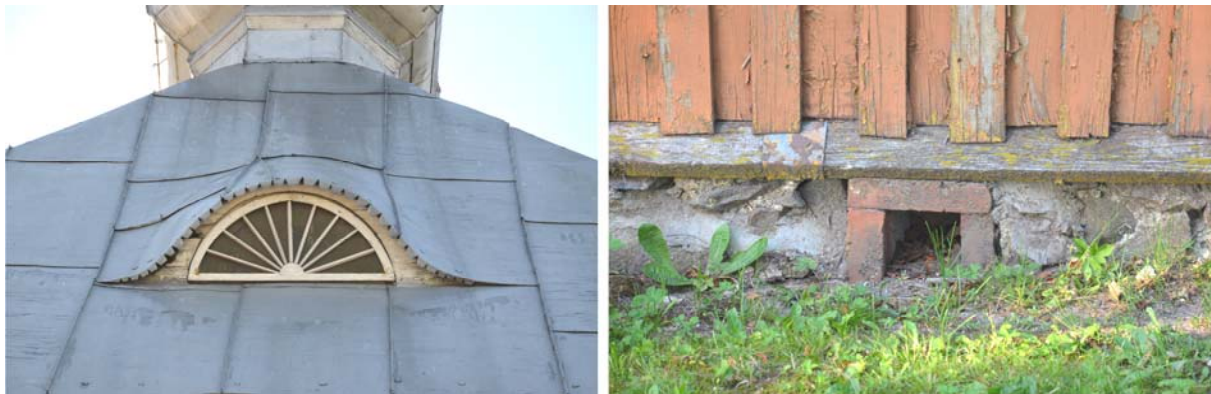
Figg. 12,13: On the left: in the attic area the local workers during the construction work preferred to install windows that guaranteed a good ventilation of the roof structures, during the year; on the right: in the past, it was preferred to open holes directly in the foundations, to ensure a good ventilation of all foundation zone.

The local workers preferred to built windows in the attic area, which, if necessary, should be left open. In attics and foundations of the recently built churches there are always open holes to ensure a good ventilation of such parts of the building (Figg.12,13).
