AIAS 2017 International Conference on Stress Analysis, AIAS 2017, 6-9 September 2017, Pisa, Italy

Defect Detection in Additively Manufactured Components: Laser Ultrasound and Laser Thermography Comparison

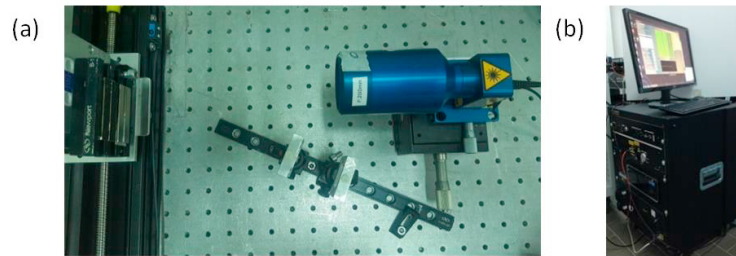
Fig. 2. Set-up for the laser ultrasound experiments (a) and the laser controller station (b).

The ultrasonic inspection system consists of an infrared Nd:YAG pulsed laser, used as source of acoustic waves, and a laser receiver, which combines a continuous-wave (CW) laser and an interferometric unit, to acquire the surface displacement. Wideband ultrasonic waves are generated with nanosecond laser pulses. The laser receiver produces a time-varying analog signal that is proportional to the instantaneous surface displacement. The output signals from the laser receiver are digitized by an analog-to-digital board converter, triggered by the pulsed laser, and transferred to a PC for further signal processing. Fig. 2(a) shows the experimental set-up and Table 2 the specifications of the system.

The two laser beams are directed to the sample surface by means of mirrors (for the laser transmitter) and the optical head (for the laser receiver). The two lasers are connected to the controller station (see Fig. 2(b)) with optical fibers and cables. The laser beam source is focused by two cylindrical lenses, with perpendicular axes, into a 0.1 mm x 0.3 mm line. Source-to-receiver distance is 1 mm.

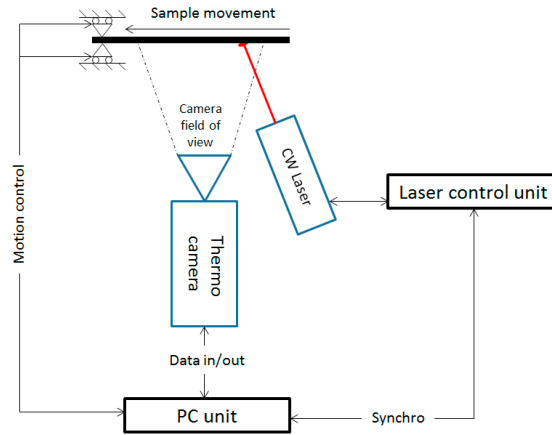
Fig. 4. Set-up for the laser thermography experiments.

Figure 4 shows the set-up used for the laser thermography experiments; Table 3 indicates the parameters of the set-up. The sample is mounted on a motorized linear micro-slide controlled by PC. The CW laser beam (see specifications in Table 2) is focused into a 0.75 mm spot on faces A and B of sample 1 and into a 14 mm x 0.5 mm line on face C of sample 2. The IR camera (see specifications in Table 3) is placed perpendicularly to the sample in order to reduce geometric distortions.

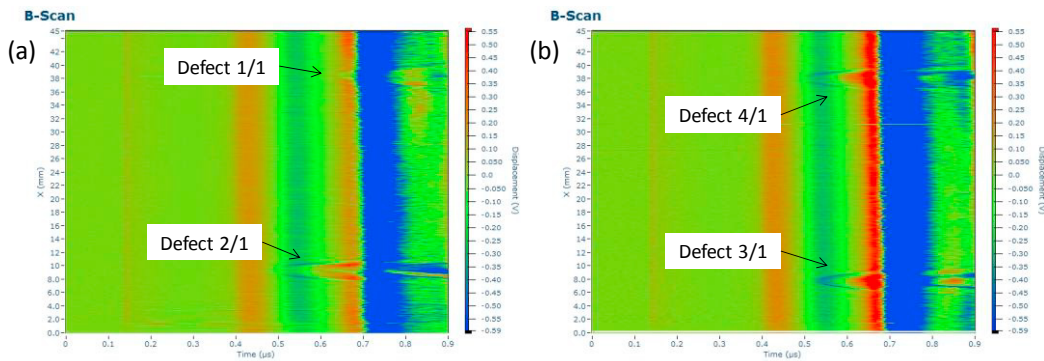
Fig. 6. B-scan images of sample 1 on face A indicating defects 1 ($\phi=470 \mu\text{m}$, $d=1.3 \text{ mm}$) and 2 ($\phi=420 \mu\text{m}$, $d=0.6 \text{ mm}$) (a), on face B indicating defects 3 ($\phi=640 \mu\text{m}$, $d=0.88 \text{ mm}$) and 4 ($\phi=640 \mu\text{m}$, $d=0.9 \text{ mm}$) (b).

B-scan images of sample 1 are shown in Fig. 6. The ultrasonic waves at ~ 0.14 μs and at ~ 0.4 μs are the direct longitudinal wave (L) and the surface wave (S), respectively. The inner discontinuities cause reflection of the longitudinal wave propagating in the bulk. The effect is seen in the B-scan images of sample 1 on face A (Fig. 6(a)) indicating defects 1 and 2, and on face B (Fig. 6(b)) indicating defects 3 and 4.

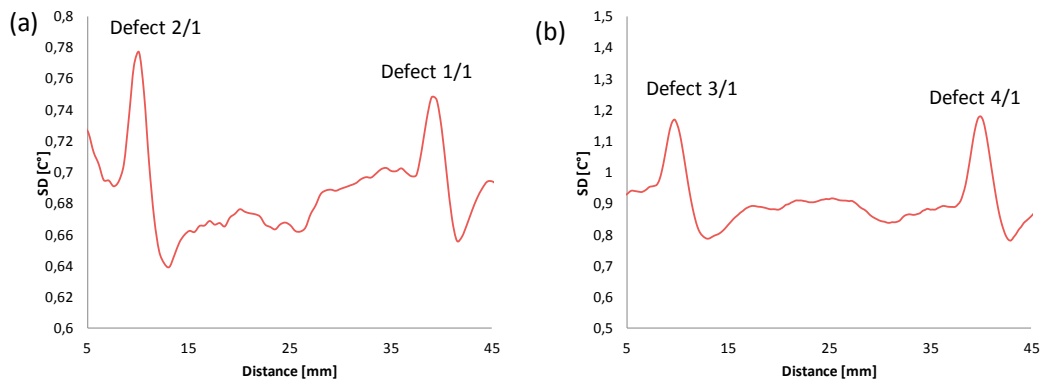
Fig. 8. Plots of SD values computed over the ROI versus the ROI position along face A (a) and face B (b) on sample 1.

Fig. 7 shows the typical defect signature obtained with the laser thermography, occurring when the laser flies over a defected zone. As discussed by Montinaro et al. (2017) in previous works, the detection mechanism in the flying laser inner probe technique (FLIPT) is based on the perturbation of the heat conduction perpendicularly to the scan direction. In particular, when the heat source passes over a defected zone the heat propagation is hampered causing on the sample surface a temperature raise, monitored by the IR-Camera in the ROI. After the defected zone end, the temperature decreases until its original trend. Figures 8(a) and 8(b) show the plot of SD values computed over the ROI versus the ROI position along face A and face B, respectively, on sample 1. As shown in Figs. 8, the four defects of sample 1 are correctly identified. In this case, the FLIPT technique is only able to detect the position of the defect but not its extension, that is overestimated, because of the not comparable dimensions of flaw and ROI. Experimental results obtained with laser ultrasound and laser thermography are in good agreement.
