# Visually low-impacting methods for the measurement of parameters related to IAQ risk indicators in exhibition halls

**Abstract.** Microclimate for cultural heritage plays a fundamental role in the degradation process of artefacts exhibited in museums. Generally, the Indoor Air Quality (IAQ) monitoring inside museums is based on conventional measurements of thermo-hygrometry parameters and long-time averaged measurements of atmospheric pollutants' concentration. Unfortunately, all these approaches require electric supply and are usually characterized by a noticeable visual impact on the exhibition space, which clearly negatively affects the visitors' experience. This paper intends to revisit and discuss a methodology (and its test application on field, to estimate the risk of damage of three artefacts displayed in an old museum of Palermo – Italy) perhaps prematurely underestimated that could usefully be re-proposed in particular contexts in which it is necessary to be careful to be as less invasive as possible, as in the case of museums housed in buildings of particular historical-cultural prestige. The discussed approach uses a non-destructive (or minimally invasive, at least)

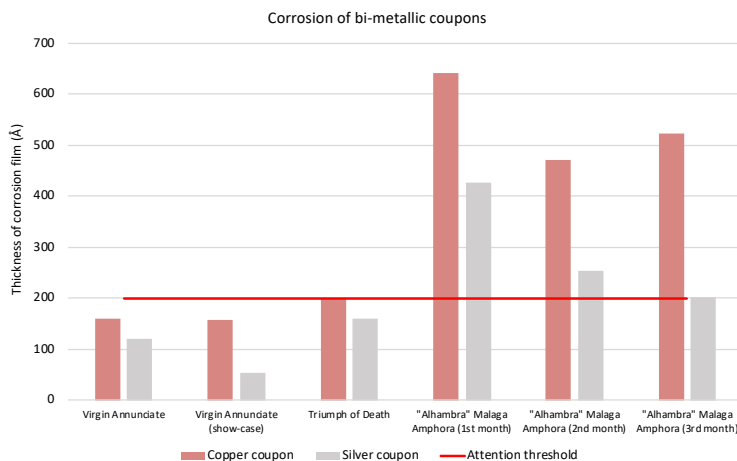
**Fig. 3.** Results of the *Purafil™* bi-metallic reactive coupon application. The continuous horizontal line indicates the overall threshold for which attention is required.

The results related to the bi-metallic coupons (chemical degradation) are reported in short in Figure 3.

As it can be noted from Figure 3, the air quality can be considered acceptable, though not totally satisfactory for the *Virgin Annunciate* and the *Triumph of Death*; it is also evident the effect of the *Virgin Annunciate* protective case, particularly on the silver coupon as showed by the lower obtained values compared to those of the coupons placed outside the protective case. The microclimate surrounding the “*Alhambra*” *Malaga Amphora* is, instead, such that the thickness of corrosion is constantly over the danger threshold. This result may be justified by the fact that it is positioned in a room of the building that is significantly exposed to external environmental conditions.
