Article

The CRATI Project: New Insights on the Consolidation of Salt Weathered Stone and the Case Study of San Domenico Church in Cosenza (South Calabria, Italy)

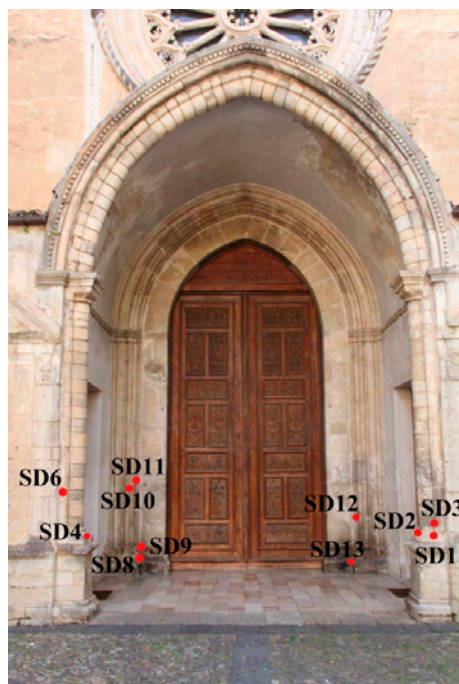
Figure 2. Portal of San Domenico Church (Cosenza, Italy) and details of the sampled areas.

Specifically, the prothyrum and the main portal, both attributable to the original building of the Dominican complex, were selected as cases study. Before sampling, a preliminary survey aimed to verify the state of preservation of the portal was carried out. In particular, the main detected forms of degradation are characterised by surface deposits (accumulation of dust, soil, etc. due to outdoor exposure), black crusts, erosion (mainly diffused in the lower part of the portal and in the areas concerned with black crusts' presence), chromatic alteration (distributed over large areas), loss of material (mainly diffused in the lower part of the portal) and biological patinas.

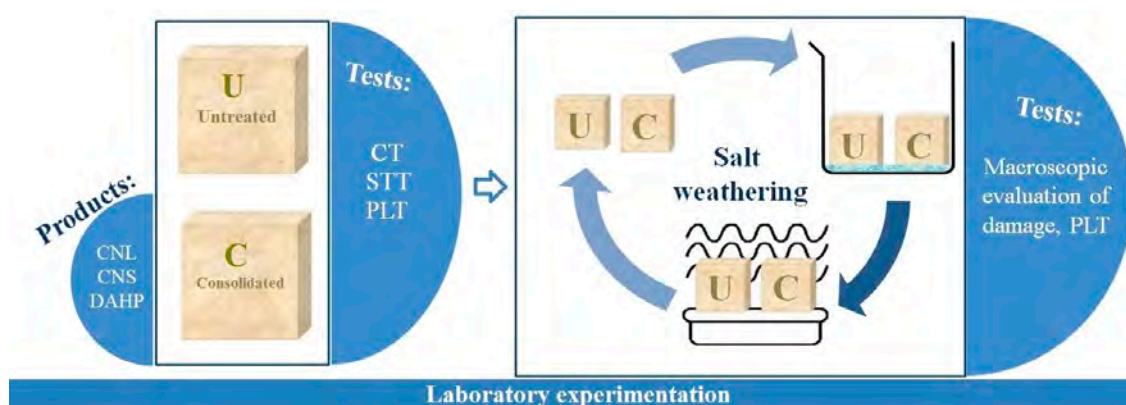
Figure 3. Scheme illustrating the experimentation workflow.

The workflow of the whole laboratory experimentation reporting the specimens list along with details on formulations and used methods is summarized in Table 2 and Figure 3. The experimentation consists of several phases: (a) specimen consolidation, (b) characterization of the formulations after application on the specimens, (c) salt weathering test on untreated and treated specimens to evaluate resistance to salt crystallization.

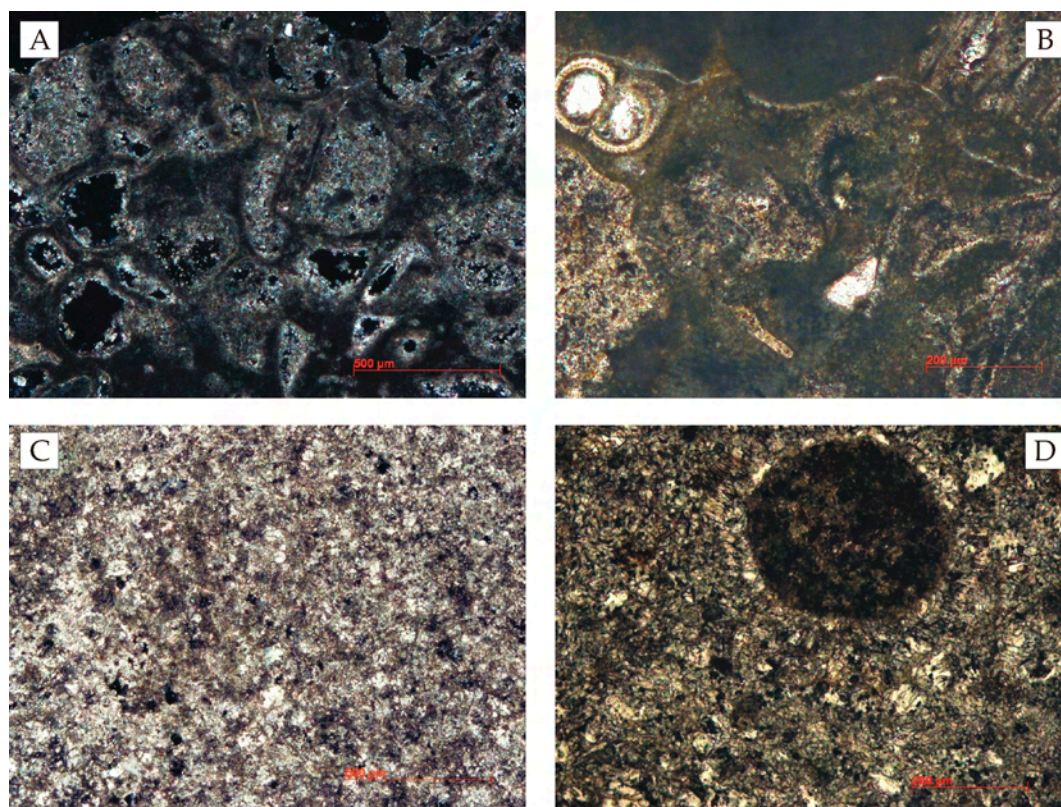
Figure 4. Representative photomicrographs by POM showing some textural features of biomicrites samples (A,B) and biosparites (C,D).

Petrographic observations of the thin sections under optical microscope reveal that samples show similar compositional features. Specifically, they can be classified as biomicrites or packstone/grainstone (Figure 4A,B) [26,27] with the exception of the samples SD11 and SD12 which are biosparites (Figure 4C,D) and SD1 showing biosparitic/micritic properties. The framework components are bioclasts dominated by fragments of molluscan shells, bryozoans, foraminifera and echinoderms 1–2 mm in size. The most abundant accessory clasts are mainly siliciclastic and they are monocrystalline quartz, biotite, muscovite, K-feldspars, plagioclase and chlorite with grains ranging from 0.1 to 0.2 mm in size. Rarely, plutonic and metamorphic rock fragments occur, and the micritic matrix is not well represented within these samples. Cementations of these rocks include, on the basis of crystal morphology, small prismatic calcite cement and locally developed meniscus cement at grain contacts. Grain size distribution is quite heterogeneous, and it is composed of at least by two secondary modes and one principal mode that fall into the coarse-grained sand (microfossils). All samples show predominantly intergranular macroporosity with cavities demonstrating a variable and irregular shape, ranged in size from 0.2 to 5 mm.

A brownish and superficial layer up to 800 µm thick is often present on the substrate. The level is related to the alteration forms macroscopically observed, with variable colours, morphologies and thicknesses. Superficial layers appear, many irregularly shaped, constituted by microcrystalline gypsum with sporadic grains of calcite (from the substrate) and carbonaceous particles.

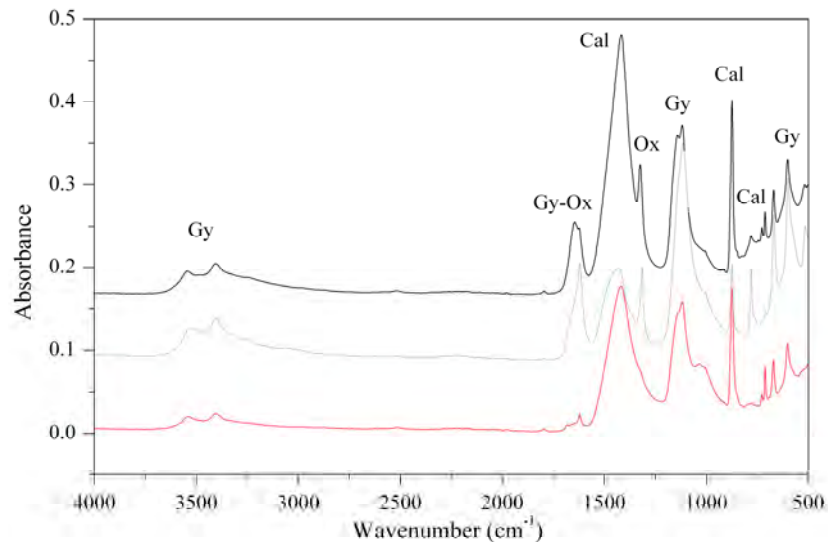
Figure 5. Representative FTIR spectra of some samples showing superficial alteration forms.

Spectra from the samples SD4, SD9, SD10 and SD12 revealed a variable amount of gypsum ($\text{CaSO}_4 \cdot 2\text{H}_2\text{O}$), showing the typical vibrational bands centred at 1109, 669, and 596 cm^{-1} as well as the

stretching vibrations of calcite (CaCO_3), peaked at 1409, 875, and 711 cm^{-1} [28] and quartz peaked at 1094 and 457 cm^{-1} .

Calcite and quartz occur due to substrate, while the presence of gypsum can represent a degradation product. In fact, if calcium carbonate is attacked by sulphuric acid generated by the sulphur compounds in the polluted atmosphere, it is transformed into gypsum [29–34]. Spectra of the samples SD8, SD11 and SD13 exhibit all the previous bands; and in addition, those related to the presence of the characteristic bands of weddellite (calcium oxalate) peaked at around 1643, 1330 and 783 cm^{-1} . The presence of this mineral is indicative of an alteration product [30,31,35,36]. Representative IR spectra are shown in Figure 5.

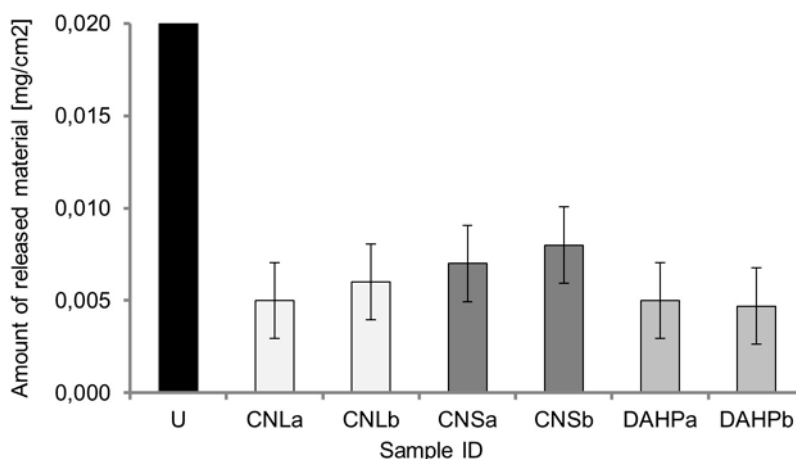
Figure 7. Scotch tape test on untreated and treated specimens.

The Scotch tape test (SST) was performed to provide information on the superficial cohesion of stone in order to investigate better the mechanical features of treated samples and to correlate them with those untreated. The results are reported in Figure 7. Treated specimens show a decrease in released material compared to untreated specimens, achieving an improvement in their superficial cohesion. Also, specimens treated with greater quantities of product give a better result. In more detail, a greater efficacy in terms of increased cohesion properties was observed in the samples treated with a mixture of nano calcium-hydroxide and diammonium hydrogen phosphate.

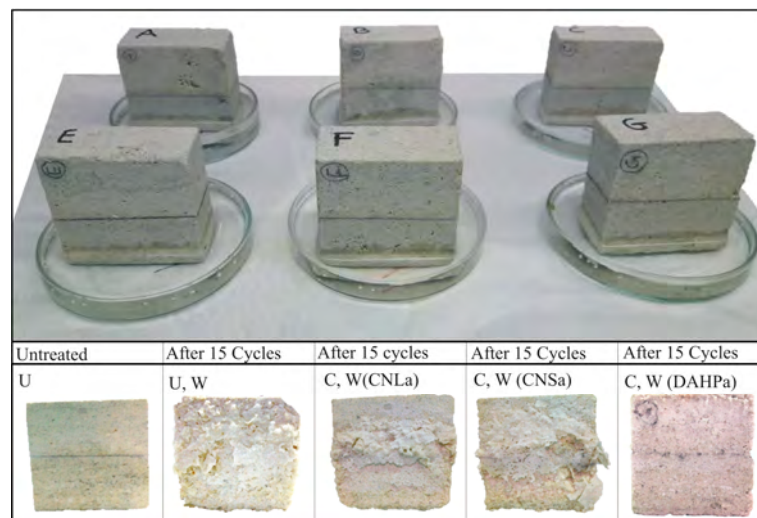
Figure 8. Salt weathering of some representative “San Lucido” stone specimens. Note: U, untreated; C, consolidated; W, weathered; CNL, CaLoSiL®; CNS, Nano Estel®; DAHP, Mixture of Ca(OH)₂ and diammonium hydrogen phosphate.

At the 15th cycles specimens suffered just rounding and loss of very small fragments, mainly at the edges. None of the samples suffered a break (Figure 8). Based on the results, and in accordance with [5], weight variations could be due to both the development of efflorescence and subefflorescence, and to the loss of material, although minimal, observed along the edges of the samples.

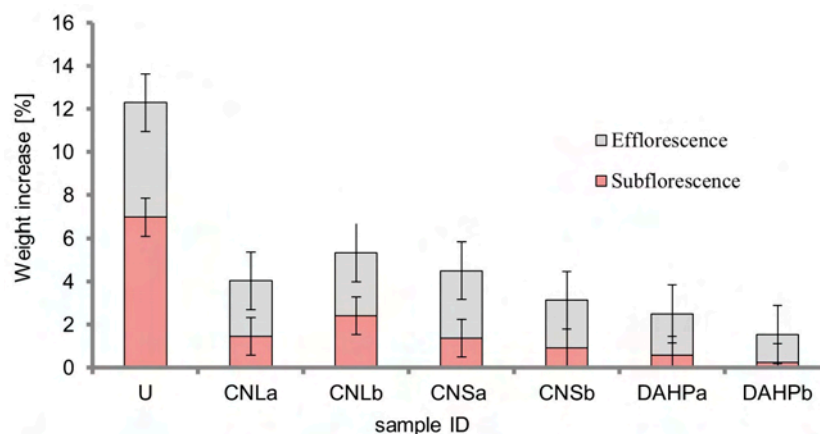
Figure 9. Weight increase (%) after salt crystallization test with evidence of the contribution of efflorescence and subefflorescence.

Considering the weights at each cycle and removing the efflorescence from each sample, the contribution of the subefflorescence was then evaluated. This occurs because, the longer the saline solution remains within the porous media, the worse the damage can be produced [42,43]. Figure 9 shows the increase in weight (%) that the specimens have undergone up to the 15th cycle, emphasizing the contribution made by the efflorescence compared to that made by the sub-efflorescence.

The difference between the consolidated and untreated samples is remarkable, both in terms of weight variations (at the end of the 15th cycle) as well as the growth of efflorescence and sub-efflorescence. These differences suggest that nano calcium-hydroxide mixed with diammonium hydrogen phosphate give a better response against salt crystallization decay process.
