Article

# Experimental Investigation on Innovative Stress Sensors for Existing Masonry Structures Monitoring

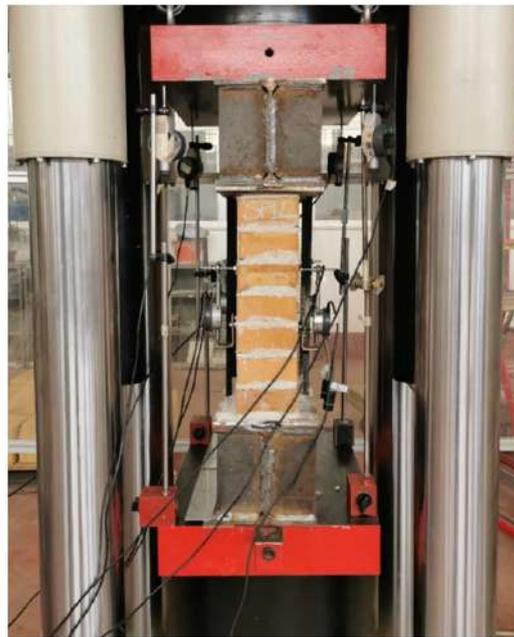
Figure 8. Test setup.

The specimens were tested in compression by using a Zwick–Roell testing machine with capacitance of 4000 kN, Figure 8. Tests were performed in a displacement controlled mode, assuming a rate equal to 0.2 mm/min. Preliminary, two pre-load cycles were carried out ranging between 20 and 100 kN for assessing a suitable contact between the testing machine and the specimen.

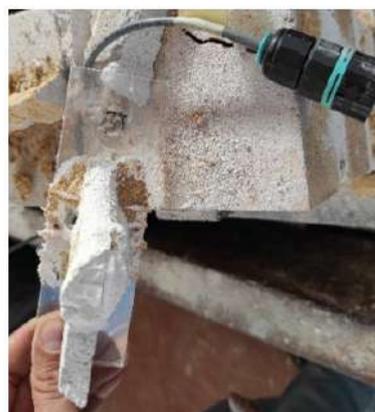
**Figure 17.** Sensor fully embedded after the test.
