## 3D MODELLING OF A HISTORICAL BUILDING USING CLOSE-RANGE PHOTOGRAMMETRY AND REMOTELY PILOTED AIRCRAFT SYSTEM (RPAS)

**KEY WORDS:** RPAS, Close-range Photogrammetry, 3D Modelling, Historical Building

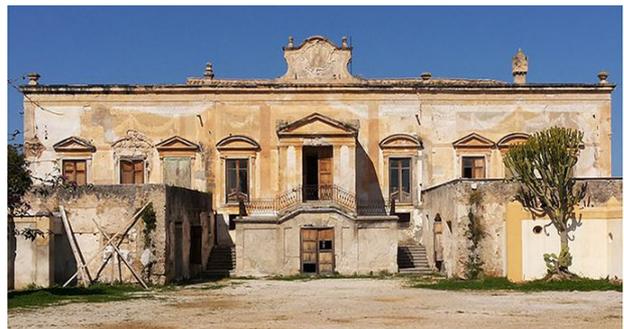
Figure 2. Main façade of *Villa Lampedusa ai Colli*.

The main façade of *Villa Lampedusa ai Colli* was also dominated by a pincers staircase (Figure 2). It was the fulcrum of these villas and often placed in a symmetric position with the main façade. The *Villa Lampedusa* staircase was characterized by two symmetrical flights which connected the ground floor with the "piano nobile".

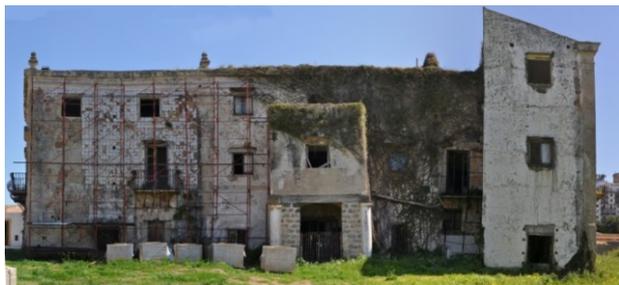
Figure 3. The state of conservation of the north-west façade.

and, above all, of a long period of abandon. At the present time, the Villa is affected by a high level of deterioration, due to infiltrations, cracks in the walls, detachments of plaster, roofs and floors unstable or even collapsed (Figure 3).

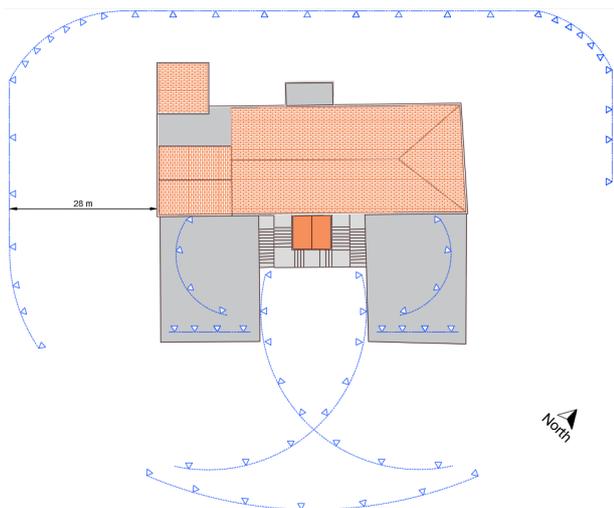
Figure 4. Terrestrial camera network.

The terrestrial images acquisition was planned to obtain complete coverage of the façade and was carried out using a digital camera Nikon D5000, with a 12.3 megapixels CMOS sensor of 23.6 mm x 15.8 mm and a focal lens of 35 mm. Convergent images were acquired from north-east, north-west and south-west sides at a distance of about 28 m to achieve a Ground Sample Distance (GSD) of 5 mm (Figure 4).

The photogrammetric acquisition of the main façade was more problematic because of the presence of two smaller bodies. Seven different images blocks were planned, with convergent and parallel photos of the main façade, from the ground plane and from the bodies' roofs, at variable distances between 5 m and 15 m, with a GSD variable from 2.3 mm to 5.5 mm (Figure 4). Overall 172 terrestrial images were acquired.

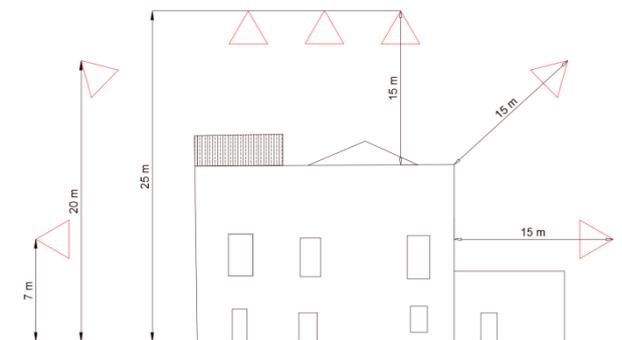
Figure 5. Schema of RPAS acquisition.

In order to acquire a complete documentation of the building three flights, with a GSD variable from 2 mm to 5.5 mm, have executed; the three flights were planned to take images with a nadir view to the roof, an oblique and a parallel view to façades (Figure 5).

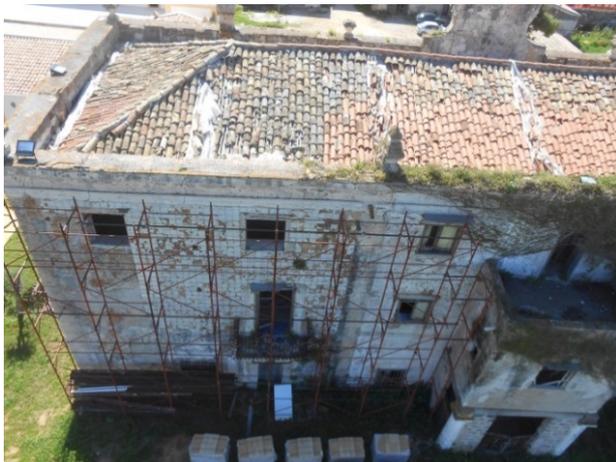
Figure 6. Oblique image from RPAS.

The flight to acquire oblique images was carried out at 20 m altitude from the ground and 15 m of distance from the building. The camera has been set up with a tilt angle of 45° to obtain images of the roof and of part of the façade (Figure 6).

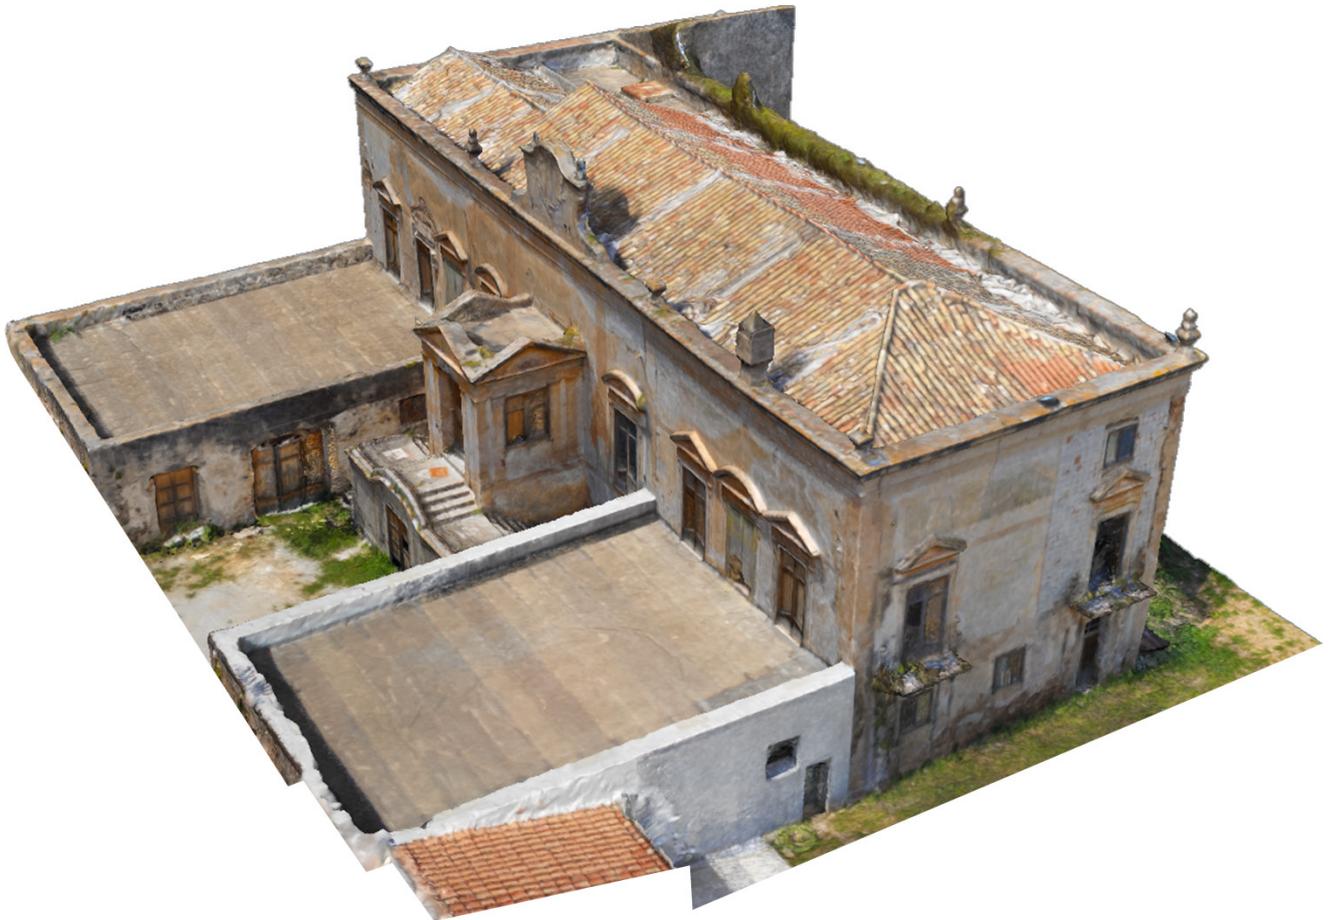
Figure 10. Textured 3D model.

A very defined mesh, in terms of numbers of polygons and geometry, was calculated from the point cloud; about 14 million faces and over 7 million vertices were indeed generated. In

order to increase the quality of the 3D model, a texture from the images of the photogrammetric survey was produced (Figure 10).

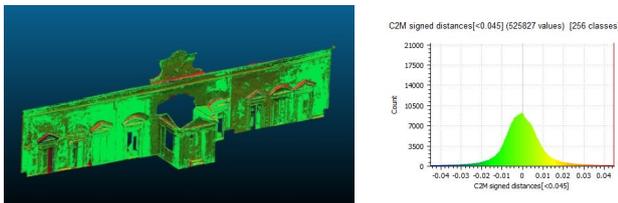
Figure 11. Comparison between the south-east photogrammetric mesh and TLS point cloud.

The photogrammetric meshes and the laser point cloud were compared in CloudCompare using the C2M. This algorithm allows computing Cloud-to-Mesh distance. For each point of the point cloud, the algorithm searches the nearest triangle of the compared mesh and computes the distances (Figures 11-13). As visible in the histogram next to pictures, the distribution of residuals is included between 0 and 4.5 cm for the south-east façade and between 0 and 1.5 cm for the north-east and the south-west façades. Table 14 shows the statistic distances computed in CloudCompare.

Longer distances between the 3D models are focused along the played windows, the adjoining walls and along the TLS unattainable areas (the upper part of cornices and the window brackets). Overall, the results of the comparison show a good accuracy of the photogrammetric approach, with an RMSE below 0.0015 m for the 80% of data.

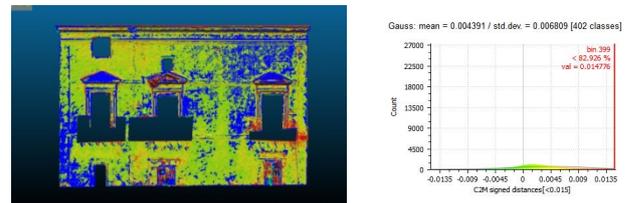
Figure 13. Comparison between the south-west photogrammetric mesh and TLS point cloud.

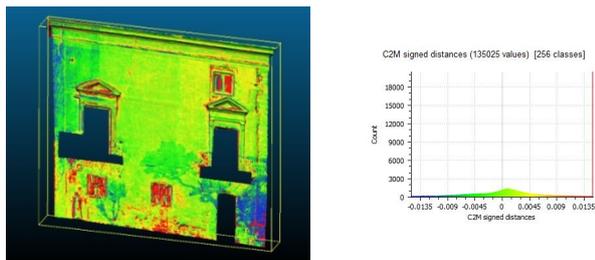
Figure 12. Comparison between the north-east photogrammetric mesh and TLS point cloud.

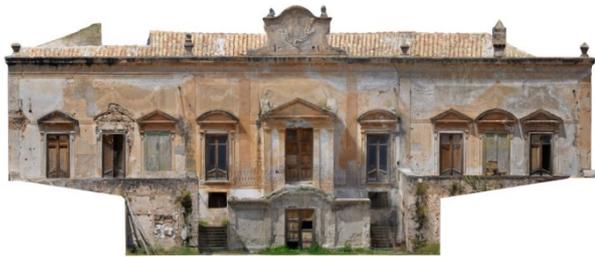
Figure 15. South-east façade ortho-image.

2D data is an essential part of a complete documentation in Cultural Heritage field. Actually, for an architectural analysis and restoration work, as in this case, 2D representations become a resource for other experts, like restorers, which can be involved in such a multidisciplinary project. For this reason, ortho-images for all façades and for the building roof were realized with a resolution of 5 mm (Figures 15-18).

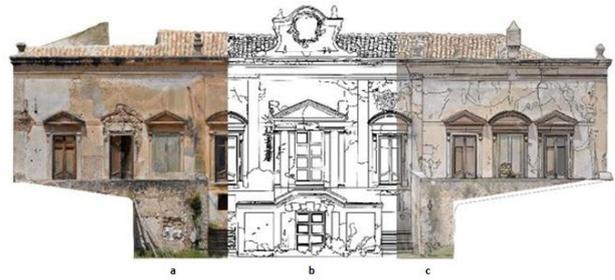
Figure 19. South-east façade: ortho-image and 2D drawing.

In order to document the architectural complex, for a complete and reliable knowledge of the monument and for a future restoration project, ortho-images were employed to get 2D information. Figure 19 shows together the south-east ortho-image and to 2D drawing realized from it.

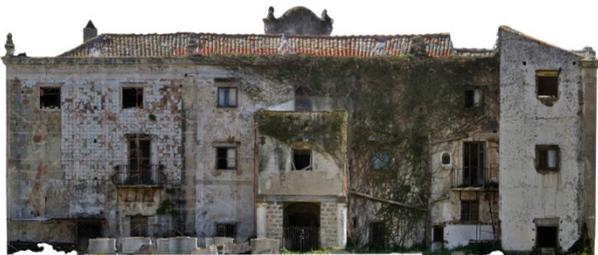
Figure 16. North-west façade ortho-image.

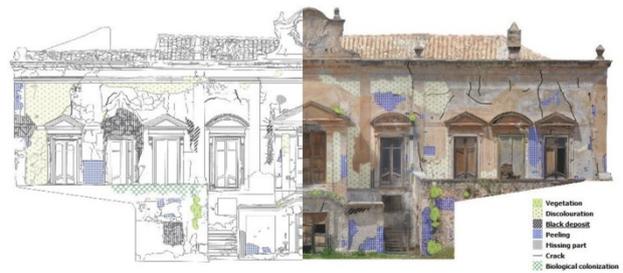
Figure 20. Map of significant damages on the south-east façade.

By means of 2D drawing, a descriptive map of degradation was carried out in order to document the state of conservation of the façades and to highlight to most significant damaged areas. The ortho-image is used to document some of the most significant damaged areas, clearly visible on the 3D reconstructed model too, waiting for future conservation activities. Figure 20 shows the map of significant damages on the south-east ortho-image.

The whole building is in a dreadful state of conservation and it needs urgent consolidation and restoration works. As visible in the last picture, the main façade, as well as the whole building, show extended and extensive cracks, local loss and fragmentation of material, peeling of surface layers, holes, black deposits, biological colonization. Moreover, the risk of floors and slabs collapse is high.

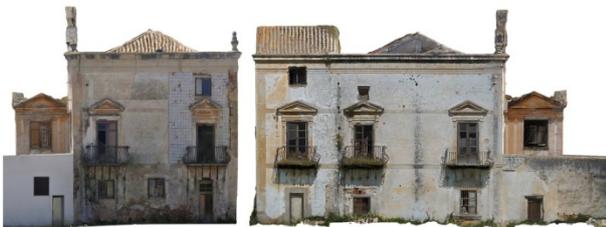
Figure 17. North-east and south-west façades ortho-images.

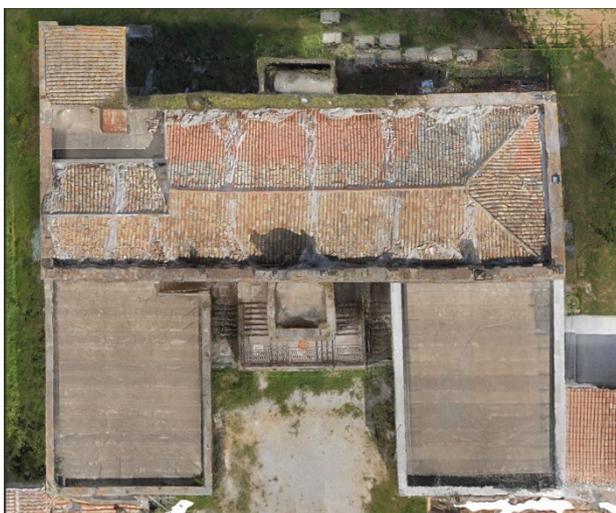
Figure 18. Nadiral ortho-image.
