Forensic Analysis of Fire in a Substation of a Commercial Center

G. Ala, *Senior Member, IEEE*, S. Favuzza, *Senior Member, IEEE*, M. Mitolo, *Fellow, IEEE*
R. Musca, G. Zizzo, *Senior Member, IEEE*

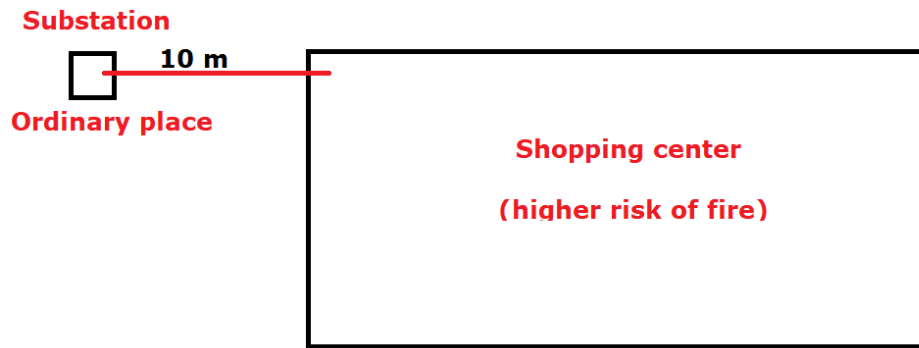
The Minister Decree 27/07/10 is not applicable to the case under examination because the substation is separated by the shopping center's building and is more than 10 m far from it (Fig. 2).

Fig. 2. Position of the substation and of the shopping center.
