Effects of corrosion on a steel bowstring bridge in marine environment: a case-study of assessment and retrofit

Michele Fabio Granata^{1*}

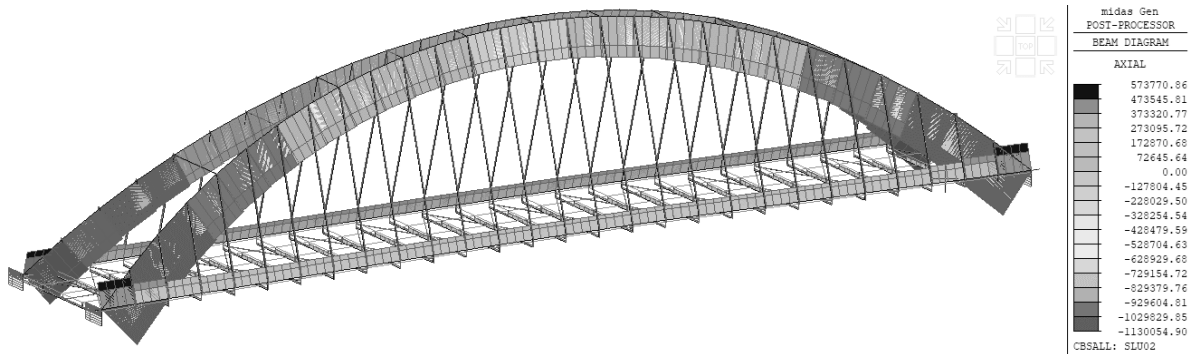
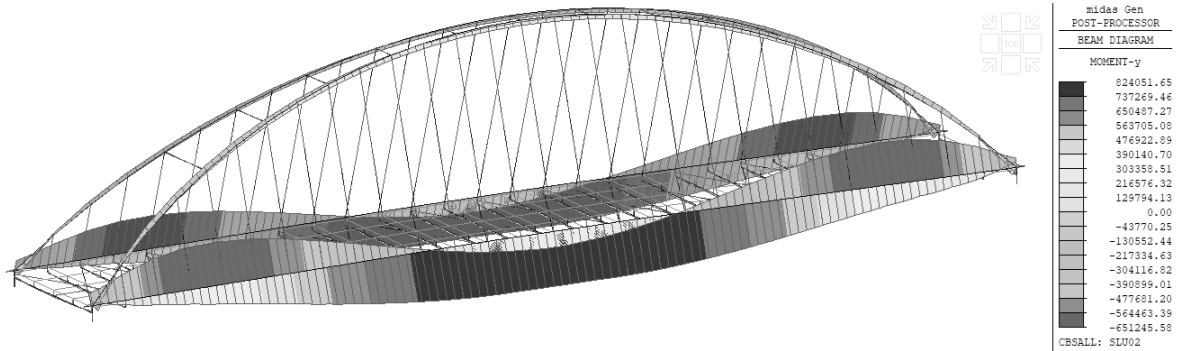
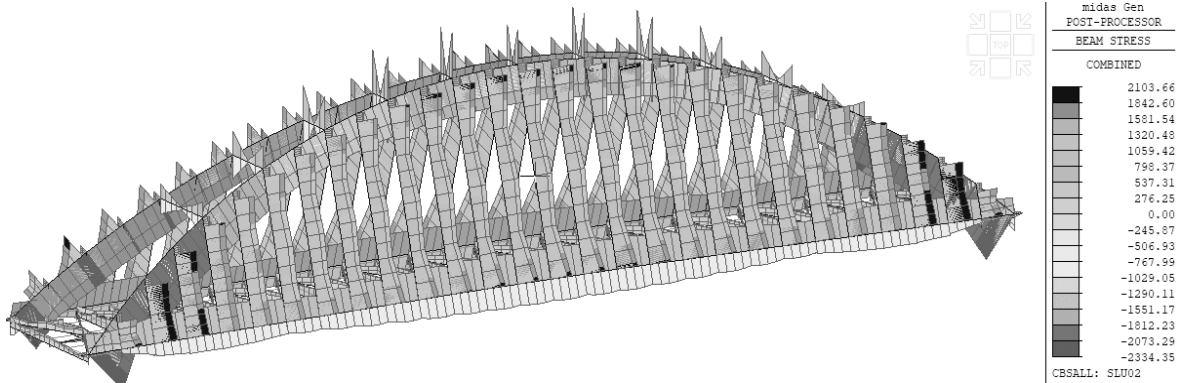
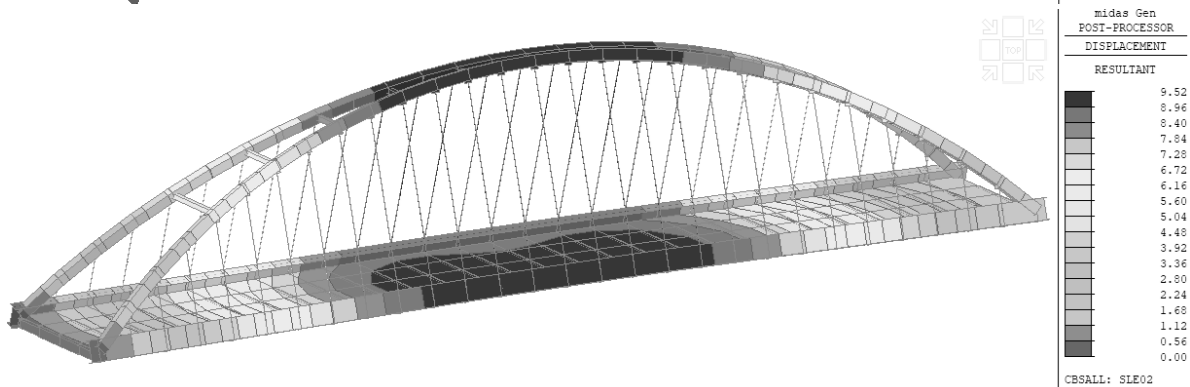
416 *Figure 9. Results of FE analysis of the undamaged bridge for dead loads + moving loads. a) Max-min axial*
 417 *force (kN); b) Max-min bending moments(kNm); c) Max-min stress in steel elements (MPa); d) Max*
 418 *displacements (cm)*
