# **Some experiences about the retrofitting of tower masonry structures**

L. Cavaleri & G. Zingone

*Dipartimento di Ingegneria Strutturale e Geotecnica,  
Università di Palermo, Italy.*

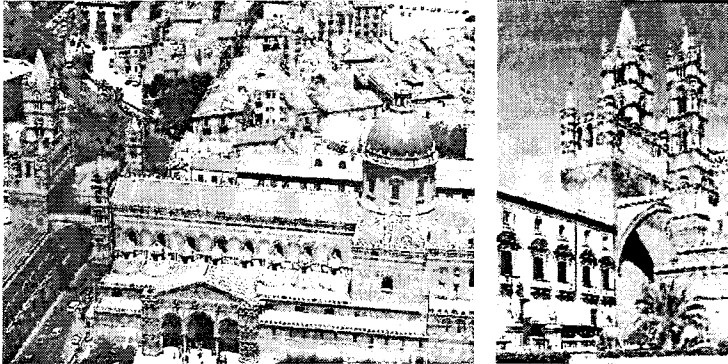
Figure 5: Two views of Palermo cathedral and its bell tower

Probably the first execution of the bell tower (Fig. 5) is dated III century B.C. during the Punic Roman age and it was inserted in the walls of the ancient urban nucleus of Palermo. So initially the tower had a defence function and was constituted by a full volume without any definition of internal spaces. The area, where actually the Cathedral is, was first occupied by a basilica that was destroyed by the Vandals in the IV century A.C.. In the VI century, on the rest of the basilica, a new church was built by the archbishop Vittorio. The new church, entitled to Virgin Mary, was jointed to the actual bell tower by means of one great arch. So in this period the tower had the double function of defence garrison and bell tower and it became a symbol of the religious power on the temporal one.

In 1169 the new church was strongly damaged by the earthquake. The damage of the tower was minimum so only few repair interventions needed. After the earthquake, in 1185, the archbishop Gualtiero Offamilio made possible the rebuilding of the church that became the actual Cathedral. The tower was assumed as a fundamental part of the new project. The Cathedral facade and the tower were connected each other by means of two great arches so the tower itself had three functions: defence of the church, bell tower, and contrast against the thrusts of the nave.

In the XIX century the upper part of the bell tower was radically transformed by Ferdinando Fuga in agreement to the project of Architect Palazzotto. The works were concluded in 1844. The tower reached the actual height of 55 mt from the base. Today the bell tower can be distinguished in two parts: the basement that belonged to the town walls, until 26 mt, and upper part that contains the bells placed at different levels, until 55 mt.

The historical analysis of the tower allowed the partially knowledge of the vulnerability factors of the structure. The visual survey evidenced then a generalised damage of the materials, above all the masonry then the chains and the reinforced concrete parts (the top and the floor at 42.10 mt). It was noted the absence, in many points, of the mortar joints, so a distributed transfer of the stresses was not possible. In this condition many ashlars were cracked. The upon mentioned chains were in many cases not effective with high risk for the angular columns. Then the oscillations of the main bell caused a diffused cracks on the masonry around the height of 42 mt so its activity was stopped. This was the clearest prove of the vulnerability of the tower to horizontal loads.
