STRUCTURAL MONITORING OF A HIGHWAY BRIDGE IN A HIGH-SEISMIC HAZARD URBAN AREA

In the framework of RAFAEL (System for Risk Analysis and Forecast for Critical Infrastructures in the AppenninEs dorsal Regions) project, the case study as critical infrastructure to monitor is a bridge in Catania (Sicily, Italy). This viaduct is called "San Paolo bridge (Fig. 1); the choice of this structure has several reasons: i) it is the longest viaduct in the highway surrounding the city of Catania and part of the E45 European motorway corridor; ii) the seismic hazard of Catania is among the highest in Italy (expected horizontal peak acceleration up to 0.25 g); iii) the viaduct was built about 35 years ago, when the seismic classification and building codes were different. In this paper, we present the preliminary results of the tests performed for the characterization of the structure and its foundation soil.

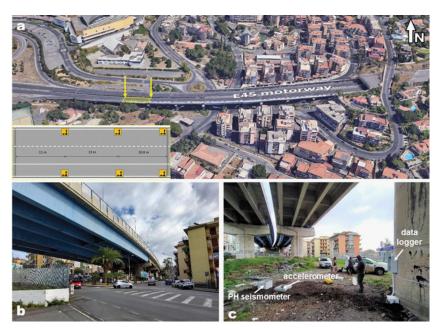
Fig. 1 - a: Google Earth view of S. Paolo bridge (the arrows indicated the segment under investigation) and plan view of sensors location for the experiments; b: lateral view (southern flank) of the structure; c: location of the posthole (50 m deep) seismometer and ground-level accelerometer.

Geophysical investigations and bridge experiments. The bridge has a total length of about 378 m and consists of 10 spans. The first and last span have a length of 33.55 m, the remaining have a length of 34 m except for the span between columns 6 and 7 which has a double length of 73 m. The bridge is supported by 9 columns and the monitored span is between the columns 4 and 5 (Fig. 1).

The results of the preliminary geophysical investigation suggested to drill the perforation at least 40 m deep. The perforation has been finally drilled down to 51 m and posthole 3-axial seismometer (model Nanometrics Trillium PH 120 s) has been placed its bottom (Fig. 1c) and set at 100 Hz sampling rate. A 3-axial accelerometer (Nanometrics Titan) has been placed at surface, next to the perforation top (Fig. 1c), at sample rate of 200 Hz. This couple of sensors, installed in January 2022, will be maintained installed for a long-term monitoring. In order to calibrate the velocimeter in the well, a velocimeter was installed at ground surface. Both sensors acquired a seismic event that occurred in January 2022. The difference between the surface and down-hole sensor is notable (Fig. 3). While the former is constantly affected by the noise of the morning traffic over the bridge (Fig. 3a), in the latter the waveforms of the event are clearly recognizable (Fig. 3b) even though a notable amount of noise is still present.

sensors were placed directly above the road, it was necessary to close the bridge to traffic. Overall, a set of 6 monitoring sites were placed in both edges of the road segment as reported in Fig. 1a. At each node were employed both a 3-axial velocimeters (Nanometrics Trillium Horizon 20s) and 3-axial accelerometers (Nanometric Titan). All the sensors were aligned in the same direction so that the two horizontal components coincide with the longitudinal and transversal directions of the bridge (Fig. 1a).
