Experimental evaluation of plasters durability aimed at maintenance planning and scheduling

Giuseppe Alaimo¹

Daniele Enea²

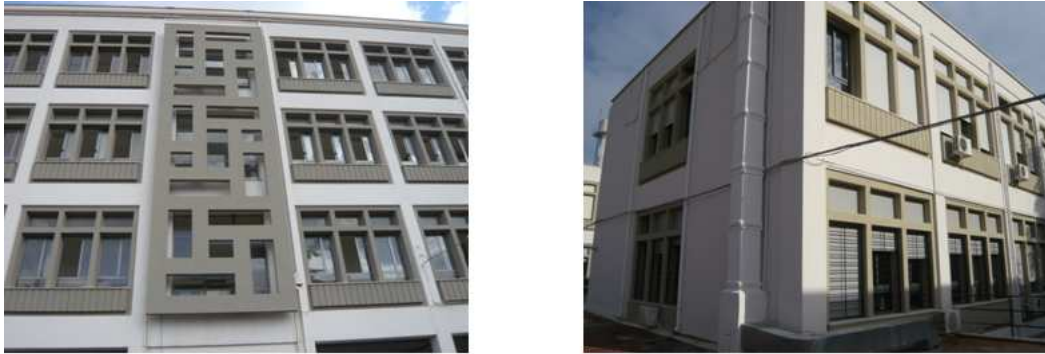
Figures 2 e 3. The brise-soleil of the body of classrooms (left) the Department of Hydraulics (right)

The three bodies are oriented in the north-west/south-east direction. The building as a whole, was built with a load-bearing reinforced concrete frame, divided into independent blocks, joined together, characterized by the presence on the facades of two or three levels of modular openings. The body of classrooms is characterized by the presence of a cantilevered reinforced concrete brise-soleil with

geometric designs, as in 'Fig. 2'. The external walls are made of square blocks of yellow limestone. The maintenance intervention of the complex (the first since its construction), prepared by the Technical Department of the University, took place over the last five years and is the starting point of this study. Particularly, the surfaces of the body of Classrooms (C) and those of the Department of Hydraulics (H), as in 'Fig. 3', and the Department of Road Infrastructures (RI) were investigated.

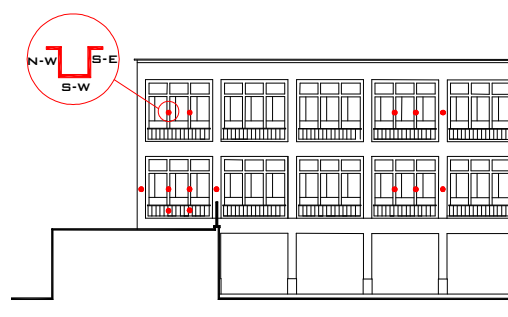
Figure 6. Department of Hydraulics South-West façade, with monitored points in red and the cross-section of a pillar, with different exposures

The monitoring of the effects of natural ageing applied on the exterior coating of the investigated buildings was applied on a representative set of points on the facades in the four different exposures, as in 'Fig. 6'. Interventions were made at different times relative to periods of natural ageing. In particular:

- February 2005 (T₃): North-East façade, body of the Classrooms;
- April 2006 (T₂): South-West facade, body of the Classrooms;
- November 2008 (T₁): North-East and South-West facades, Department of Hydraulics;
- December 2009 (T₀): North-East and South-West facades, Department of Road Infrastructures.

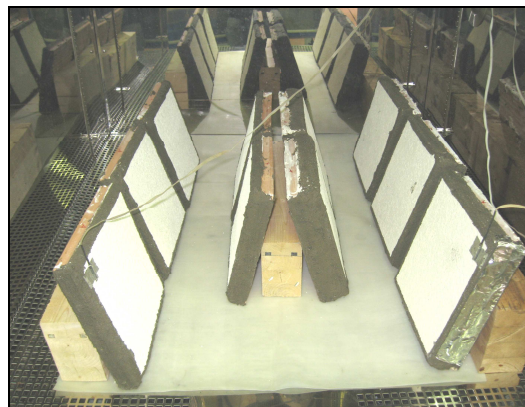
Figure 7. The samples inside the climatic chamber

Three steps of artificial ageing were set both for the white samples and the gray ones, repeating the cycle 28, 56 and 84 times, corresponding to 336, 672 and 1008 hours of stressing action in the climatic chamber. The samples were placed in the climatic chamber inclined at 60° as in 'Fig. 7'. Measures were taken at zero time (S_0 corresponds to T_0 of the natural ageing), and after every step (S_1 , S_2 and S_3). For each step, the colour measurement was taken on a couple of samples. The recorded values for the colorimetric coordinates were variable: for the white samples, the colour coordinate L^* showed values between 89.21 and 90.64 points, the coordinate a^* a variation between 0.14 and 0.37 and the coordinate b^* , a range of values between 5.18 and 7.25. For the gray samples, ranges of values measured for the three colorimetric coordinates are: $L^*=65.92\div72.23$, $a^*=0.43\div0.73$, $b^*=11.75\div12.47$.

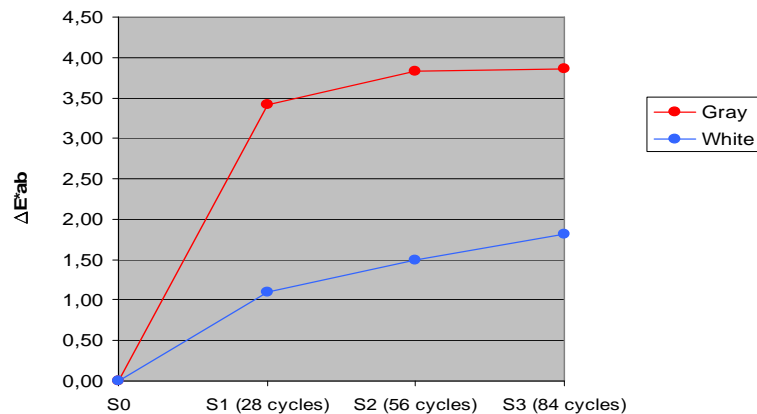
Figure 10. Colour changing on the laboratory samples (artificial ageing)

And for artificial ageing:

- The first attempt at rescaling, for white colour, shows that the degradation produced artificially in laboratory, after application of 84 cycles of ageing (S3), is equal to the natural degradation measured on surfaces naturally aged after a year, so it is appropriate to proceed with further steps to reach ΔE^*_{ab} values comparable to natural ageing after a year. Regarding the gray colour, the application of three cycles of ageing involves a colour difference measured comparable to the North-East one after a year of natural ageing.
