# Article Energy Efficiency in Historic Architecture: The "Ex Institute of Zoology and Comparative Anatomy" in Palermo

Keywords: historic architecture; energy efficiency; energy saving

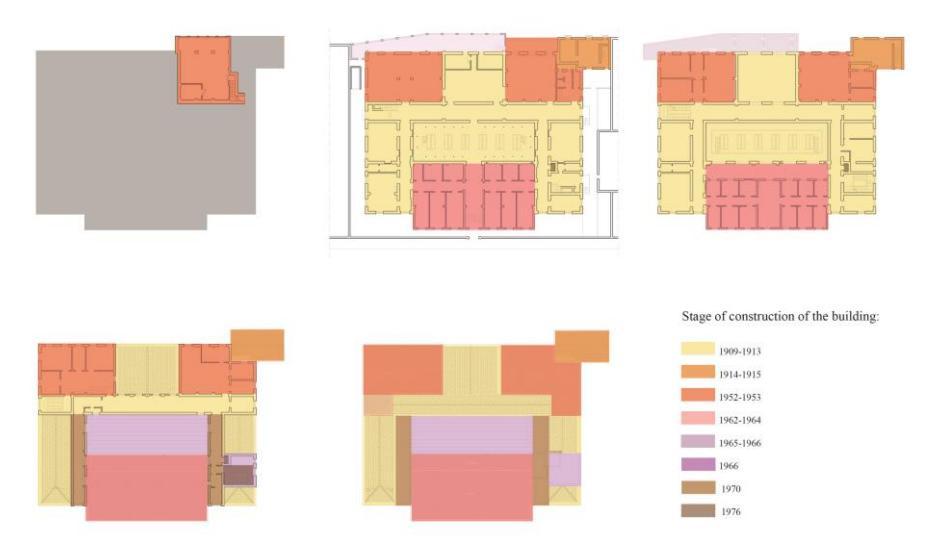
Figure 2. Stages of construction of the parts of the building during the 1900s.

On 1 January 1997, following the Decree n° 3020 of 17 December 1996 of the Academic Senate, the Institute of Zoology was transformed into the Department of Animal Biology. In 2013, the Department of Animal Biology was split into the Department of Biological, Chemical and Pharmaceutical Sciences and Technologies (STEBICEF) and the Department of Earth and Sea Science (DISTEM). Both departments continue to coexist in the same complex [23,24]. In the following Figures 2 and 3 are shown the construction phases of the building and the main facade.

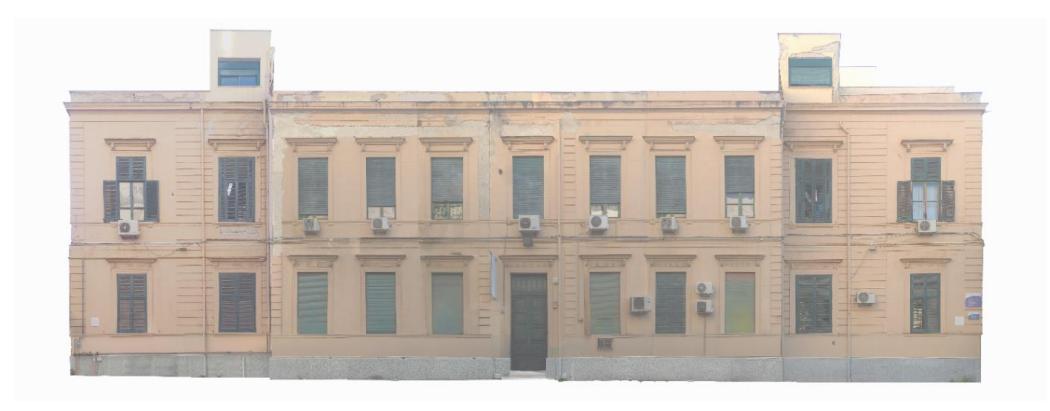
Figure 3. The main facade of the building.

For the roofs built in a later period, brick and cement floors were used. The analysis of the deteriorations was carried out on the facade of the building facing via Archirafi. The prospectus is characterized by two types of walls built in two different periods, in particular, the two wings to the original nucleus, and the central one to the expansion of 1962–1966.

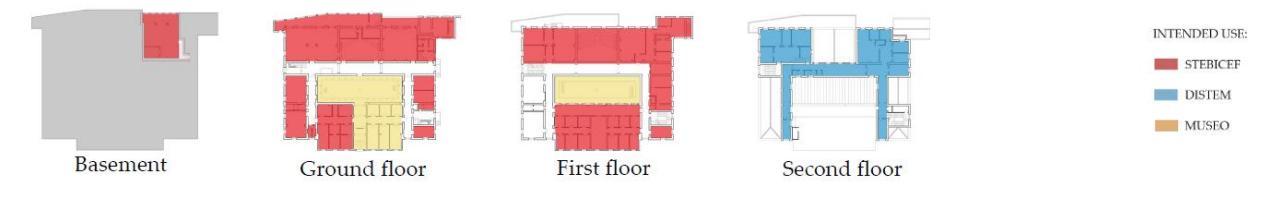
Figure 4. Scheme of the distribution of the three departments that coexist in the complex.

including the consumption relating to the specific equipment used in the laboratory [25]. In Figure 4, the three departments are distinguished.

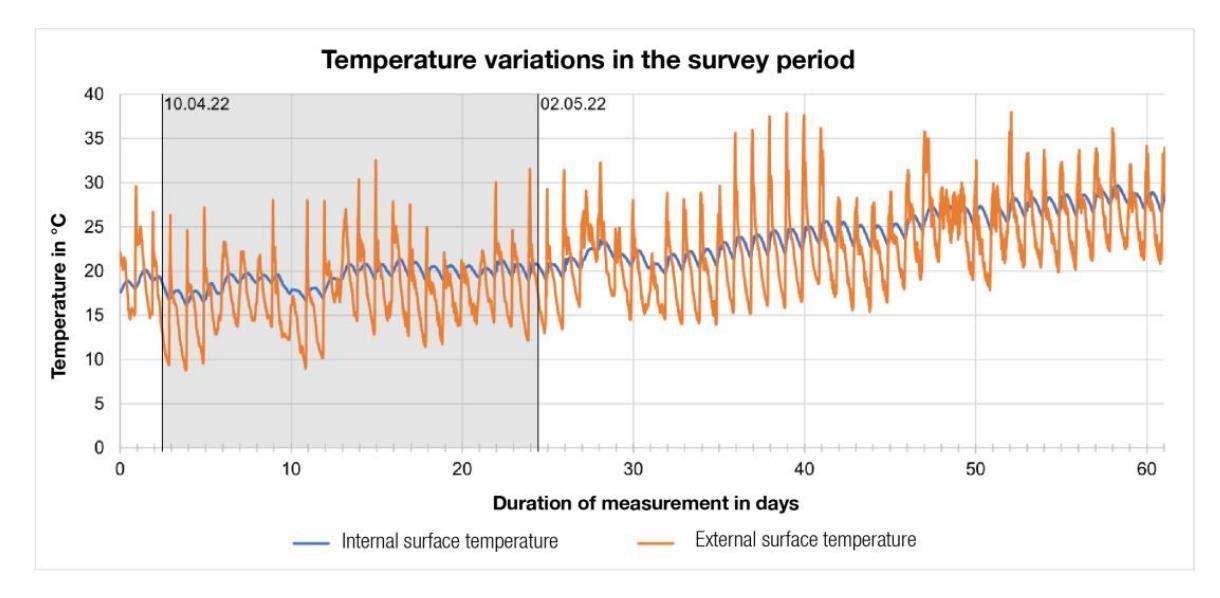
Figure 5. Temperature variations in the survey period.

A thermal conductance test was carried out on the wall of the building corresponding to the addition of 1952–1953. The measurement of the thermal transmittance in situ with the heat flow meter is a standardized procedure applied to the opaque surfaces of a building. It is based on the analysis of the thermal flow that passes through the architectural structure as well as the internal and external surface temperatures (UNI EN 9869-1:2015) [28]. In the preliminary phase, an area of the building was identified far from heat sources, shafts and any thermal bridges for intermittent use; for this reason, the corridor on the second floor was chosen as a suitable place for the test. The analysis was carried out by placing two probes on the internal surface of the perimeter infill under investigation, and a second pair of probes outside the structure. These instruments, connected to an internal plate, are used to calculate the internal and external surface temperature (see Figure 5).

Data were collected for 17,636 steps per hour. In the analysis period, barring sporadic exceptions, the range of variation in the external surface temperature overlaps that of the internal surface temperature, as shown in the graph below. This circumstance has a very negative impact on the success of the test. The graph also shows a relative stability of the temperature (especially internal) before exceeding eight thousand readings. For this reason, subsequent data have been discarded. The data corresponding to the first days of the survey were also discarded, because the calculation of the conductance

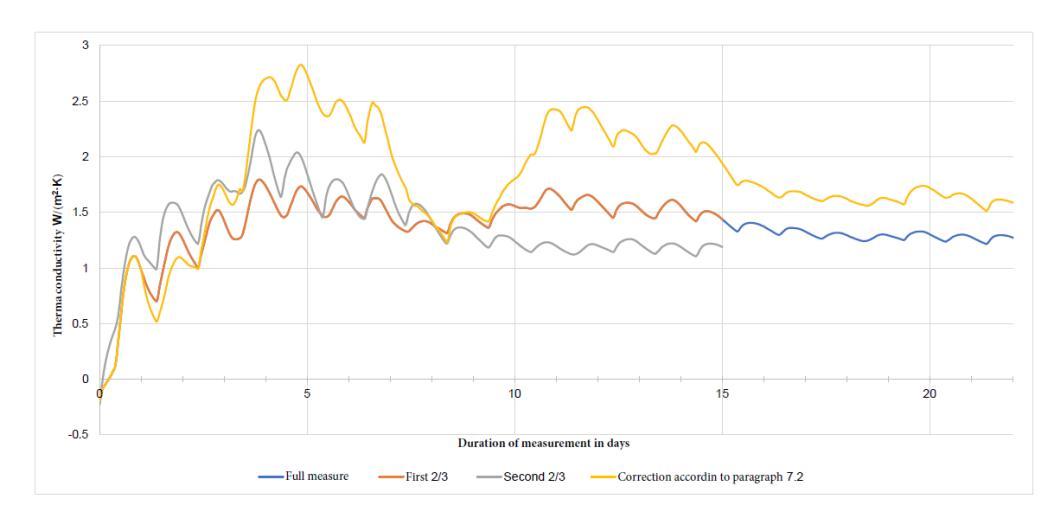
Figure 6. Measured values of thermal resistance.

- 3. The strength obtained considering the first two-thirds of the test period is  $0.65 \text{ m}^2 \cdot \text{K} \cdot \text{W}^{-1}$  (0.64 m<sup>2</sup> · K · W<sup>-1</sup> if the average of the last twelve hours is calculated), while when considering the last two-thirds of the test period it is  $0.84 \text{ m}^2 \cdot \text{K} \cdot \text{W}^{-1}$  (0.83 m<sup>2</sup> · K · W<sup>-1</sup> with the average of the last twelve hours); the deviation is 22.5% (22.53% with the values calculated on the basis of the average of the last twelve hours of testing); therefore, it is clearly outside the ±5% range. In Figure 6 are shown the results obtained for thermal resistance measurements.

Following the corrective criterion, we obtain  $\Lambda = 1.59 \text{ W} \cdot \text{m}^{-2} \cdot \text{K}^{-1}$  (R = 0.63 m<sup>2</sup>·K·W<sup>-1</sup>). The R value is much smaller than the R = 0.86 m<sup>2</sup>·K·W<sup>-1</sup> value (as the sum of the R<sub>k</sub> terms). The deviation is equal to 26.33%, outside the range ±5% The conditions under letters "a", "b" and "e" of the list in paragraph 7.2.3 are satisfied. As for "d", the ±5% interval is always respected if these are calculated by considering the average of the results of the last twelve hours. Instead, if the final value is considered, only the comparison between the R-value at the end of the test and that of twenty-four hours earlier is respected.

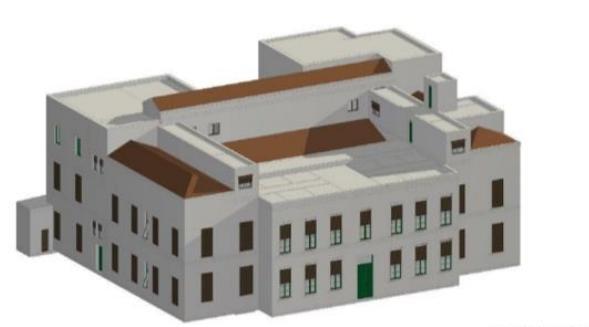
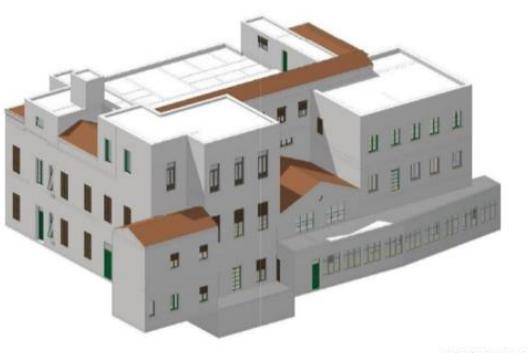
Figure 7. BIM model of the building under study.

The estimation of the loads was performed with the aid of the TERMUS-BIM software, creating the BIM model. The analysis is carried out starting from the climatic data of the place where the building is located, just entering the locality and the climatic zone. By compiling the properties of materials and the stratigraphy of the individual construction elements, the program allows you to identify the transmittance values and verify that they comply with the UNI EN ISO 13788 standard [31]. In Figure 7 is shown the BIM model of the building, and in Table 1 are listed the energy required, the thermal load and the CO<sub>2</sub> emitted in one year.
