ENERGY SAVINGS IN BUILDING RESTORATION - AN APPLICATIVE CASE

Keywords: *School building, energy performance of building, building restoration.*

The “La Masa” school

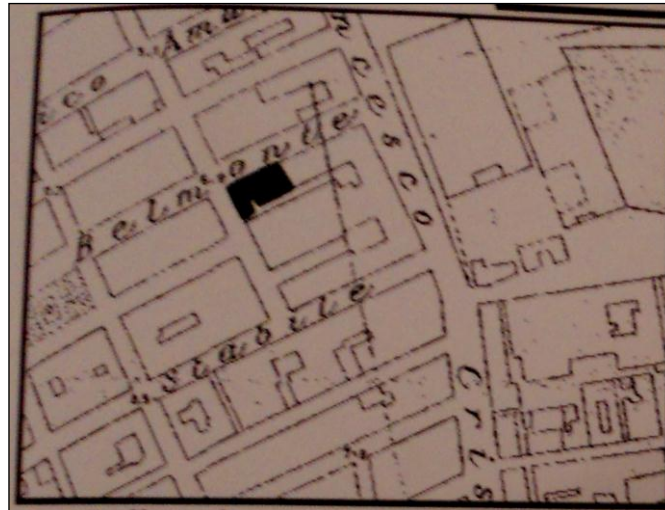
Figure 1: Urban plan (1939) (Archive of the office contract, Municipality of Palermo).

The “La Masa” school is placed in an urban area that was expanding in the early years 1900s (see Fig. 1 and Fig. 2).

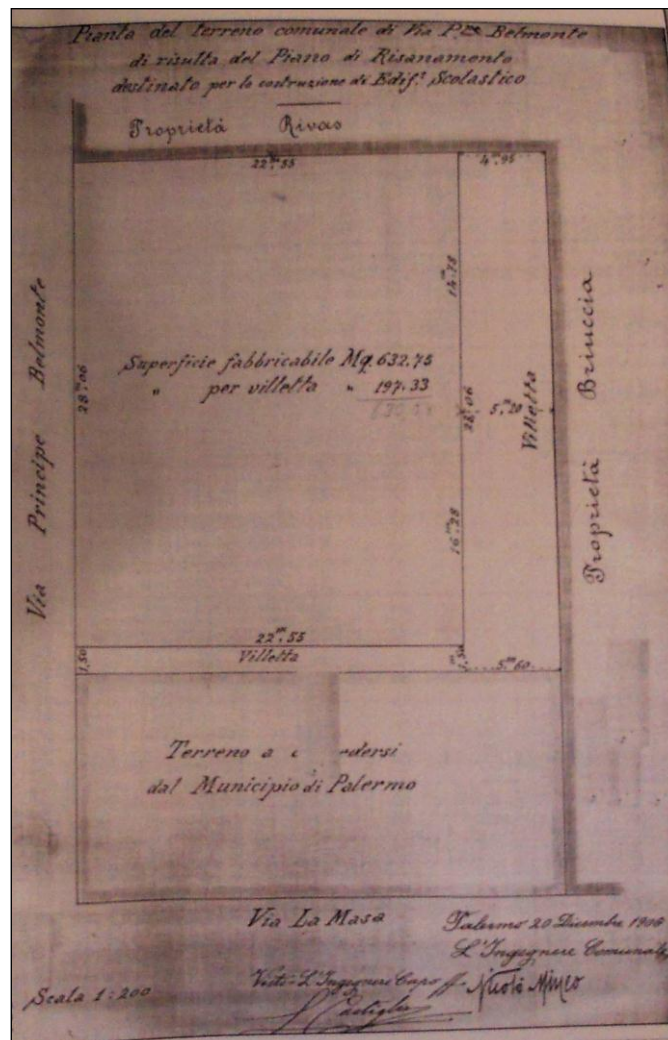
Figure 2: Location of area (1908) (Archive of the office contract, Municipality of Palermo).

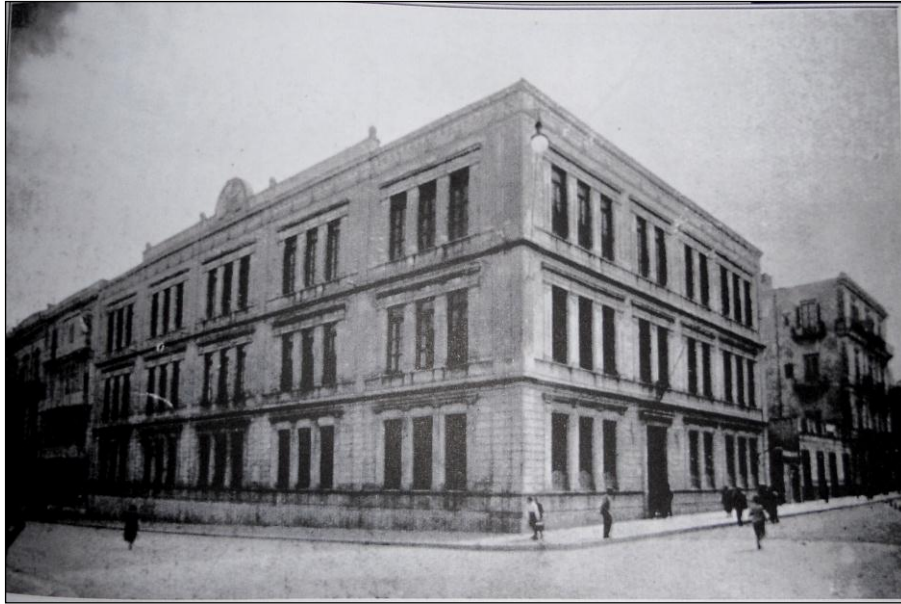
Figure 4: The school after the addition of a storey (1930) (Archive of the office contract, Municipality of Palermo).

In 1929 the “La Masa” school was enlarged with the addition of a storey in order to obtain 14 classroom (see Fig. 4). The materials and techniques adopted were the same as the original construction.

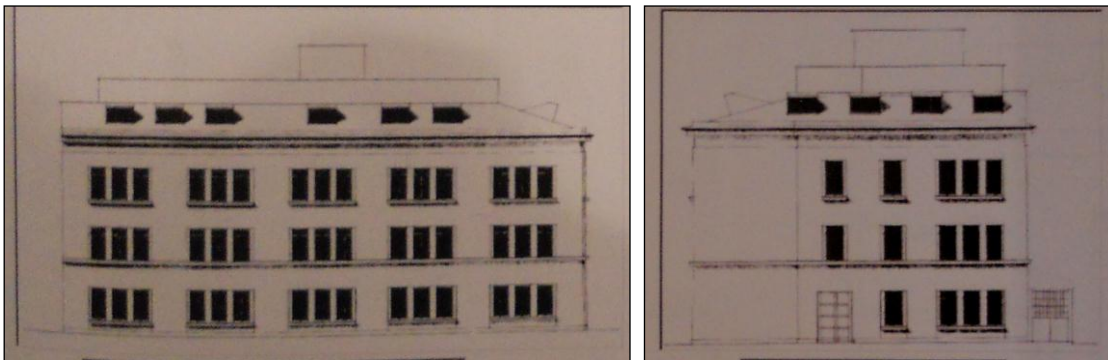
Figure 5: Façades of the “La Masa” school (after 1947).

In 1947 the wooden floors have been replaced with brick and concrete floors, and a part of the structure with reinforced concrete. The outside ornaments are no longer and the current appearance of the building is much more austere and simple (see Fig. 5 and Fig.6).

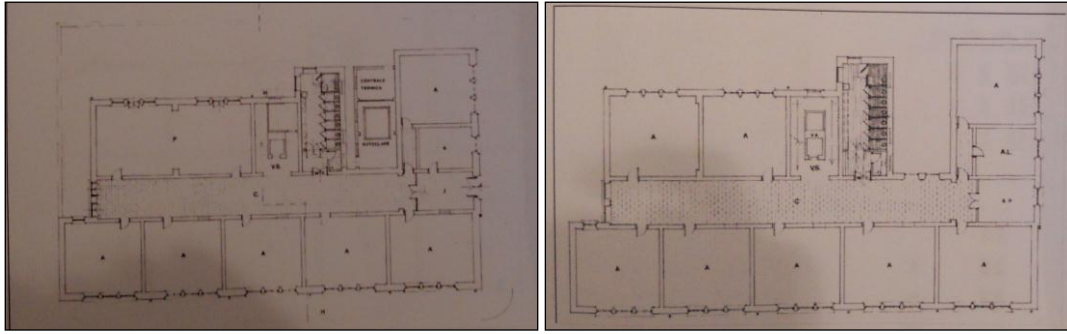
Figure 6: Plans of the “La Masa” school (after 1947): first and second floor.

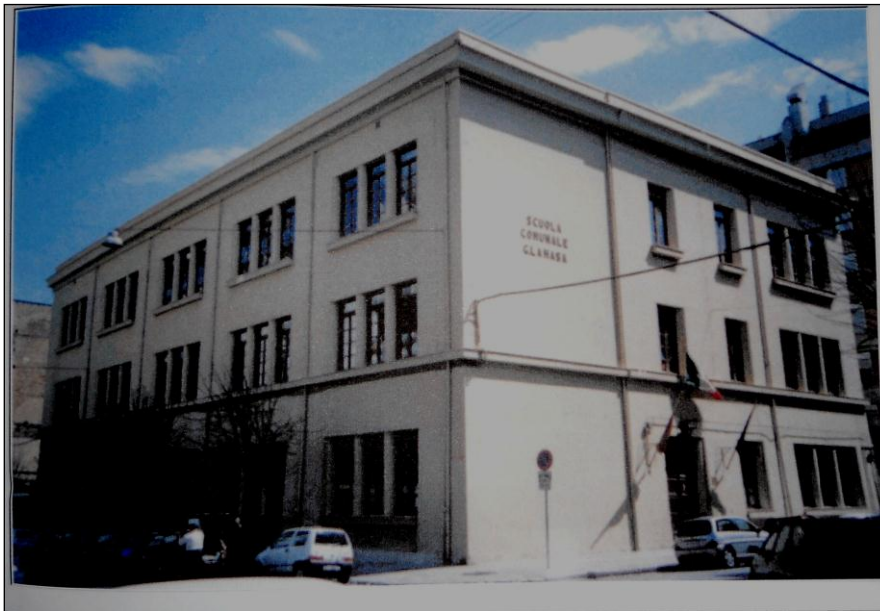
Figure 7: Photography of the school façade in 1990.

In the 1990, the school was refurbished and was checked the structural integrity of building (see Fig.7).

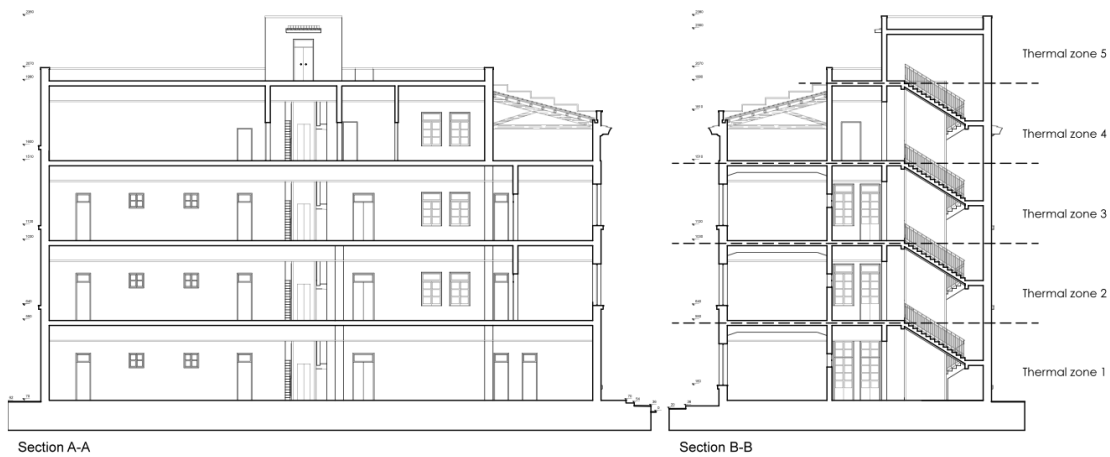
The building was divided into calculation conditioned zones at temperature of 20°C (see Fig. 8):

- first floor – Zone n. 1 (ground floor);
- second floor – Zone n. 2;
- third floor – Zone n. 3;
- forth floor – Zone n. 4;
- fifth floor – Zone n. 5.

The attic and the boiler room are unconditioned areas.

Figure 8: Cross section of building and thermal zones.

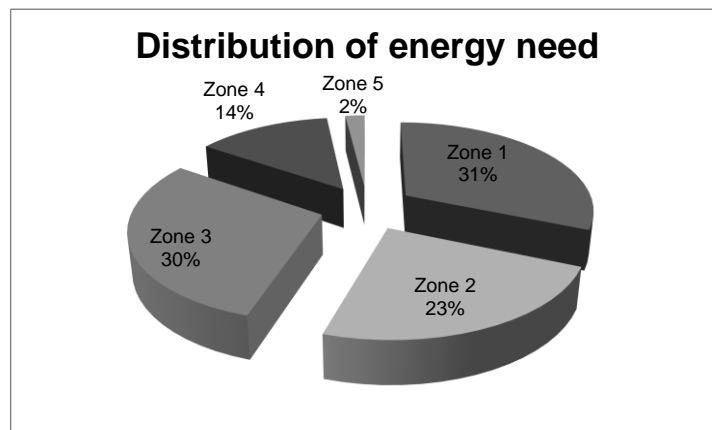
Figure 9: Percentage distribution of energy need for heating

The results relate to the calculation period of heating season (December 1 – March 31) set by Italian legislation. The climatic data were taken by the UNI 10349 Italian standard (UNI 10349, 1994). Table 3 and Fig. 9 report the results of calculation of energy need for heating with reference to the building envelope

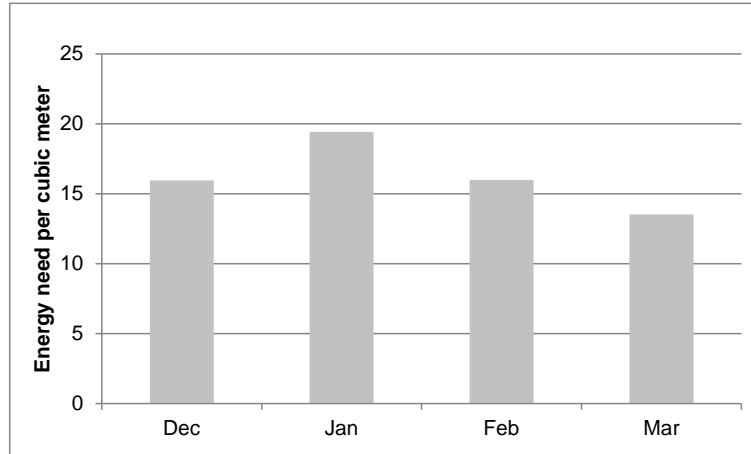
It is certainly more useful to know the energy need per cubic meter that, in this case, is equal to 64,9 MJ/m³. The Figure 10 shows the trend of the energy need per cubic meter during the heating season.

Figure 10: Percentage distribution of energy need for heating

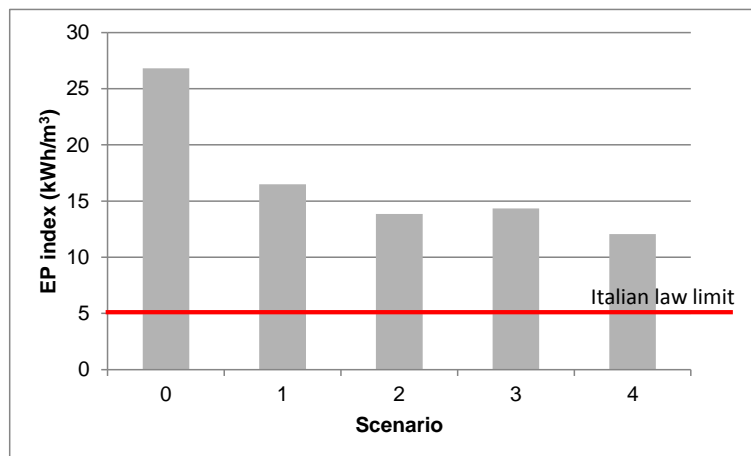
The proposed action scenarios influence considerably the energy consumption of building; in fact, these actions reduce the energy consumption between 38.5% to 55.1%. However, none of these actions is able to cut down the energy consumption so much so that the Energy Performance index goes below the law limit value (see Fig. 11).

Figure 11: Graph of the EP index of various scenarios.

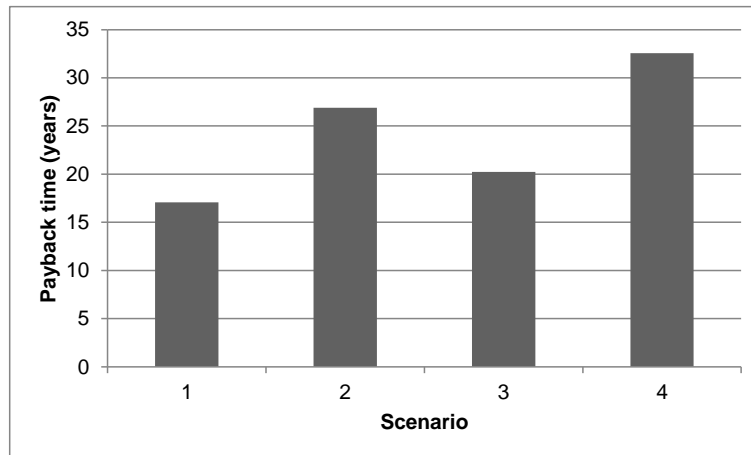
With regard to financial statement analysis, the payback times of action scenarios are assessed in order to evaluate the profit of each scenario (see Fig. 12).

Figure 12: Graph of the payback time of various scenarios.

The scenarios 2 and 4 are necessary to achieve the level of insulation required by Italian law “D.Lgs 192/05” (ITALIAN DECREE n.192, 2005), but both of them are not economically viable even unacceptable (payback times are longer than the useful life of interventions); on the contrary, the scenarios 1 and 3 are economically viable.
